CA18/2/3/8063				
		SOUTH AFRICAN CIVIL AVIATION AUTHORITY AIRCRAFT ACCIDENT REPORT AND EXECUTIVE SUMMARY				
Aircraft Registration	ZS-RXA	Date of Accident	17 January 2006	Time of Accident	0815Z	
Type of Aircraft	Robinson R22 Beta II		Type of Operation	Training		
Pilot-in-command Licence Type		Student Pilot	Age	41	Licence Valid	Yes
Pilot-in-command Flying Experience		Total Flying Hours	37.8	Hours on Type	37.8	
Last point of departure		Cape Town International Aerodrome (FACT)				
Next point of intended landing		Cape Town International Aerodrome (FACT)				
Location of the accident site with reference to easily defined geographical points (GPS readings if possible)						
Crashed into the sea 800m off-shore near Cape Point (GPS position: South 34°20.465 East 018° 28.991)						
Meteorological Information		Surface wind; 230°/7kt, Temperature; 20°C, Cloud cover; Scattered at 1000 feet				
Number of people on board	1 + 0	No. of people injured	0	No. of people killed	1

AIRCRAFT ACCIDENT REPORT

Name of Owner : Halocopter Partnership
Name of Operator : Starlite Aviation
Manufacturer : Robinson Helicopter Company
Model : R22 Beta II
Nationality : South African
Registration Marks : ZS-RXA
Plac

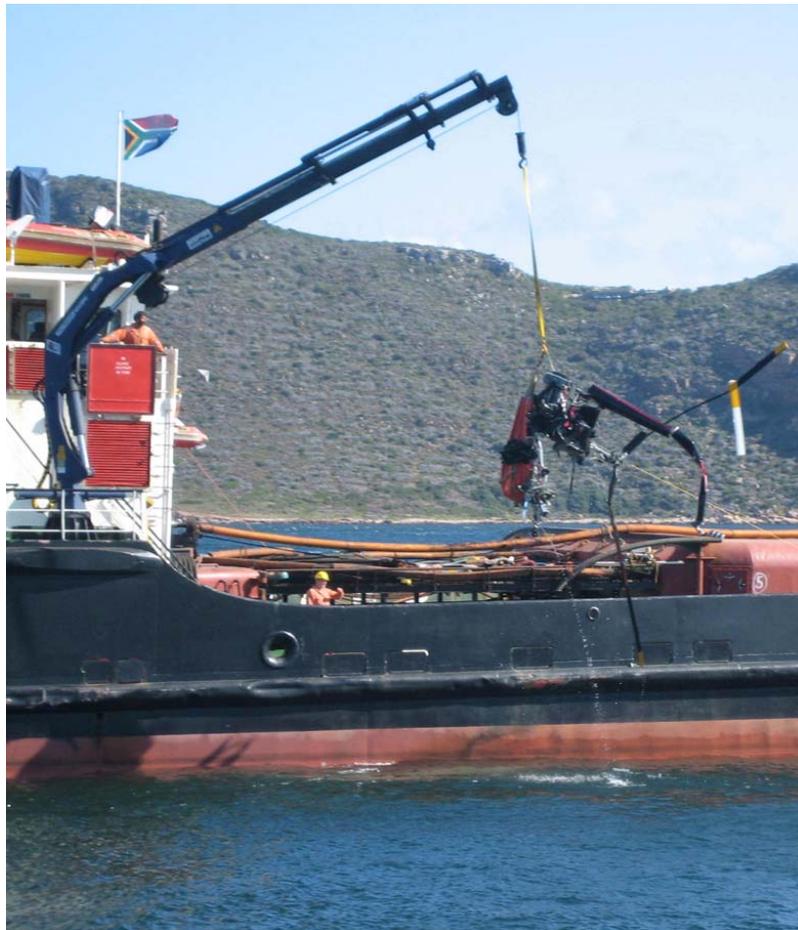
1.3.1 The helicopter was destroyed during the impact sequence and subsequent submersion.

Figure 2. A view of the wreckage being lifted from the sea onto the recovery vessel.

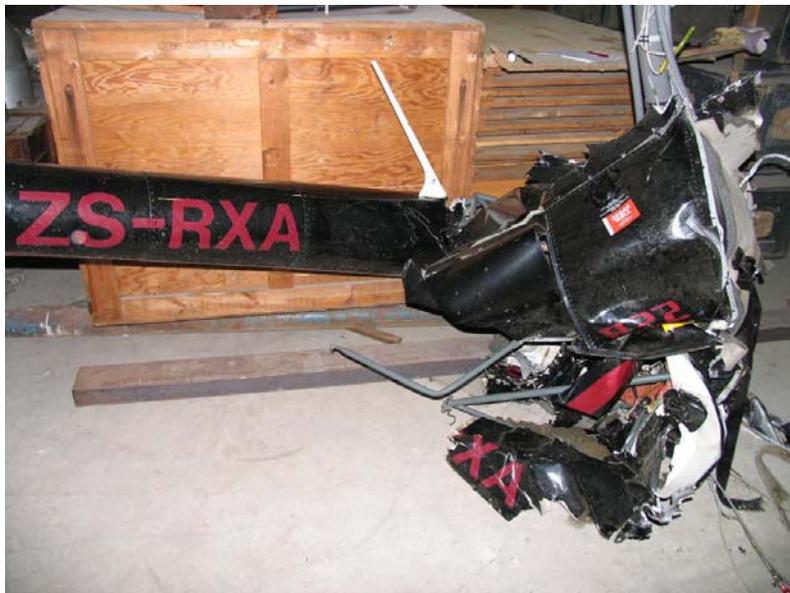
Figure 3. View of the wreckage after it was salvaged from the sea.

The engine was removed and the wreckage was repositioned to a hangar in order to conduct the wreckage layout inspection, which was concluded the following day. Even though the wreckage was found to be severely disrupted due to impact, it was possible to assess that all failures that were identified, were consistent with overload mode with the tail cone and tail rotor assembly still fairly intact.

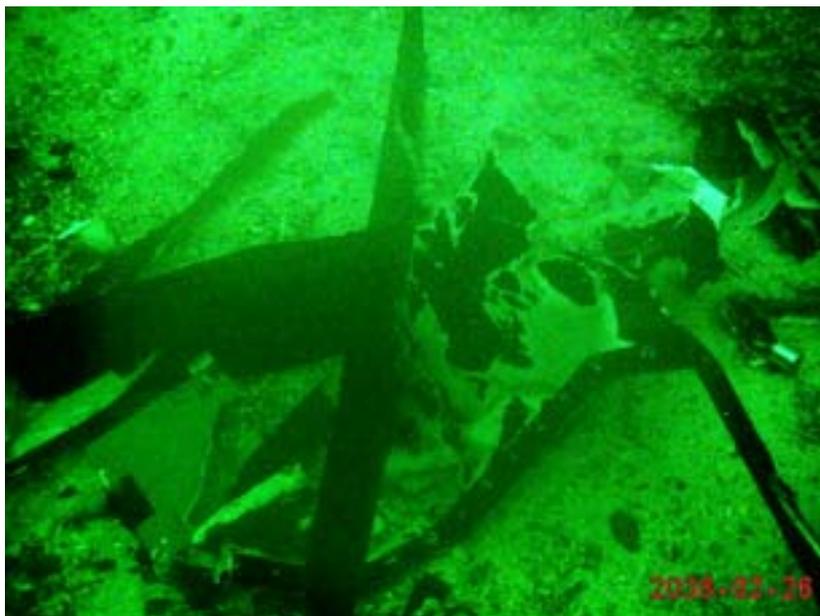
- 1.12.1 The helicopter was observed to have crashed into the sea in a nose-down attitude. Following impact with the water, the wreckage sank to a depth of 27m to the bottom of the ocean. Although the canopy/cabin area was severely disrupted following the impact sequence, the wreckage remained fairly intact. Certain lightweight articles that were installed on the helicopter surfaced, and were found floating in the area where the helicopter went down. Rescue boats that surveyed the area located several floating objects from the sea surface.

Figure 6. A view of the wreckage on the seabed as taken by one of the divers.
