AIRCRAFT ACCIDENT REPORT AND EXECUTIVE SUMMARY

Reference:	CA18/2/3/8389	
Aircraft Registration	ZS-FTH	Date of Accident	14 November 2007		Time of Accident	1320Z
Type of Aircraft	PA28-140		Type of Operation	Training		
Pilot-in-command Licence Type		Commercial	Age	54	Licence Valid	Yes
Pilot-in-command Flying Experience		Total Flying Hours	4 070		Hours on Type	180
Last point of departure		Brakpan Benoni Aerodrome (FABB)				
Next point of intended landing		Brakpan Benoni Aerodrome (FABB)				
Location of the accident site with reference to easily defined geographical points (GPS readings if possible)						
On the traffic island of the N17 highway, GPS position: S26° 15.204" E028° 18.482"						
Meteorological Information		Surface wind 9 kts, temperature, 29°C, visibility CAVOK				
Number of people on board	1 + 1	No. of people injured	1 + 1	No. of people killed	0	
Synopsis						
<p>On the 14 November 2007 at approximately 1315Z, the instructor and a student pilot took off from runway 18 at Brakpan Benoni Aerodrome (FABB) on a dual training flight with the intention of returning to FABB.</p> <p>The pilot stated that on take-off, during the climb-out phase, the aircraft experienced a sink a

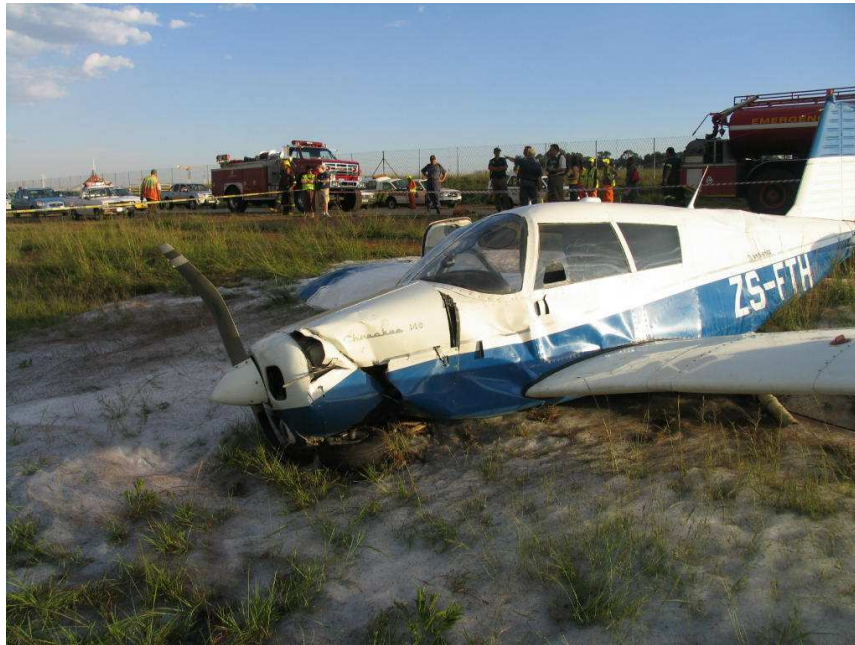
Figure 1: Damage to the aircraft

1.3.1 The aircraft was substantially damaged.

1.12.2 The fuselage aft of the cockpit remained relatively intact. The right wing, the undercarriage and the propeller were substantially damaged during the impact sequence.

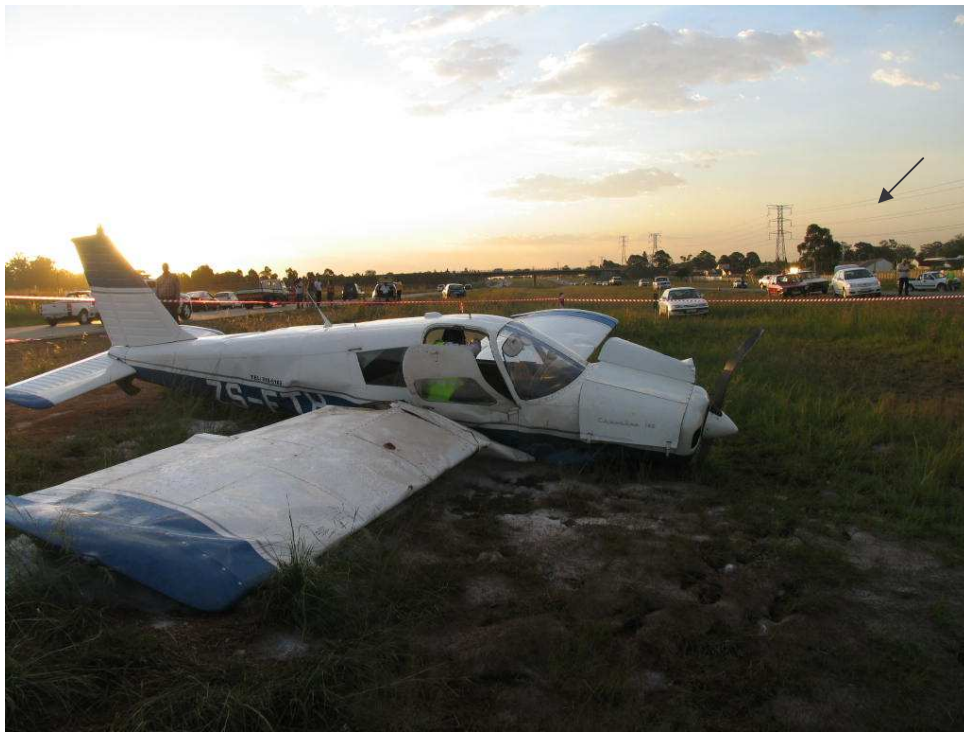
Figure 2: The accident site and nearby power lines

1.4.1 There was minor damage caused to the Eskom power lines.

1.12.1 The accident site was a level grassy area next to the N17 highway in Brakpan. The aircraft made initial impact with Eskom power lines that run parallel to the highway. The aircraft struck the upper earth wire, banked to the left and crashed on the highway island. Evidence and airframe damage indicated that it struck the ground on a south-easterly heading, while in a slight nose-down and low-right-wing attitude.

Eskom power lines that the aircraft impacted before it crashed

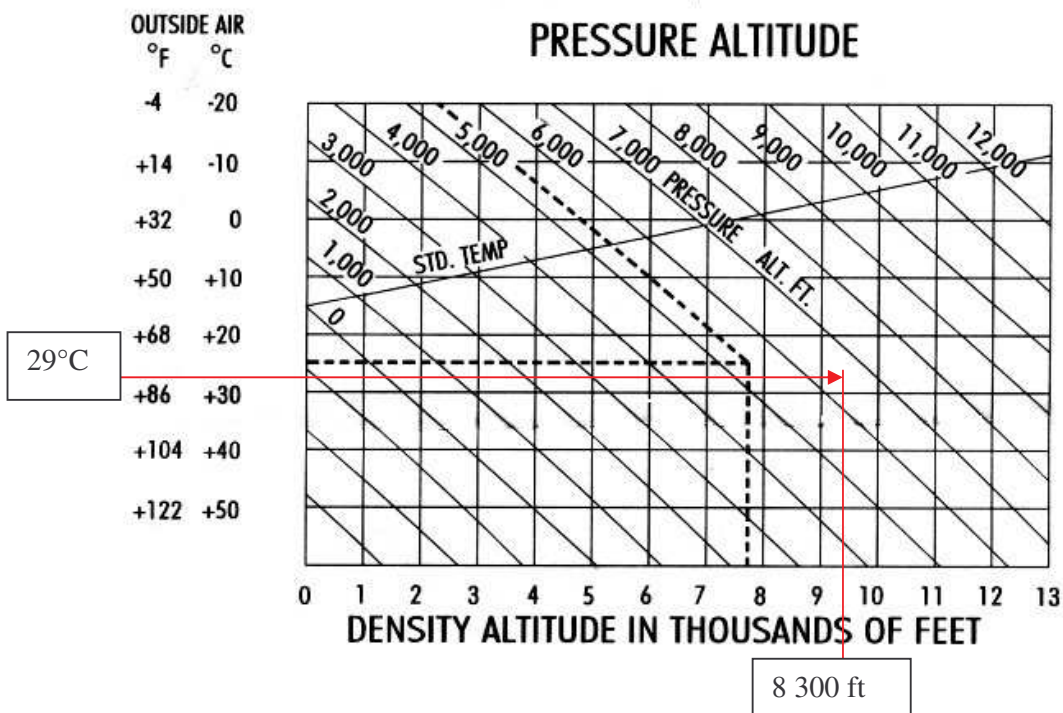
Figure 3: Density altitude chart

1.16.3 The airport is located at an elevation of 5 300 ft and the temperature at the time of the accident was measured at 29°C. Using the density altitude chart, the density altitude was determined to be approximately 8 300 ft.

- 2.3 The prevailing environmental conditions at the time of the accident were considered to have been a factor in this accident, with the reported temperature at 29°C and the density altitude calculated to be approximately 8 300 ft.

- 2.4 The relatively high density altitude on the day, and the aircraft gross weight (which was just below the maximum take-off weight) combined to adversely affect the aircraft's acceleration and climb performance. As a result, the aircraft's climb performance was inadequate for the aircraft to clear all obstacles (namely Eskom power lines).
