AIRCRAFT ACCIDENT REPORT AND EXECUTIVE SUMMARY

Reference:	CA 18/2/3/8562	
Aircraft Registration	ZS-HBS	Date of Accident	18/10/2008	Time of Accident	± 1100Z	
Type of Aircraft	ROBINSON R 44 II		Type of Operation	Pleasure Flight		
Pilot-in-command Licence Type		Commercial (H)	Age	36	Licence Valid	Yes
Pilot-in-command Flying Experience		Total Flying Hours	4115		Hours on Type	1440
Last point of departure		The farm Lepeng, Lydenburg district. (Mpumalanga)				
Next point of intended landing		Rand Aerodrome (FAGM). (Gauteng)				
Location of the accident site with reference to easily defined geographical points (GPS readings if possible)						
In a gorge next to the Spekboom River. (S 24° 58.029 E 030° 25.701)						
Meteorological Information		Temperature: 21°, Visibility: > 10km, Dew point: 13°C, Surface wind: 310/10KT				
Number of people on board	1+2	No. of people injured	0	No. of people killed	1+2	
Synopsis						
<p>On 18 October 2008, the aircraft was on a return flight from the farm Lepeng to Rand Aerodrome.</p> <p>At approximately 1100Z a witness who was at Kudu Ranch, overlooking the Spekboom River valley, heard the sound of a helicopter. He heard what sounded like a sudden loss of

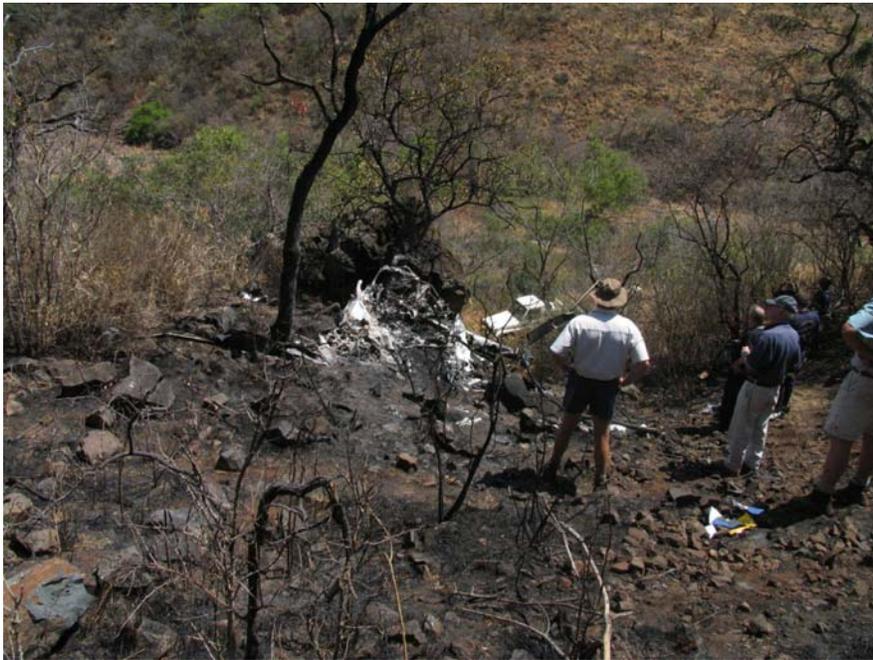
The helicopter collided with the ground in a steep valley next to the Spekboom River. The helicopter's direction on impact was at 191° Magnetic at a height of 3519 feet above mean sea level. The site was in a steep valley with rocky terrain. **(Figure 1)**

Figure 1 The accident site.

The aircraft collided with a huge rock, which prevented the aircraft from rolling down the valley.

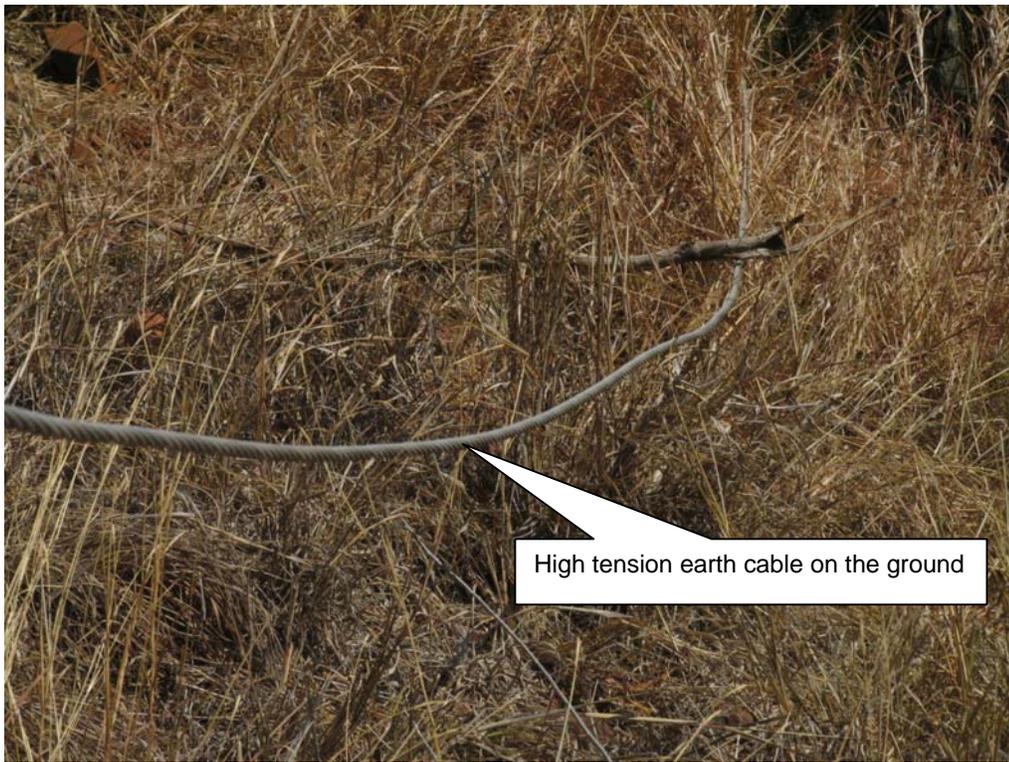
The severed end of the high tension earth cable was found approximately 100 metres before the accident site which made the investigator believe that the cable was dragged by the helicopter after the collision with the high tension cable. This severed cable hanged down from the pylon and touched the ground about 400 m before the accident site. **(Figure 2)**

Figure 2 High tension earth cable on the ground.

It would appear as if this cable had been dragged by the helicopter after being severed.

The high tension earth cable did not have any high visibility markers to indicate its position across the valley.

2.10 The broken end of the high tension earth cable was found approximately 100 metres before the accident site which made the investigator believe that the cable was dragged by the helicopter after the collision with the high tension cable.

a) The SACAA issue a safety recommendation to pilots to minimize the unnecessary exposure of aircraft and crews to low-level hazards, including power lines, and thus reduce the risk of wire strikes.

b) The SACAA issue guidance material to inform pilots on safety hazards during low-level operations.

c) The SACAA and ESCOM consider the feasibility of the establishment of a national database of information on the location of known power lines and tall structures for access by pilots and to be used for flight route planning purposes.

d) The SACC addresses a letter to ESCOM advising them of the cause of this accident and request a review of their policy in respect of the marking of power lines and other lines that infringe on aviation safety.

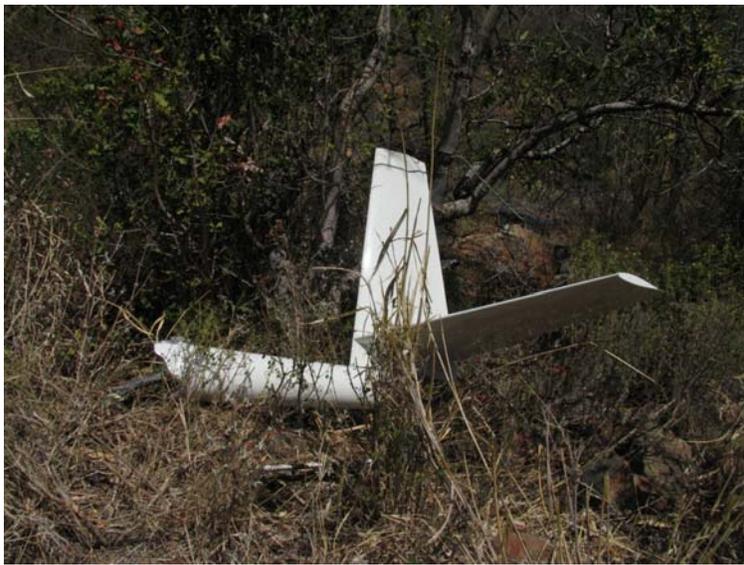
The part of the tail boom that separated from the aircraft (**Figure 3**) was found approximately 50 m past the main wreckage in the direction of intended flying. Evidence (paint marks the same colour as the main rotor blades) shown this part of the tail boom was separated from the rest of the tail boom as a result of the main rotor blades cutting through the tail boom. It was also evident, when inspecting the damage to the tail rotor blades; that the tail rotor was not rotating when this part of the tail boom made contact with the ground.

Figure 3 Part of the tail boom that was separated from the aircraft

- 2.4 Inspection of the helicopter's tail boom revealed that the rear part of the tail boom was separated from the aircraft by the main rotor blades. The investigator is of the opinion that a harsh movement on the cyclic control caused a flap movement of the main rotor blades which caused the main rotor blade path to be lower than normal where by it made contact with the tail boom and separated the rear end of the tail boom from the aircraft. The rear part of the tail boom was found approximately 50 metres from the main site. Evidence showed that the tail rotor was not rotating when the rear part of the tail boom made contact with the ground.

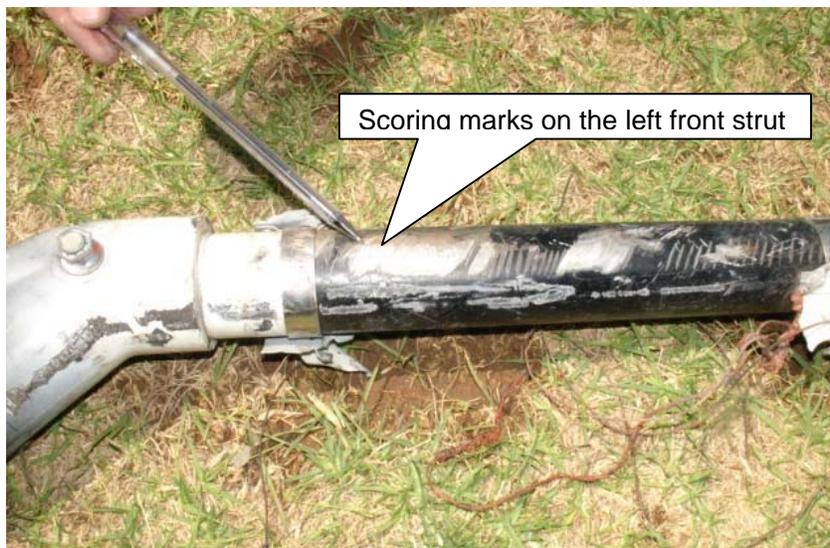
During the inspection of the aircraft skid gear, scoring marks on the left-hand front skid strut indicated that the aircraft had made contact with the high tension earth cable. **(Figure 4)** No scoring marks were found on the right-hand skid gear.

Figure 4 Scoring marks on the left-hand skid gear.

- 2.6 The left landing gear skid strut showed clear evidence of an object rubbing against the strut with associated scoring marks. The investigator is of the opinion that these scoring marks were caused by the high tension electrical earth cable struck by the landing gear skid. The left-side landing gear strut was also found to be deformed to the rear.

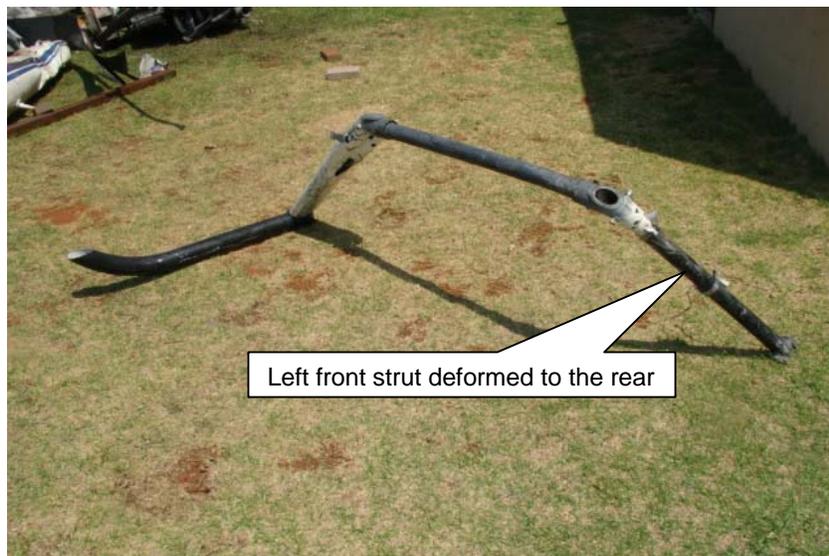
It was also found the left hand side of the skid gear was deformed to the rear **(Figure 5)** One of two bolts connecting the cross tube to the elbow at the right front side was sheared during the collision with the high tension wire.

Figure 5 Left front strut deformed to the rear

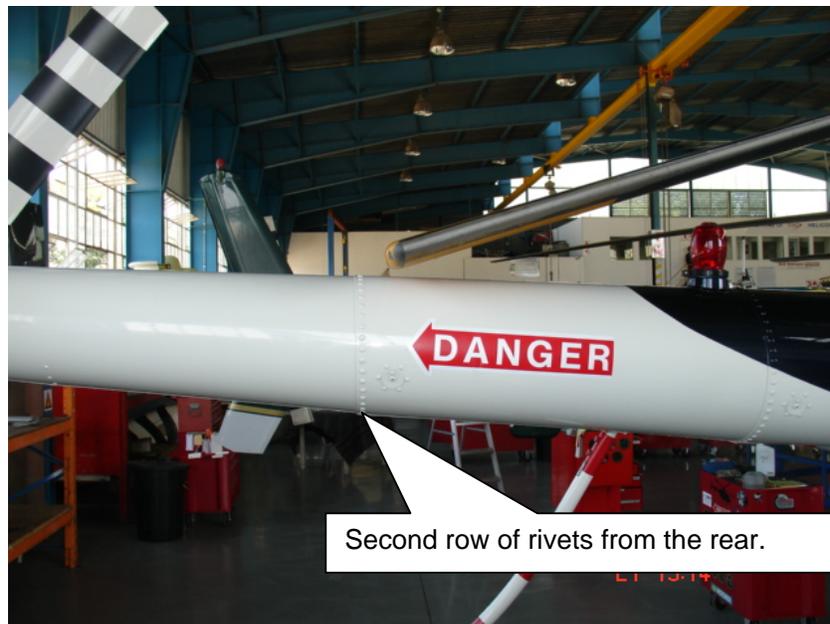
1.16.1 Tests conducted on a similar aircraft revealed that maximum downwards movement of the main rotor blades, when stationary, will stop approximately 1.5 centimetres above the tail boom. **(Figure 6)**

Figure 6 Maximum downward positions of the main rotor blades when stationary.

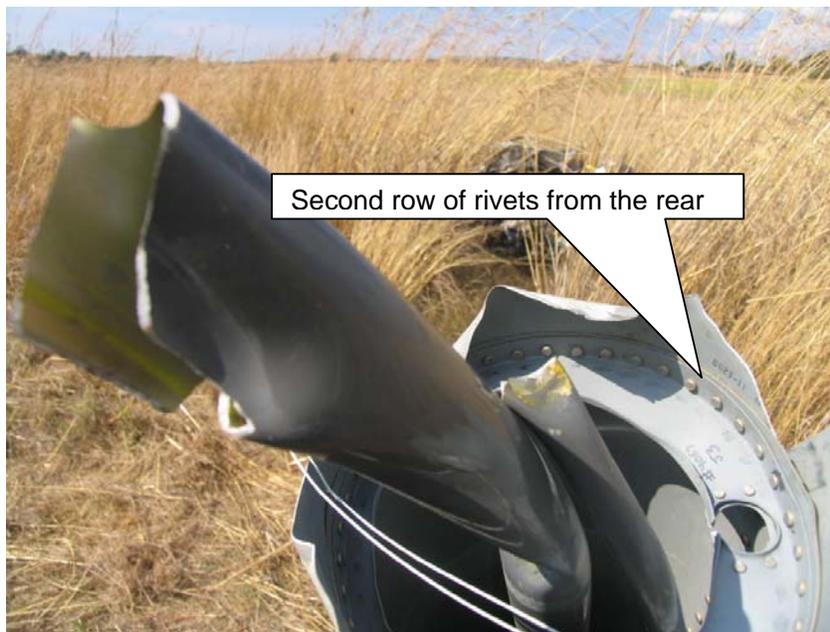
1.16.2 The position of the main rotor blades in relation to the tail boom correlates to the precise position of damage on the tail boom of the aircraft involved in the accident. **(Figure 6 and 7)**

Figure 7 Damage caused at the second row of rivets on the accident aircraft.
