SOUTH AFRICAN CIVIL AVIATION AUTHORITY
(SACAA)

ACCIDENT INVESTIGATION REPORT

FINAL REPORT

**Jetstream Aircraft 4100 ZS-NRM:
Loss of control after engine failure
and misidentified engine shutdown
after take-off from Durban Airport,
South Africa
on 24 September 2009**

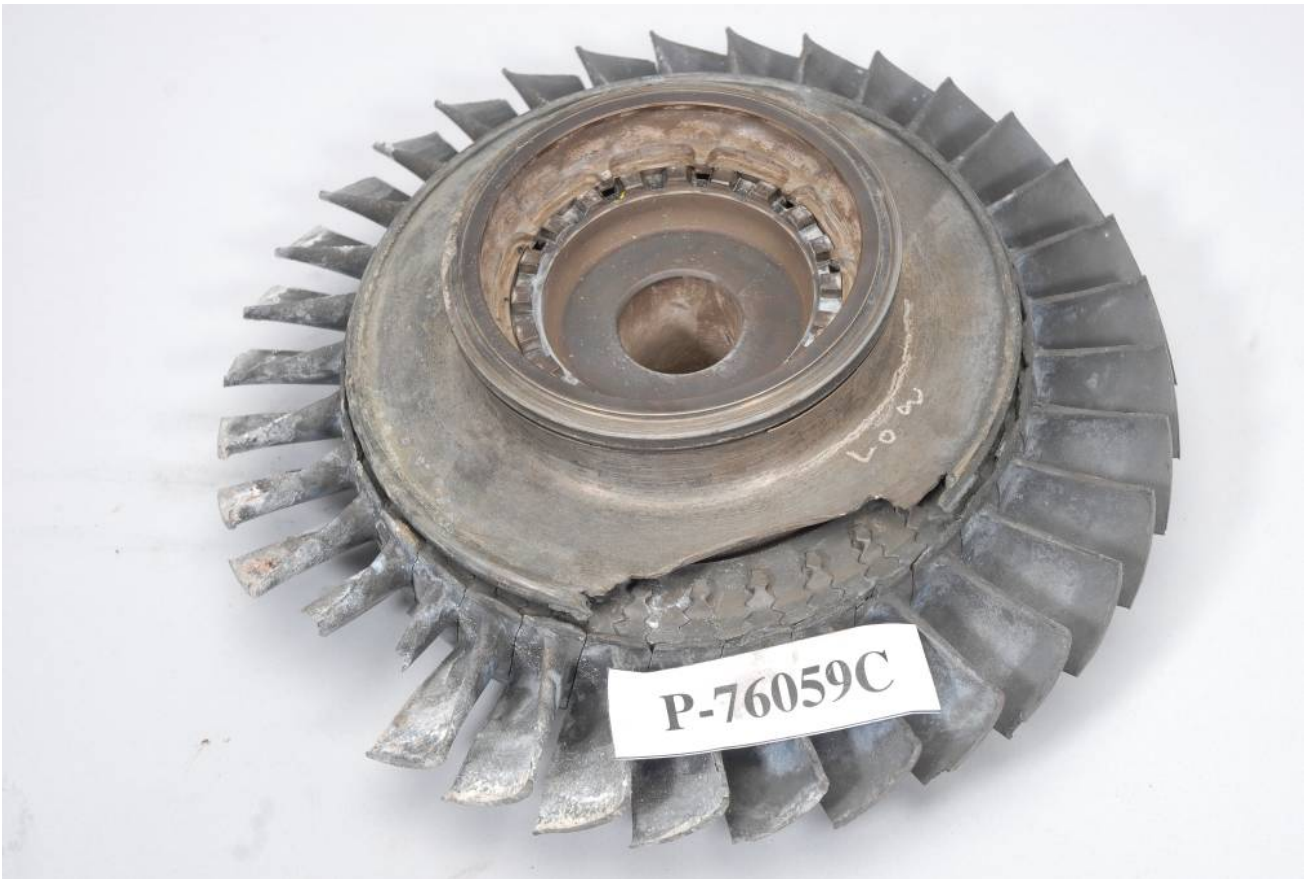
Examination of the wreckage confirmed that the right-hand engine (engine 1) had suffered a catastrophic failure of the second-stage turbine seal plate and that subsequently the serviceable engine had been shut down, resulting in a forced landing.

Figure 1. The failed seal plate.

The FAA should require Honeywell Aerospace to expedite efforts to produce an engineering solution to the problem of second-stage turbine rotating air seal failures on Honeywell TPE331-14G/H engines.
--

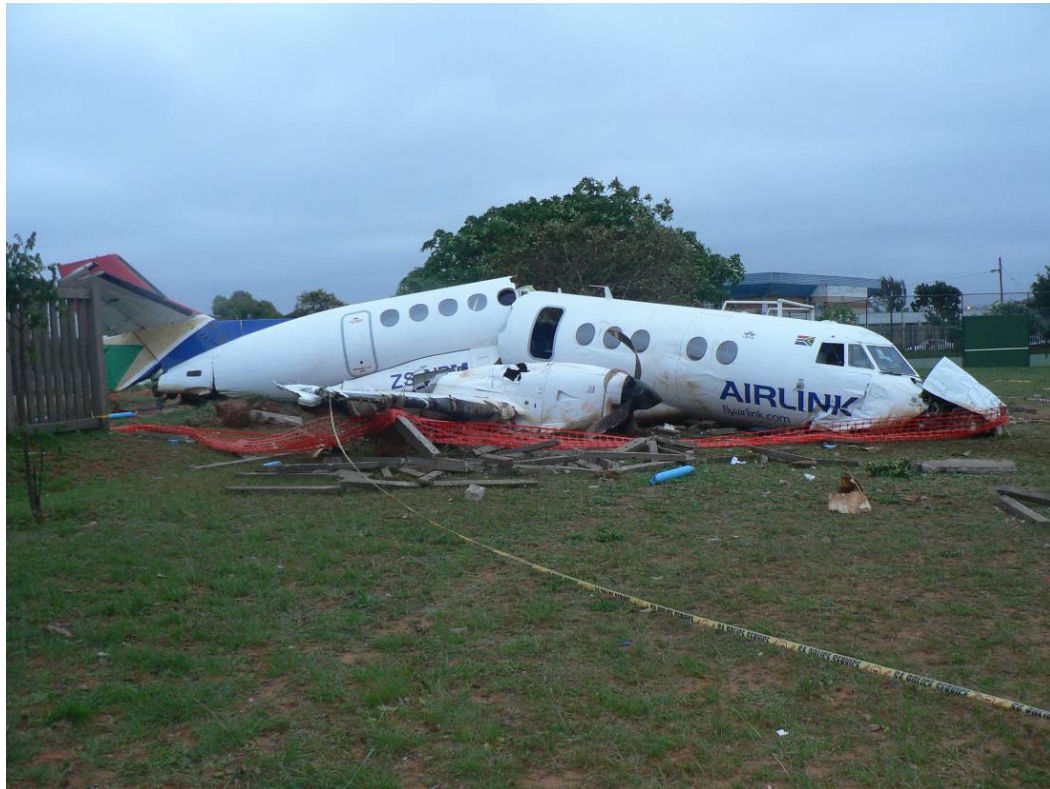
1.3.1 The aircraft was destroyed during the forced landing due to impact forces.

Figure 3. The main wreckage.

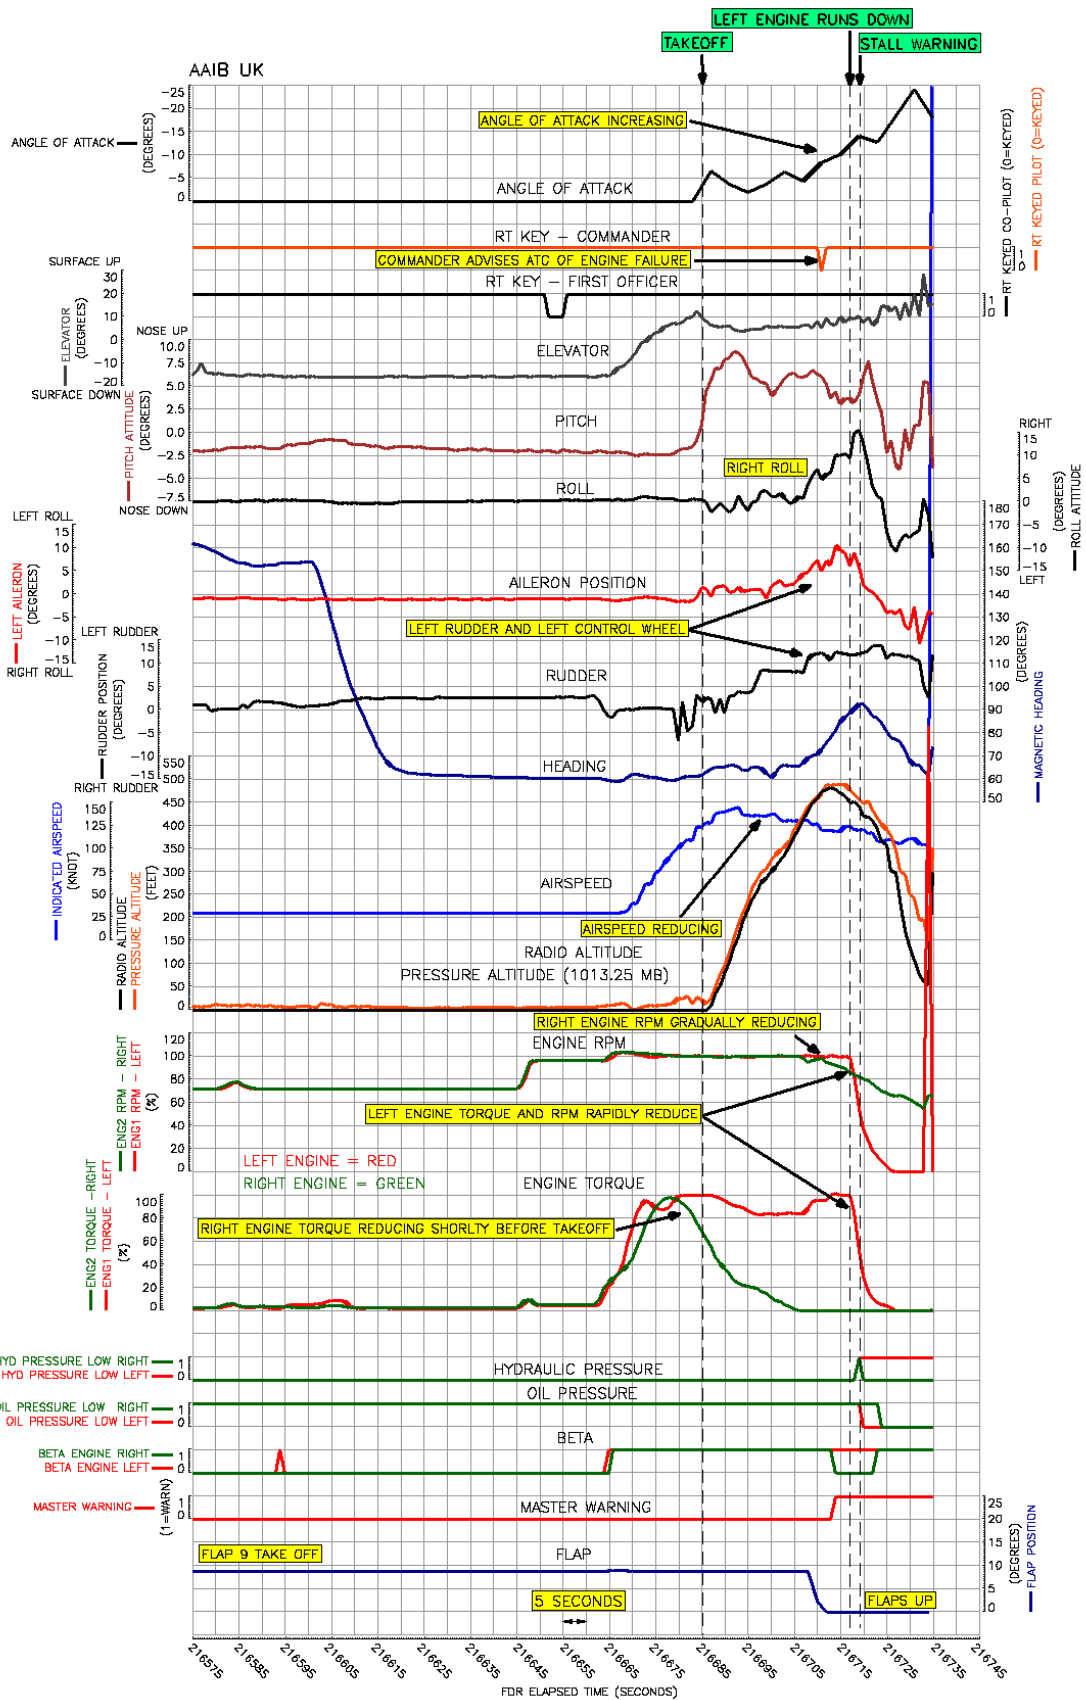
Figure 4. The FDR parameters.

- 2.7 Analysis of the FDR data (Figure 4) revealed that during take-off, at about the moment of rotation, five seconds before actually lifting off the runway, the right-hand engine failed and the thrust gradually reduced to zero in about 25 seconds. The take-off was continued. As shown by the FDR data, the dynamic effects caused by the failing engine were minimal, although the aircraft entered two small rudder pulses to the right immediately after the engine failure. The aircraft started climbing and the captain initially maintained approximate runway heading with a small, but increasing rudder input to the left. The bank angle (roll) varied slightly around wings-level; roll control power by the ailerons was adequately available. Despite the reduction of thrust from the right-hand engine, the airspeed continued to increase for about 12 seconds to approximately 135 kt, which was still much higher than the required V_2 (103 kt) for this flight phase. The captain increased the rudder deflection for maintaining the heading, but allowed a small bank angle to the right, into the inoperative engine, rather than away from it. Consequently, the drag must have increased and as a result, the airspeed started to decrease. The bank angle could still be controlled using the ailerons, but was not five degrees (or less, as is preferred by the manufacturer) away from the inoperative engine, as is required for minimum drag and lowest possible minimum control speed while the thrust is asymmetrical.

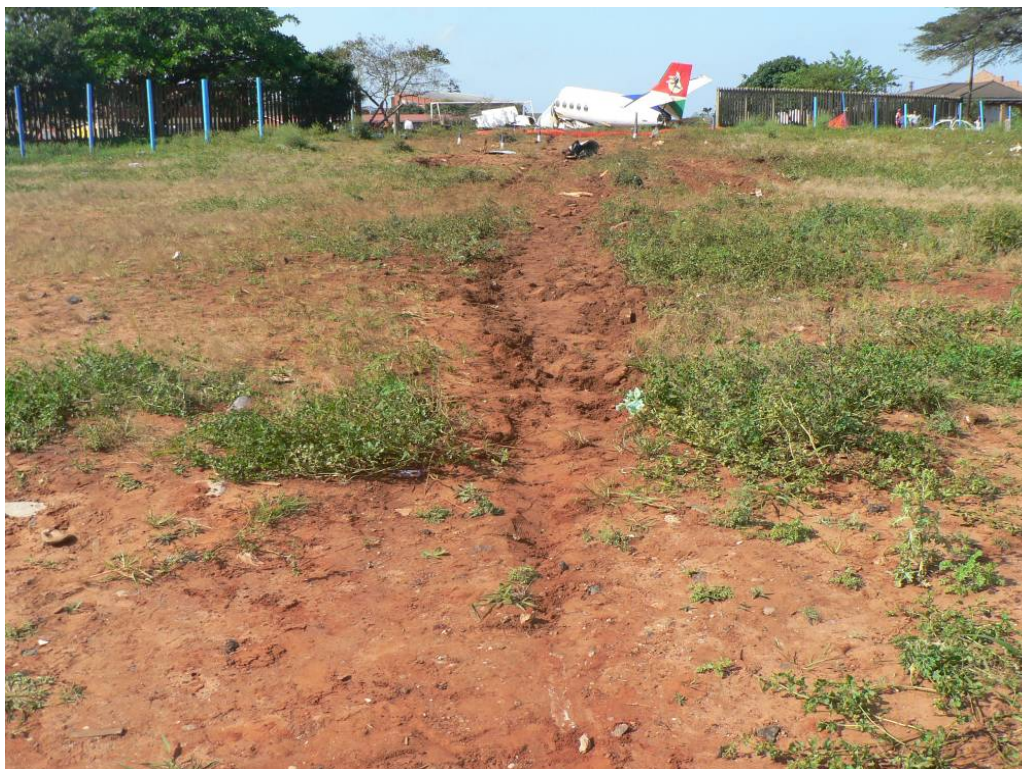
1.12.1 The ventral fin on the tail cone struck the ground first, followed by the propeller blades of both engines. The propeller ground marks indicated that the propellers hit the surface approximately 7 m before the right engine collided with the ground. The left engine then struck the ground. The aircraft skidded for approximately 25 m before hitting a power pole and skidding across a tarmac road. The bottom nose section of the aircraft then collided with a palisade fence and the fuselage broke apart above the wings. The distance from the first impact point to the main wreckage was 62 m and the main wreckage came to rest on a heading of 60°M.

Figure 5. The first impact mark of the tail cone.

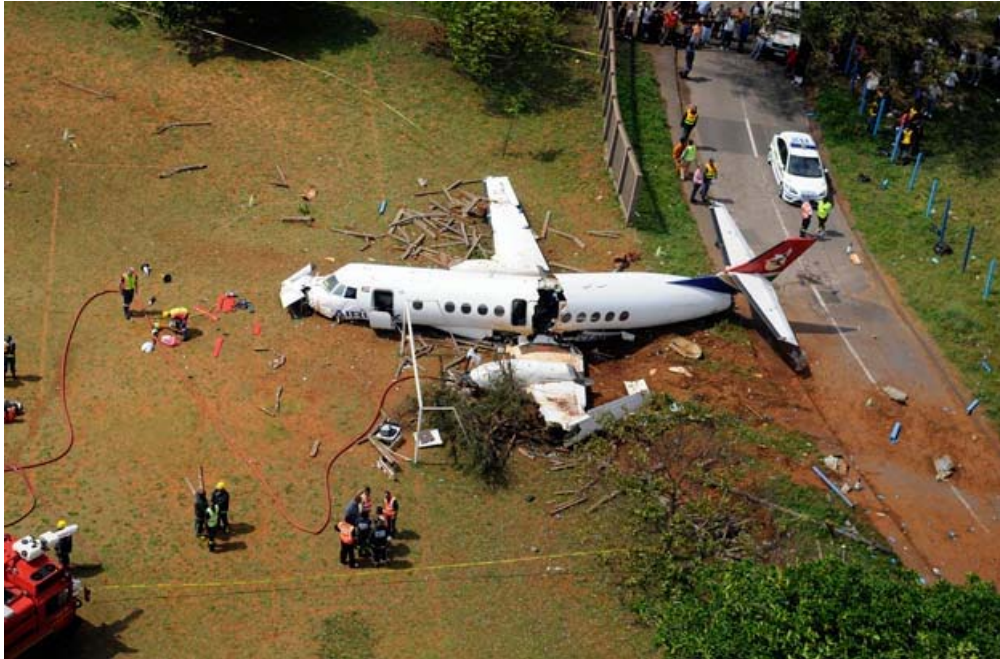
1.12.2 Both pilots' seats were bent forward by the impact deceleration. Both power levers were found in the full power position. Evidence suggests that the captain was not wearing his shoulder harness at the time of impact.

1.12.3 The No. 1 (left-hand) engine fuel condition lever was found in the cut-off position and the No. 2 (righthand) engine fuel condition lever was found in the flight position. The elevator trim pointer was within the green arc.

Figure 6. The main wreckage.

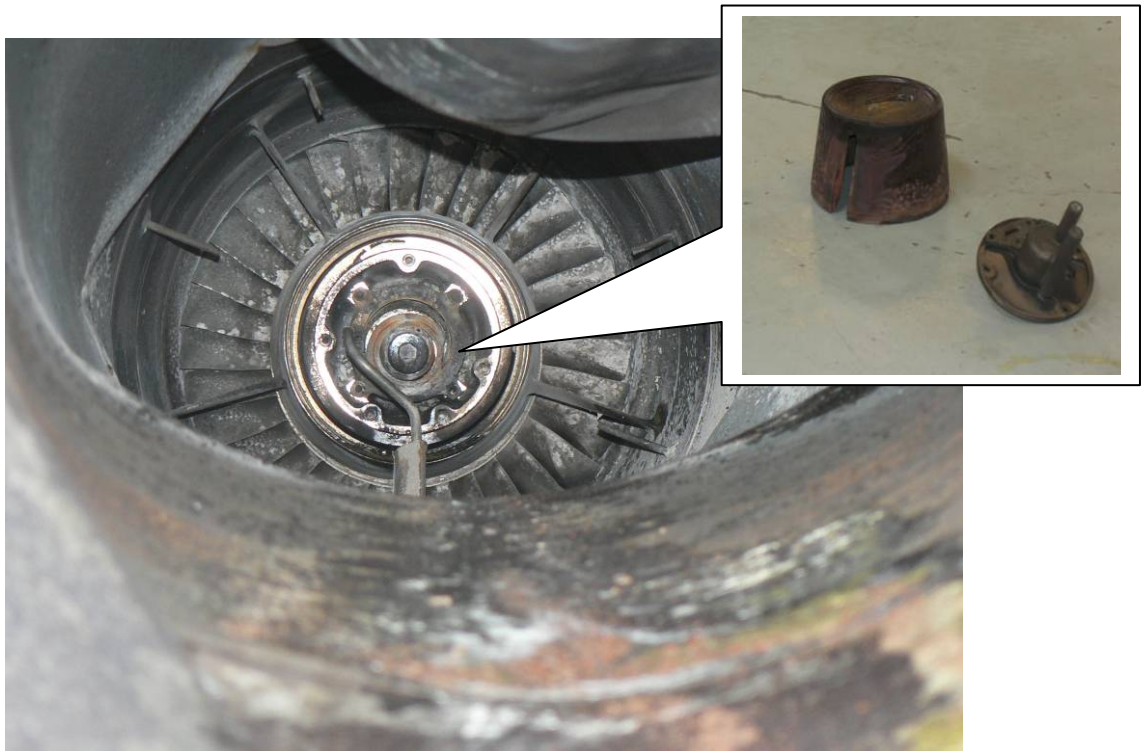
- 1.16.1.1 During the investigation at the accident site, the left and right engines were found to have damage to the nose cone, propellers, engine cowls, intake cowls and exhausts. The right engine rear bearing cover was found missing. Although a search was conducted at the accident site, the airport and surrounding areas, it was not recovered.

Figure 7; The right-hand engine with rear bearing cover and tail cone missing.
The insert picture shows similar parts from another engine.

- The rotation of the propeller produced a corresponding rotation of the turbine section;
- A review of the rear turbine bearing area disclosed that the tailcone, thermal blanket, bearing cover, rear turbine bearing inner race, roller elements, bearing cage, bearing retaining nut, and lock cup to be missing;
- The bearing cover attachment portion of the turbine bearing oil supply line and oil scavenge line had separated and was missing.

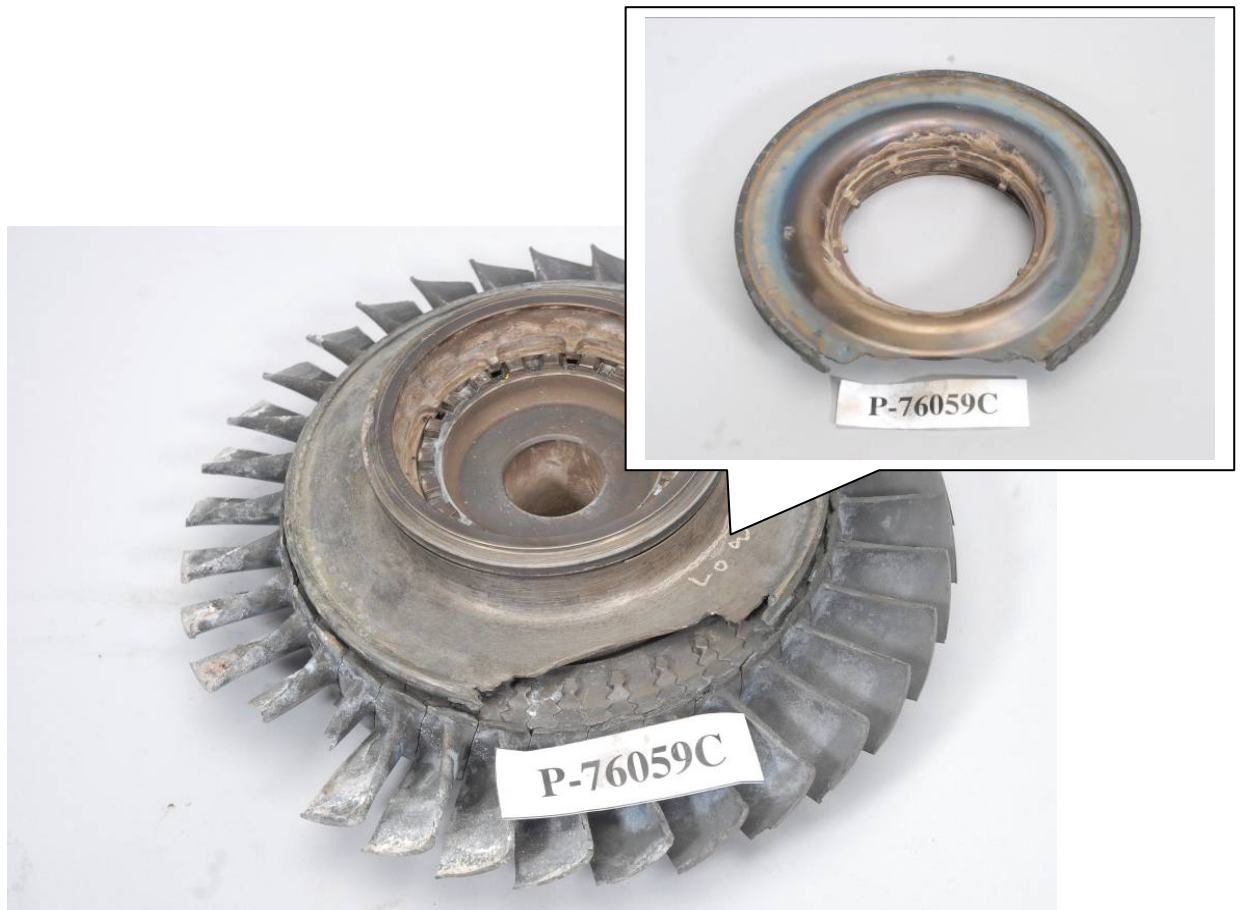
- Metal particles were found on the magnetic chip detector;
- Metal particles were found in the oil filter;
- The second-stage turbine seal plate had failed (this was considered to be the primary cause of the engine failure);
- Damage was caused to the impeller, turbine rotor blades and turbine stator.

In 1999, when the first case of second-stage turbine rotating seal plate rim failure was recognised, metallurgical examination revealed that a fatigue mechanism had been responsible and that the fatigue had originated at an area of sharp fretting or wear caused by contact between the rim and the blade roots. Blade movement was discounted as the cause of the contact and instead it was thought that the seal plate itself had been flexing, probably under some form of resonant condition.

Figure 8. The right-hand engine's second-stage turbine seal plate.

The most damaging effect of the seal plate rim failure appears to be a severe imbalance of the second-stage turbine rotor. Typically, this vibration led to fatigue failures of the rear bearing oil feed and scavenge pipes with consequent oil starvation and deterioration of the bearing. It is understood that detachment of the bearing cover, tail cone and retention nut had not been seen before, except for one case that occurred in 2009.

On the right engine of ZS-NRM, the seal plate had failed after 1 314 CSN, while the left engine was found with the seal plate rim worn beyond limits after only 570 CSN.

- 2.22 The event began with the separation of the second-stage turbine seal plate rim, most likely during the accident flight. The oil supply line separated in fatigue shortly after the second-stage turbine seal plate rim separation. The turbine bearing appeared to have begun to degrade because of oil starvation approximately 17 seconds after acceleration to 96% speed.

Two previous cases of second-stage turbine seal plate rim failure, similar to the accident failure, led to the issue of Service Bulletin (SB) 72-7204 in 2001, which required examination of the seal rim for wear at each hot section inspection (HSI) of the engine, currently every 4 500 engine hours.

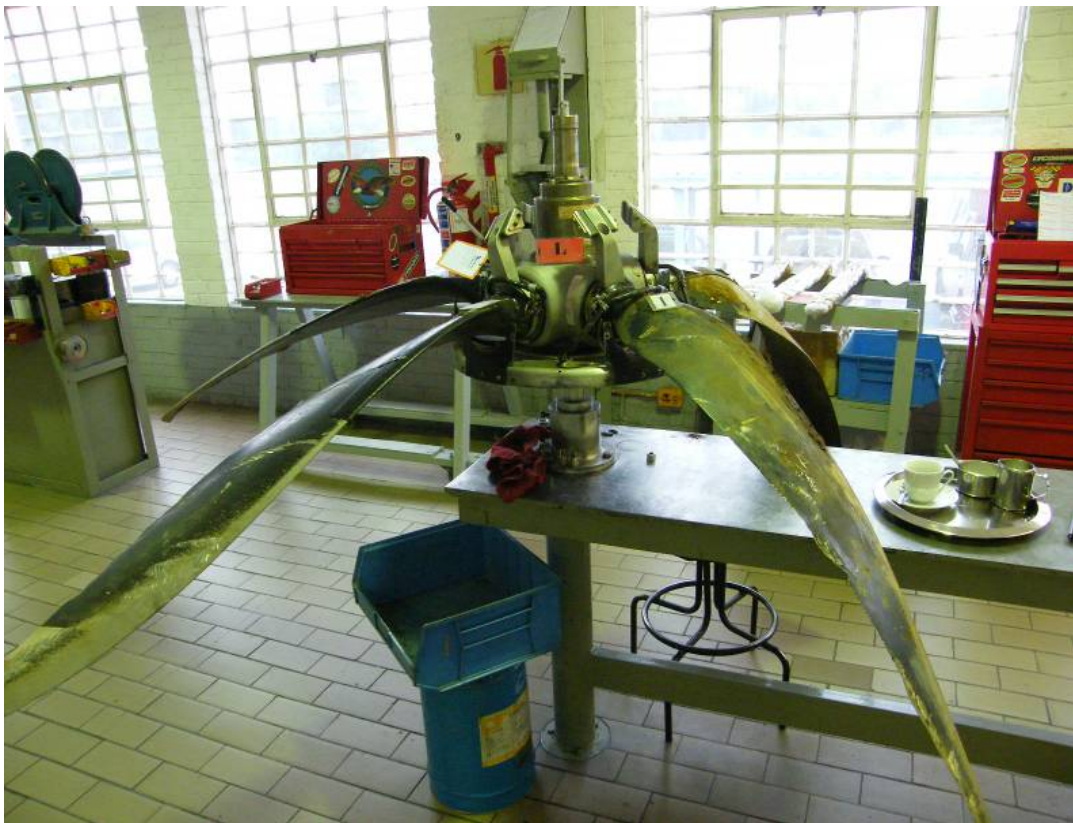
- i. As found, all the blades were on the latches with a low blade angle;
- ii. The propeller blades were bent aft and found at a low blade angle at the accident site. Examination of the pitch change mechanism found it to be fractured, allowing the propeller blades to move within the hub;
- iii. The blades did not show any significant signs of power during the impact sequence;
- iv. No visual assembly anomalies or maintenance errors were noted during the propeller teardown and examination.

Figure 9. Damage to No. 1 propeller.

1.16.4.1 The status of each propeller at impact was established from a combination of the physical examination and FDR data. It was concluded that the left propeller had been feathered on impact and was not rotating: the "as found" low blade angle was explained by fracture of the pitch change mechanism, which had forced the blades out of the feathered position on impact.

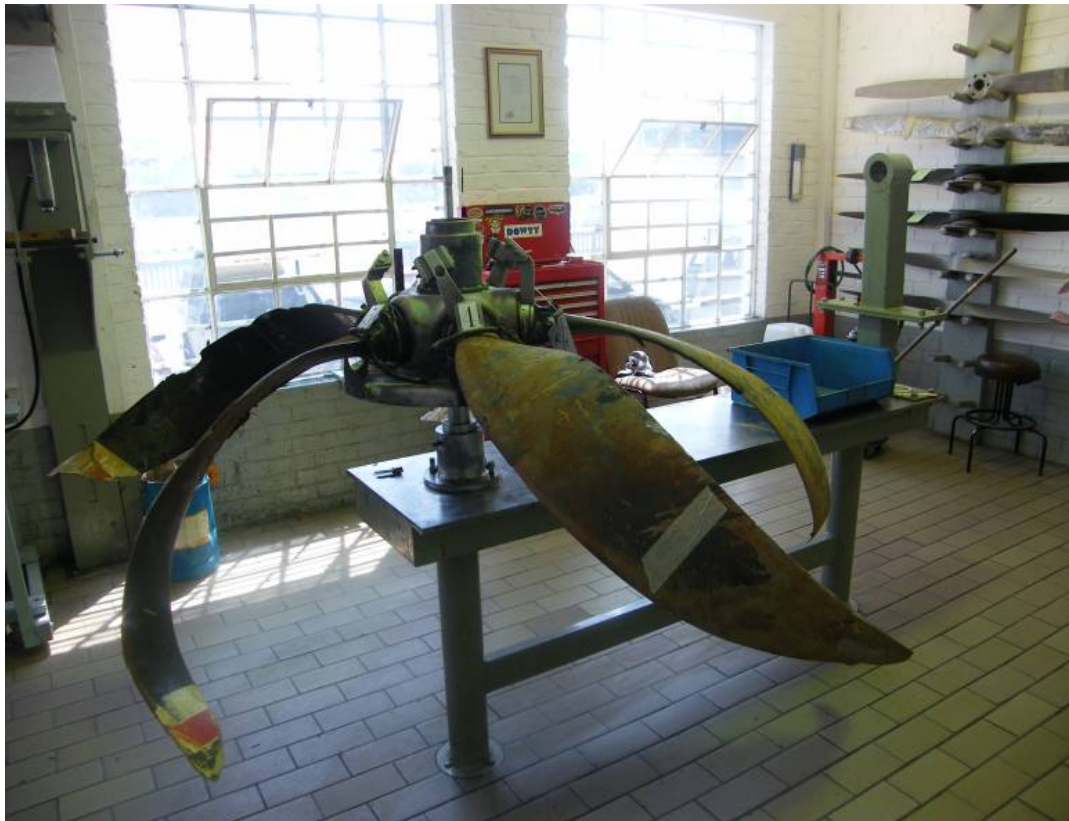
- i. All the link pins were broken and it could not be established whether the propeller blades were on the latches at the time of impact;

- ii. The propeller blades were curled in the direction opposite to rotation, consistent with the propeller blades rotating at impact. The amount of propeller blade curling is consistent with the propeller rotating at reduced speed. The propeller blades were found at the accident site in the reverse pitch position;
- iii. This is confirmed by the damage sustained to the trailing edges of all the blades as well as the twisting of the blades. According to the FDR, it would also appear that the propeller RPM at the time of impact was approximately 56%;
- iv. No visual assembly anomalies or maintenance errors were noted during the propeller teardown and examination.

Figure 10. Damage to No. 2 propeller.

The right propeller, despite being found in the reverse pitch condition, had been rotating at a low speed and with a low blade angle on impact. Information from the FDR indicates that the RPM was about 65%. The blades had moved after initial impact due to fracture of all five pitch link pins in the hub.
