AIRCRAFT ACCIDENT REPORT AND EXECUTIVE SUMMARY

Reference:	CA18/2/3/8703	
Aircraft Registration	ZS-HAN	Date of Accident	2 November 2009		Time of Accident	1420Z
Type of Aircraft	Robinson R22 Beta		Type of Operation		Private	
Pilot-in-command Licence Type		Private Pilot (Helicopter)	Age	39	Licence Valid	Yes
Pilot-in-command Flying Experience		Total Flying Hours	68.4		Hours on Type	56.9
Last point of departure		Rand Airport (S 26° 14' 31.1" E 28° 09' 4.8") FAGM				
Next point of intended landing		Rand Airport (S 26° 14' 31.1" E 28° 09' 4.8") FAGM				
Location of the accident site with reference to easily defined geographical points (GPS readings if possible)						
Threshold of runway 17 at Rand Airport. Elevation 5 483 ft AMSL.						
Meteorological Information		Wind direction: 330°; Wind speed: 7 knots; Temperature: 11°C; Visibility: >10 km; Rain expected in vicinity				
Number of people on board	1 + 1	No. of people injured	0	No. of people killed	0

Name of Owner/Operator : Henley Air (Pty) Ltd
Manufacturer : Robinson Helicopter Company
Model : Robinson R22 Beta
Nationality : South African
Registration Marks : ZS-HAN
Place : Rand Airport
Date : 2 November 2009
Time : 1420Z

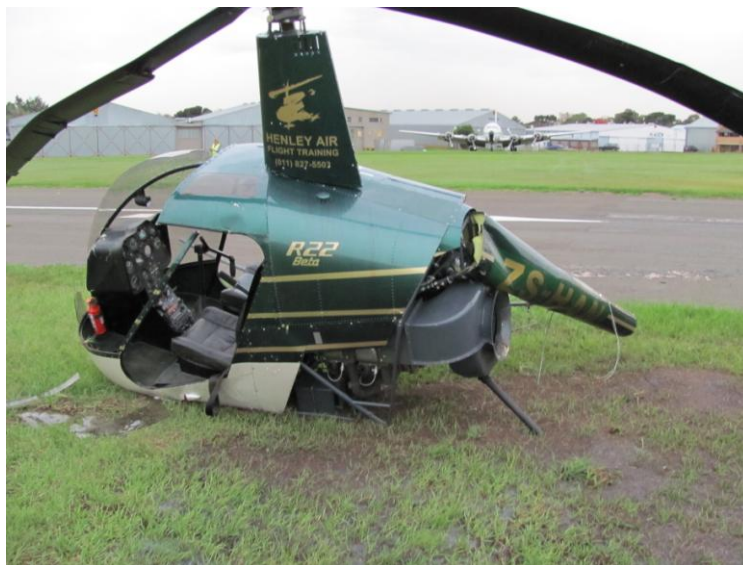
1.3.1 The helicopter sustained substantial damage to the main rotor blades, left windshield, tail boom and left skid.

Figure 1. The damage to the main rotor blades, windshield and left skid.

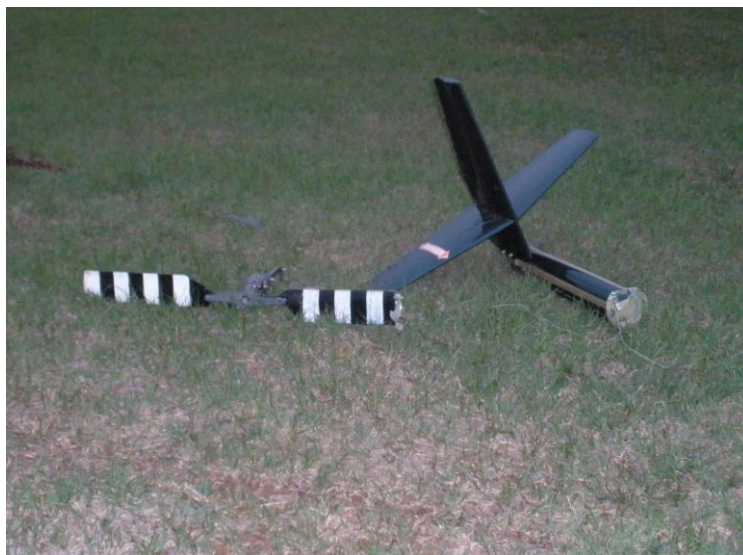
- 1.1.4 The main rotor blades, left windshield, tail boom and left skid were damaged. The pilot and passenger suffered no injuries.

Figure 2. The broken tail boom and rotor.

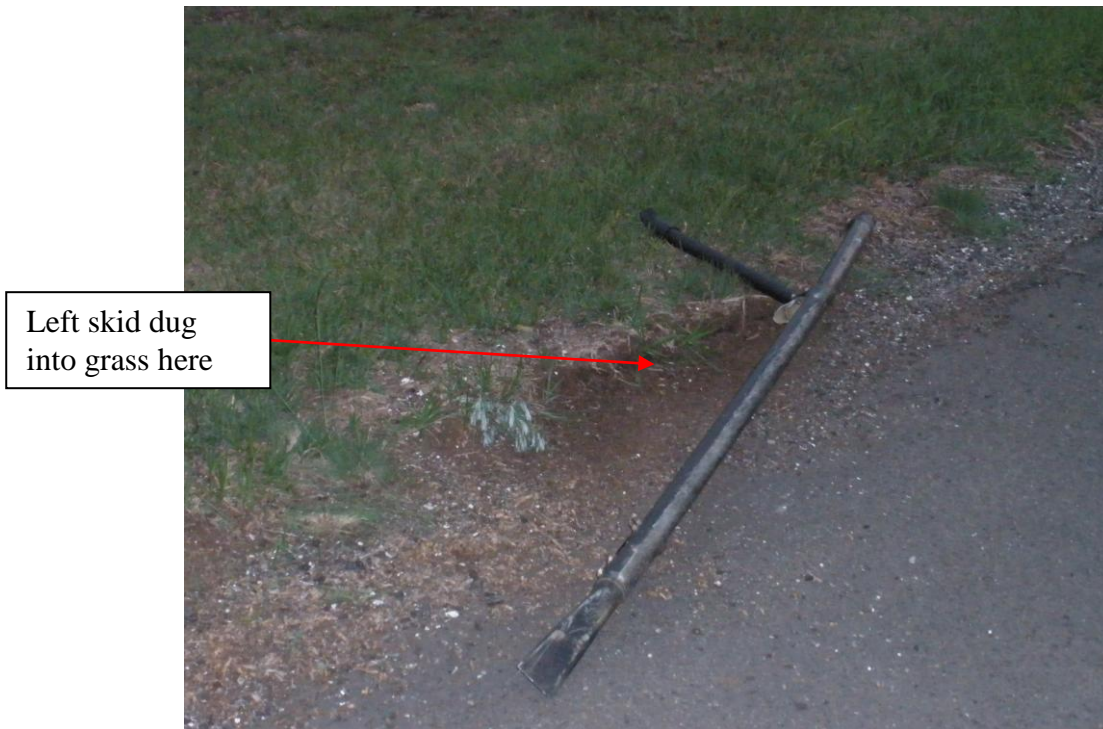
skidded for approximately 7 m before its left skid dug into the grass shoulder on the edge of the runway.

Figure 4. The left skid dug into the grass at the edge of the runway.

- 3.2.1 The left skid dug into the grass shoulder, causing the helicopter to roll onto its left side.

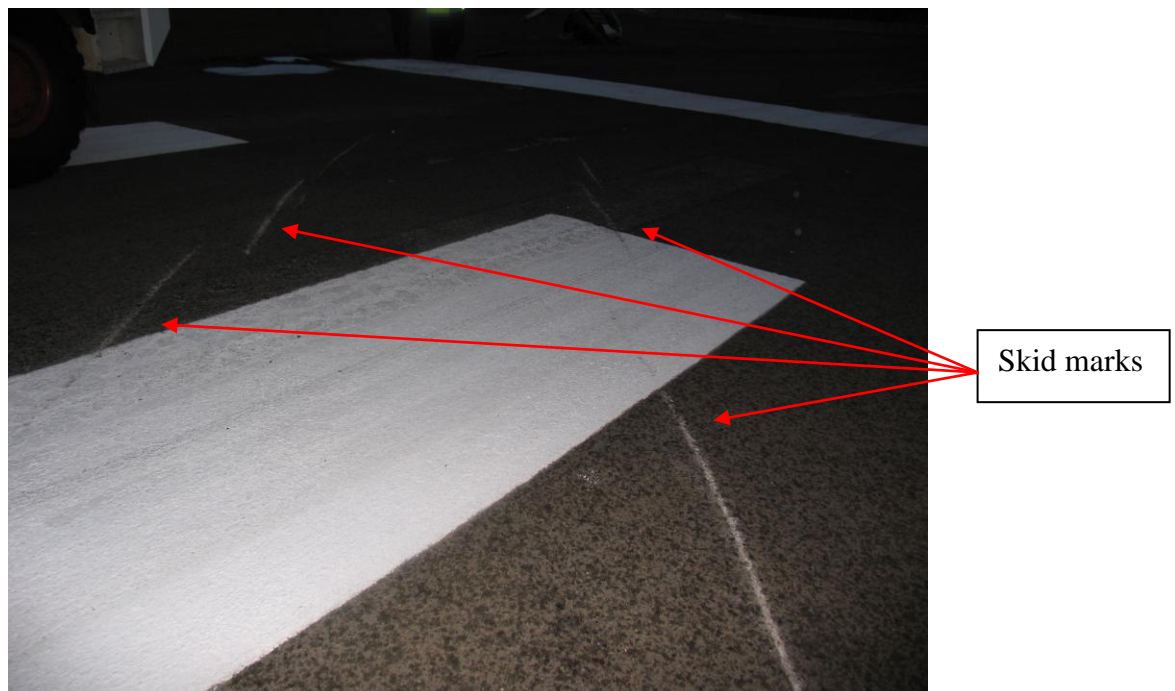
- 1.1.3 The aircraft touched the ground and skidded for approximately 7 m before the left skid dug into the grass verge alongside the runway. The helicopter rolled onto its left, the main rotor blades struck the ground and the aircraft came to rest on its left side.

Figure 5. The helicopter skidded for about 7 m.

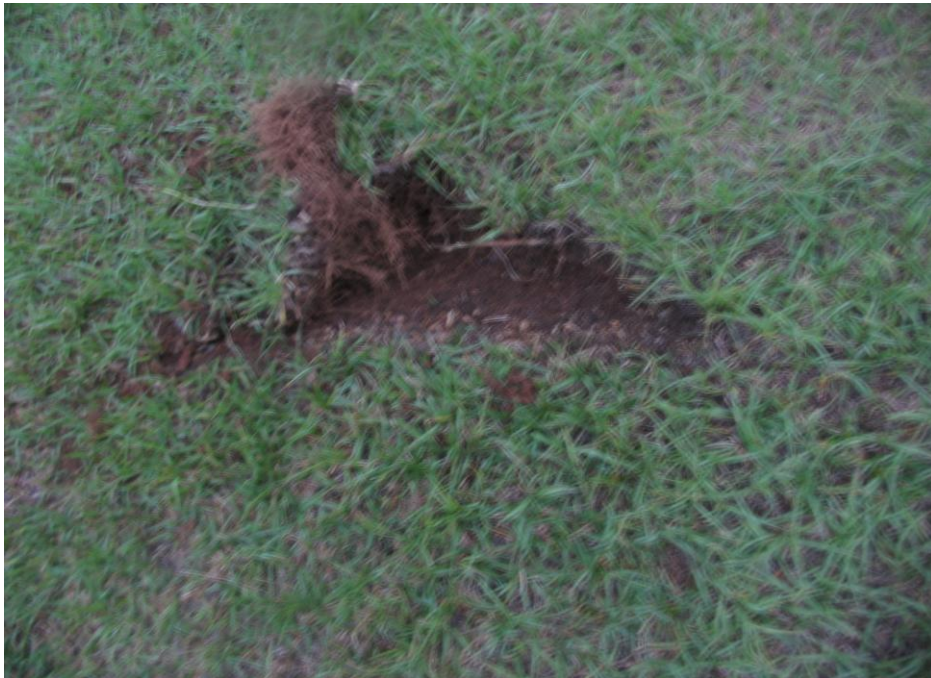
1.12.2 The main rotor blades impacted with the ground and the helicopter came to rest on its left side.

Figure 6. The main rotor blade impact.
