AIRCRAFT ACCIDENT REPORT AND EXECUTIVE SUMMARY

Reference:	CA18/2/3/8813	
Aircraft Registration	ZS-EXW	Date of Accident	27/07/2010		Time of Accident	0519Z
Type of Aircraft	Piper PA32-300		Type of Operation	Private		
Pilot-in-command Licence Type	Commercial	Age	58		Licence Valid	Yes
Pilot-in-command Flying Experience	Total Flying Hours	3047.0		Hours on Type	1800.0	
Last point of departure	Louis Trichardt Aerodrome (FALO) in Limpopo					
Next point of intended landing	Kruger Mpumalanga Aerodrome (FAKN) in Mpumalanga					
Location of the accident site with reference to easily defined geographical points (GPS readings if possible)						
At 23°03.221' E 29°52.683' in Louis Trichardt						
Meteorological Information	Surface Wind: calm; Visibility: CAVOK; Temperature: Unknown					
Number of people on board	1 + 1	No. of people injured	2		No. of people killed	0
Synopsis						
<p>The pilot, accompanied by a passenger, flew the aircraft on a private flight in visual flight rules from Louis Trichardt Aerodrome with the intention to fly to Kruger Mpumalanga International Aerodrome. The pilot reported that she was cleared for takeoff from Runway 10 and to climb to 8000 ft directly to Kruger Mpum

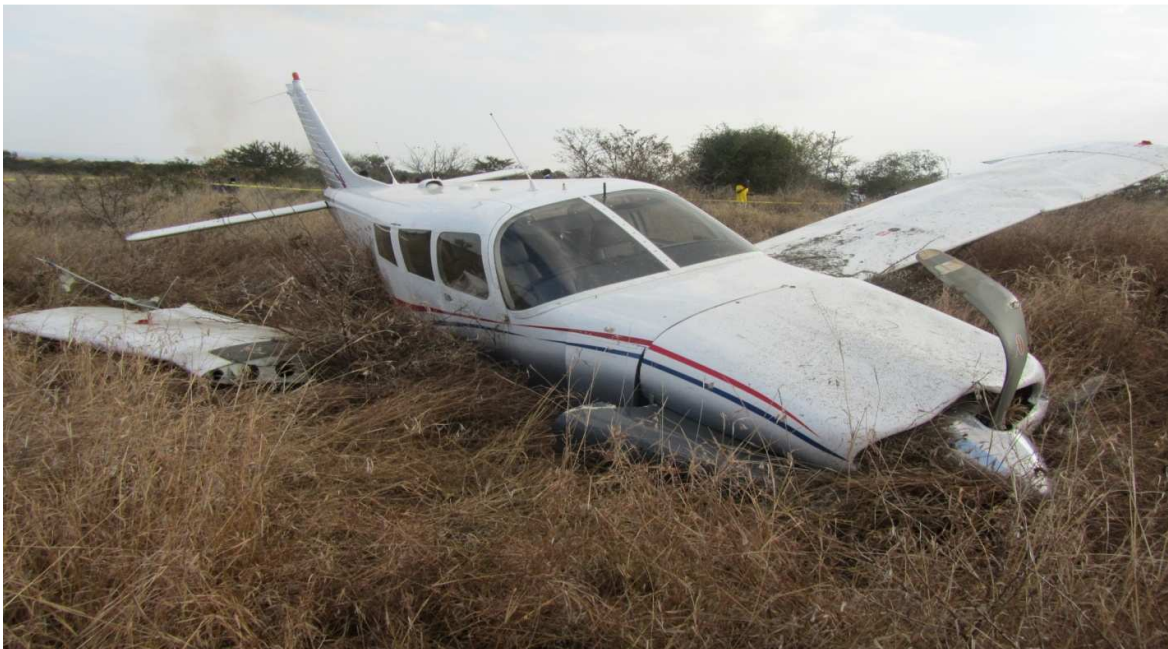
1.3.1 The aircraft sustained substantial damage.

Figure1 shows damage caused to aircraft.

- 1.6.4 On-site inspection of the wreckage revealed that all of the structural damage was consistent with the impact; nothing was found to suggest that there had been any pre-impact failure of the primary structure. The fuel selector was found selected on the left-hand main tank. The right-hand tank was still full and had detached from the aircraft; and the left-hand tank was empty and intact.

1.12.1 During the forced landing, the aircraft touched down and went through a stream where the landing gear sustained damage. The right side wing struck a thorn tree and separated from the aircraft. The aircraft ended up swinging around through 90 degrees and then it came to a stop.
