AIRCRAFT ACCIDENT REPORT AND EXECUTIVE SUMMARY

Reference:	CA18/2/3/8850	
Aircraft Registration	ZU-XML	Date of Accident	13 October 2010		Time of Accident	1130Z
Type of Aircraft	SA Ravin 500		Type of Operation		Private	
Pilot-in-command Licence Type		Commercial	Age	53	Licence Valid	Yes
Pilot-in-command Flying Experience		Total Flying Hours	530		Hours on Type	131,8
Last point of departure		Wonderboom Aerodrome (FAWB)				
Next point of intended landing		Krugersdorp Aerodrome (FAKR)				
Location of the accident site with reference to easily defined geographical points (GPS readings if possible)						
Krugersdorp Aerodrome (FAKR)						
Meteorological Information		Surface wind: 15 kts gusting 25 kts; Temperature: 23°C; Visibility: >10 km				
Number of people on board	1 + 0	No. of people injured	0	No. of people killed	0	
Synopsis						
<p>The pilot took off from Wonderboom Aerodrome for Krugersdorp Aerodrome on a private flight. During the final approach at Krugersdorp, he experienced a downdraft two to three metres from the threshold of runway 08. The pilot reduced power while landing in a downdraft. He lost directional control, the aeroplane rolled over the taxiway, and the left wing st

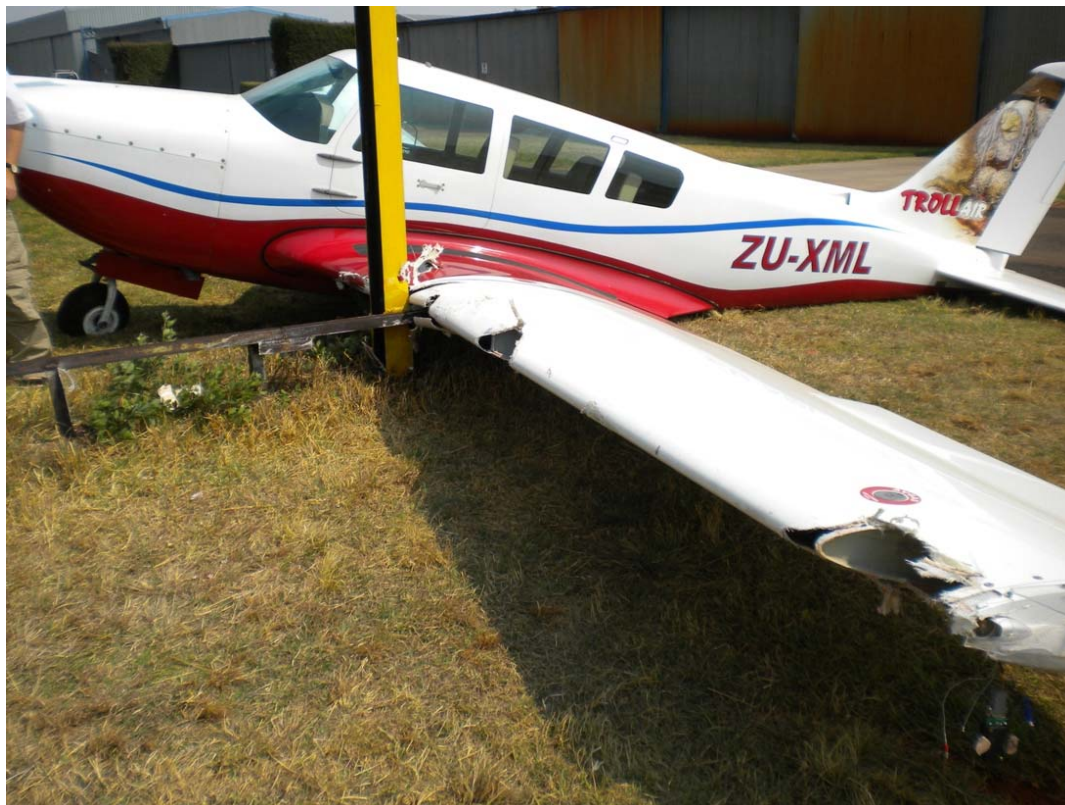
1.3.1 The aircraft sustained damage to the undercarriage, left wing and tailplane.

1.12.1 During the final approach for landing, the pilot experienced a downdraft. The aircraft was forced onto the runway, rolled over the taxiway and collided with extension of the hangar door before coming to a halt. The aeroplane remained intact after the impact.

Figure 1. The aircraft after the accident.
