AIRCRAFT ACCIDENT REPORT AND EXECUTIVE SUMMARY

Reference:	CA18/2/3/9047	
Aircraft Registration	ZS-HRZ	Date of Accident	27 May 2012		Time of Accident	1321Z
Type of Aircraft	Bell 206B (Helicopter)		Type of Operation		Private flight	
Pilot-in-command Licence Type		Private	Age	45	Licence Valid	Yes
Pilot-in-command Flying Experience		Total Flying Hours	190,9		Hours on Type	21,4
Last point of departure		Grand Central aerodrome (FAGC), (Gauteng province)				
Next point of intended landing		Grand Central aerodrome (FAGC), (Gauteng province)				
Location of the accident site with reference to easily defined geographical points (GPS readings if possible)						
Portland Park, Midrand (GPS position S 25°59'34.12" E 028°7'37.08" at an elevation of 5 100 ft)						
Meteorological Information		Surface wind; light and variable, Temperature; 19°C , Visibility; +10 km				
Number of people on board	1 + 1	No. of people injured	2	No. of people killed	0	
Synopsis

AIRCRAFT ACCIDENT REPORT

Name of Owner : Money Aviation (Pty) Ltd
Name of Operator : Private flight
Manufacturer : Bell Helicopter Textron
Model : 206B
Nationality : South Africa
Registration Marks : ZS-HRZ
Place : Portland Park, Midrand
Date

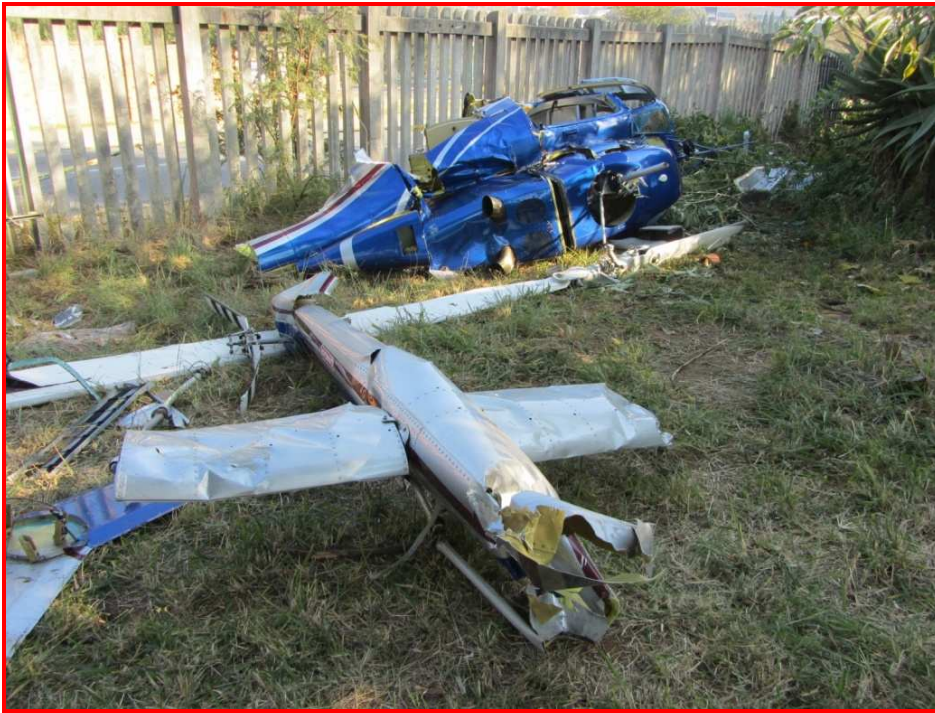
- 1.3.1 The helicopter was extensively damaged during the impact sequence.

Figure 1. A photo of the wreckage with the concrete wall visible in the back.

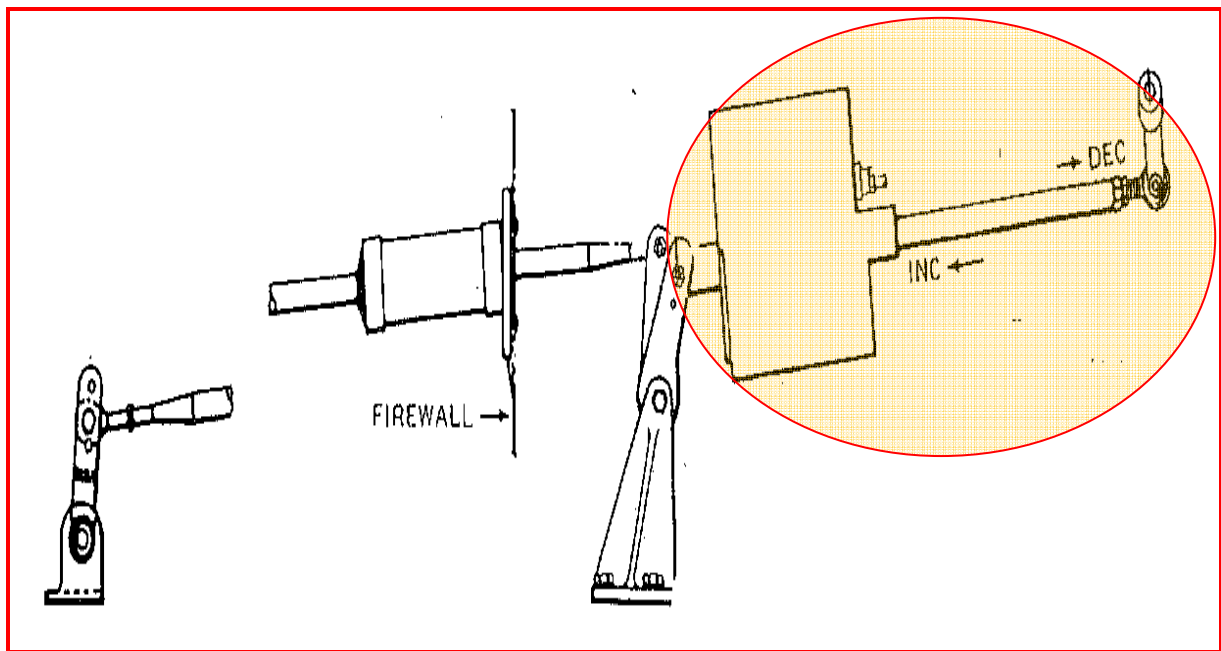
1.18.1.4 The Linear Actuator was tested and was found to function correctly.

Figure 3. Schematic diagram of the Linear Actuator.

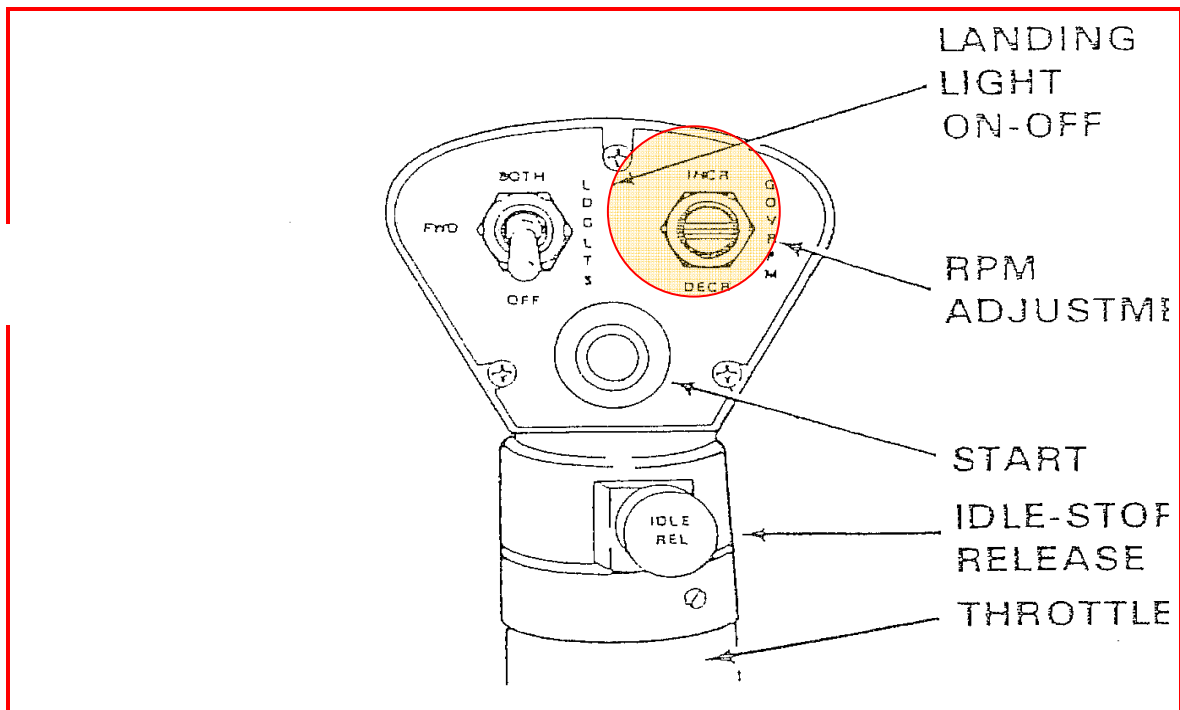
1.18.1.1 The linear actuator system control is operated by a switch on the collective pitch lever (see figure 4), which will increase / decrease N2/NR RPM when the switch are either pushed forward or backwards. It is important to note that throttle must be in the fully open for the pilot to be able to manually increase / decrease the N2/NR RPM between the minimum range of 97% and a maximum of 100%.

Figure 4. Schematic diagram of the collective pitch lever, indicating the N2/NR RPM adjustment button.

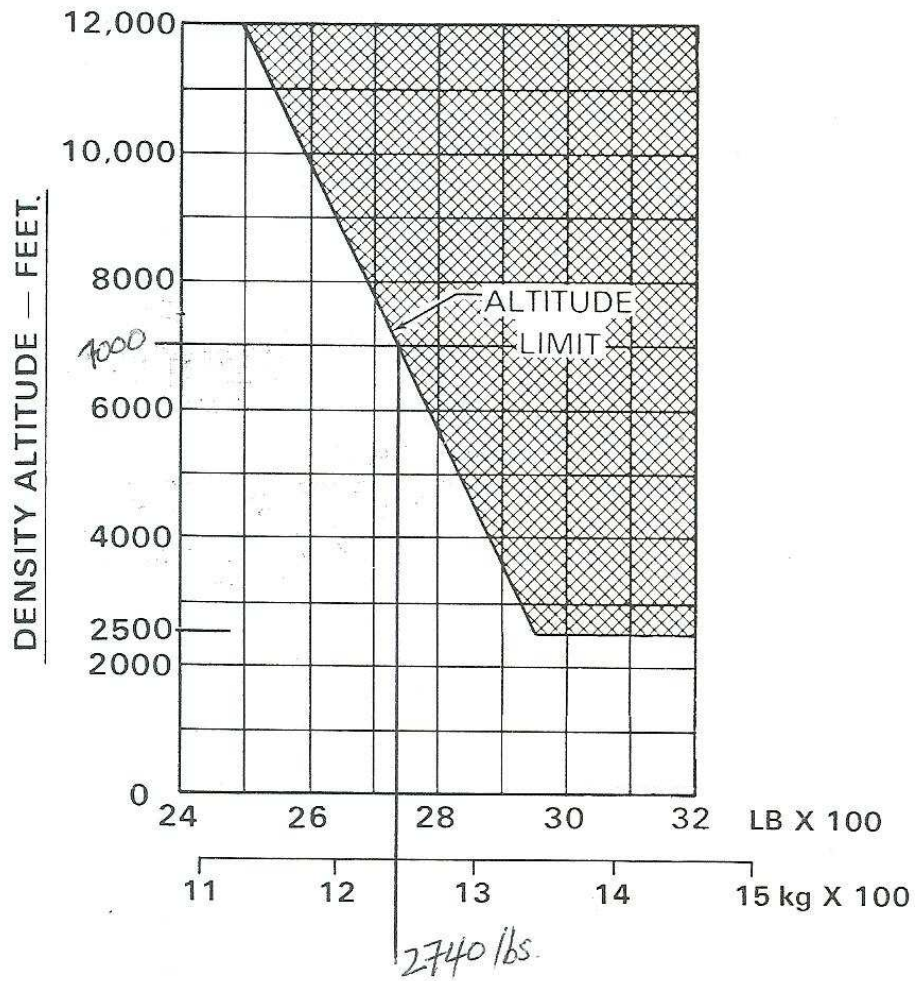
Figure 4-7. Altitude vs gross weight limit for height-velocity diagram

According to the altitude versus gross weight limit for height – velocity diagram in the POH, the maximum allowable take-off weight on the day with a density altitude

of 7000 feet was not allowed to have exceeded 2 740 pounds (1 243 kg). The take-off weight for the accident flight was calculated to be 2 880 pounds, which was 140 lbs (64 kg) above the gross weight limit as stipulated in the POH, (see the graph on the next page).
