<b>AIRCRAFT ACCIDENT REPORT AND EXECUTIVE SUMMARY</b>
---

Reference:	CA18/2/3/9156	
<b>Aircraft Registration</b>	<b>ZS-HSR</b>	<b>Date of Accident</b>	23 March 2013		<b>Time of Accident</b>	12:25
<b>Type of Aircraft</b>	Bell 206B		<b>Type of Operation</b>	Commercial		
<b>Pilot-in-command Licence Type</b>		CPL	<b>Age</b>	33	<b>Licence Valid</b>	Yes
<b>Pilot-in-command Flying Experience</b>		<b>Total Flying Hours</b>	1052,3		<b>Hours on Type</b>	11,2
<b>Last point of departure</b>		Pietermaritzburg airfield FAPM – KwaZulu-Natal				
<b>Next point of intended landing</b>		Pietermaritzburg Botanical Gardens (PBG)				
<b>Location of the accident site with reference to easily defined geographical points (GPS readings if possible)</b>						
Between Botanical Gardens boundary and Zwartkop Street, about 3,75 nm from FAPM (S 29°36' 30" E 30°20' 44")						
<b>Meteorological Information</b>		FAPM METAR at 10:00z. Surface wind 160° at 18 knots; temperature 28°C; dew point 19°C; ceiling and visibility okay; QNH 1013 no significant weather reported.

**Name of Owner/Operator** : King Shaka Aviation  
**Manufacturer** : Bell Helicopter Textron  
**Model** : Bell 206B  
**Nationality** : South Afri

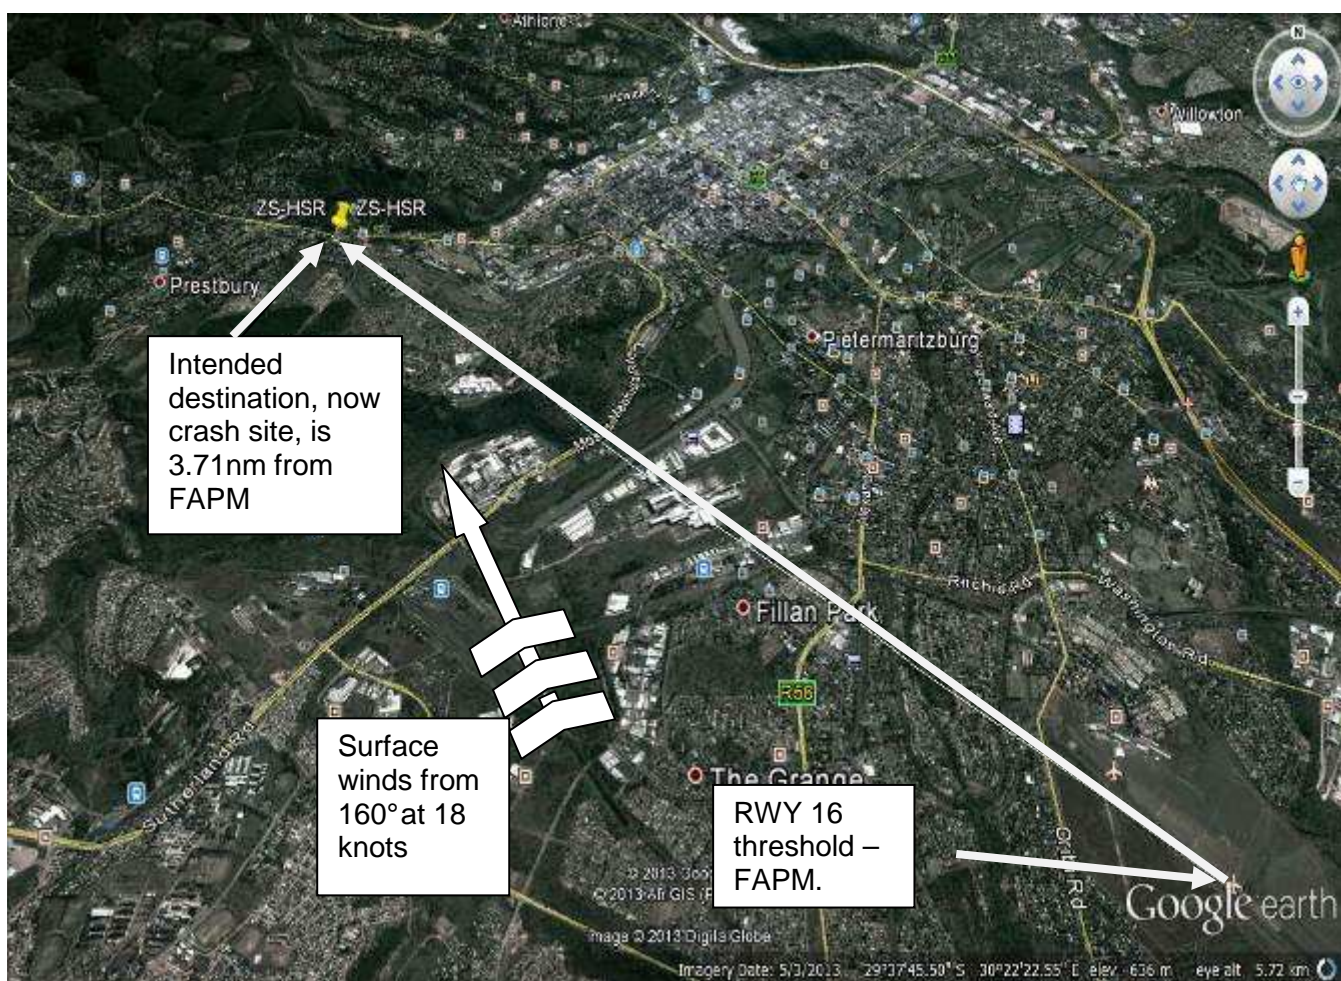
- 1.1.2 Once all four passengers were on board the pilot requested departure clearance from FAPM ATC. The aircraft was cleared to climb to 500 feet AGL and to route direct to its destination. The flight was to be conducted under visual flight rules (VFR) At 11:54B the aircraft took off from FAPM to the botanical gardens and climbed as instructed. There was no traffic to affect, the sky was clear and the wind was from 160° at 18 knots, which makes it a tail wind.

Figure 1: Flight to destination is 3.71 nm (6,91km) with a tail wind of 18 knots

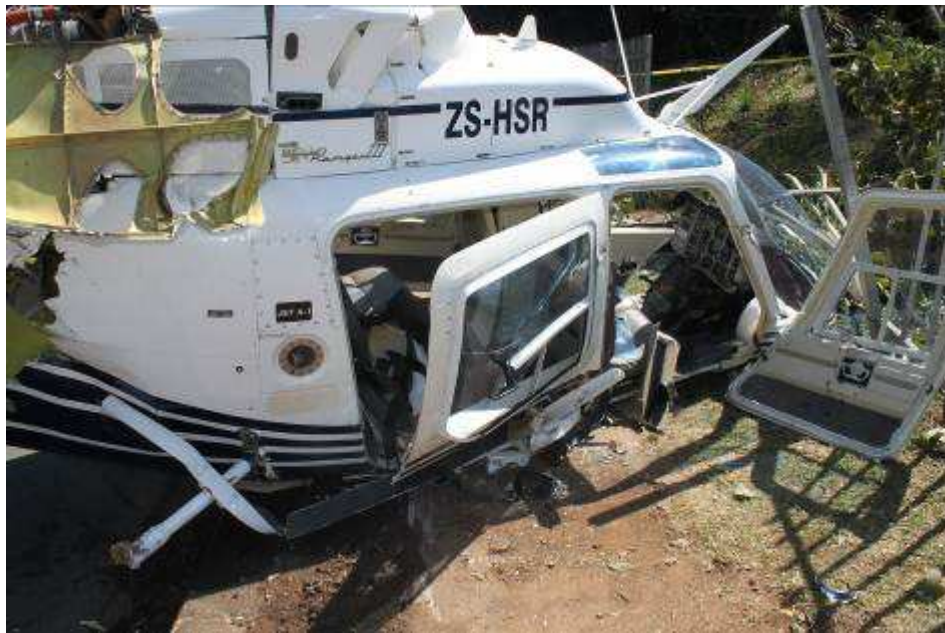
1.3.1 The aircraft suffered substantial damage in the accident.

**Figure 2: Severity of the accident**

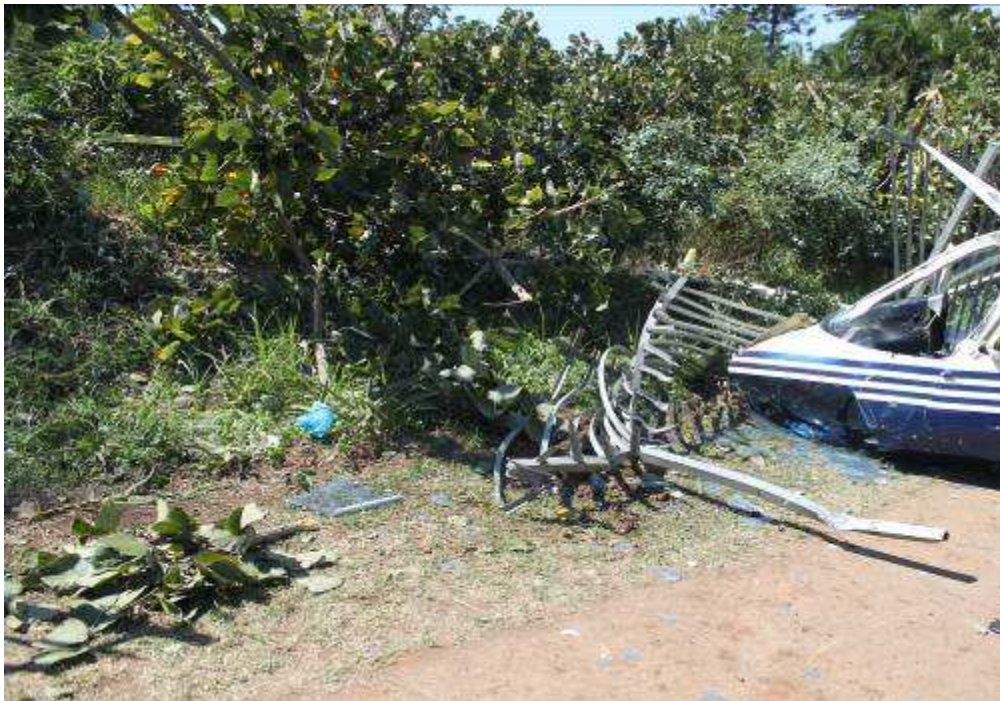
- 1.4.1 During the forced landing, the main rotor blades tore through and damaged approximately 10 m of the Botanical Gardens palisade fence and severed some tree branches and a 20 cm thick tree trunk nearby.

**Figure 3: Damage to the fence and vegetation**

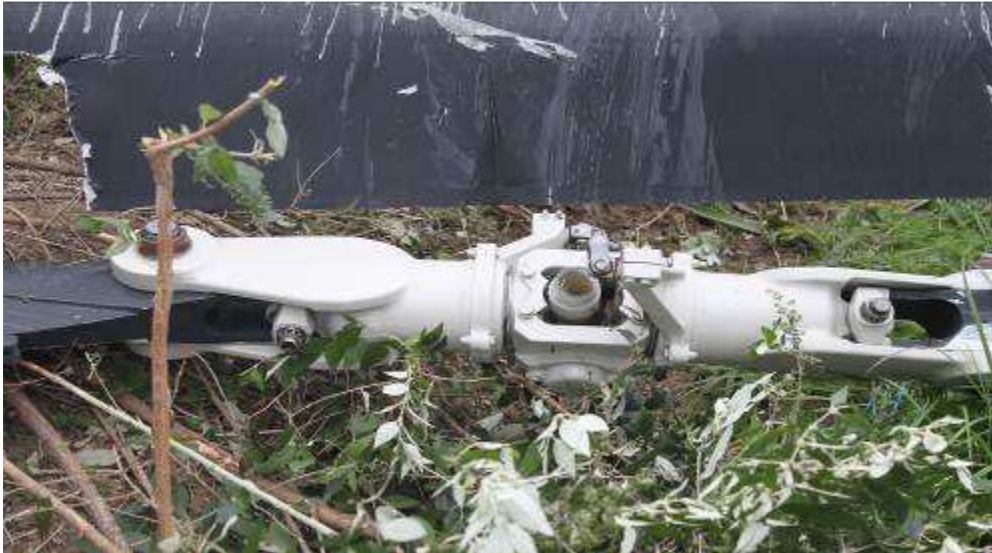
1.12.2 The accident site, Zwartkop Street, runs between the boundary of the gardens and the ad hoc landing site, with vegetation and tall trees. The main rotor was sheared off the mast and ended approximately 2 m from the wreckage. All the debris from the aircraft was found approximately 100 m from the wreckage.

**Figure 4:** The main rotor that was sheared off the mast

- The main rotor continued rotation against a jammed transmission system and simply sheared it off the rotor mast. The shear marks on the mast do not resemble pre-existing metal fatigue. The whole surface was shiny, consistent

with failure/shearing that occurred as a result of an accident.

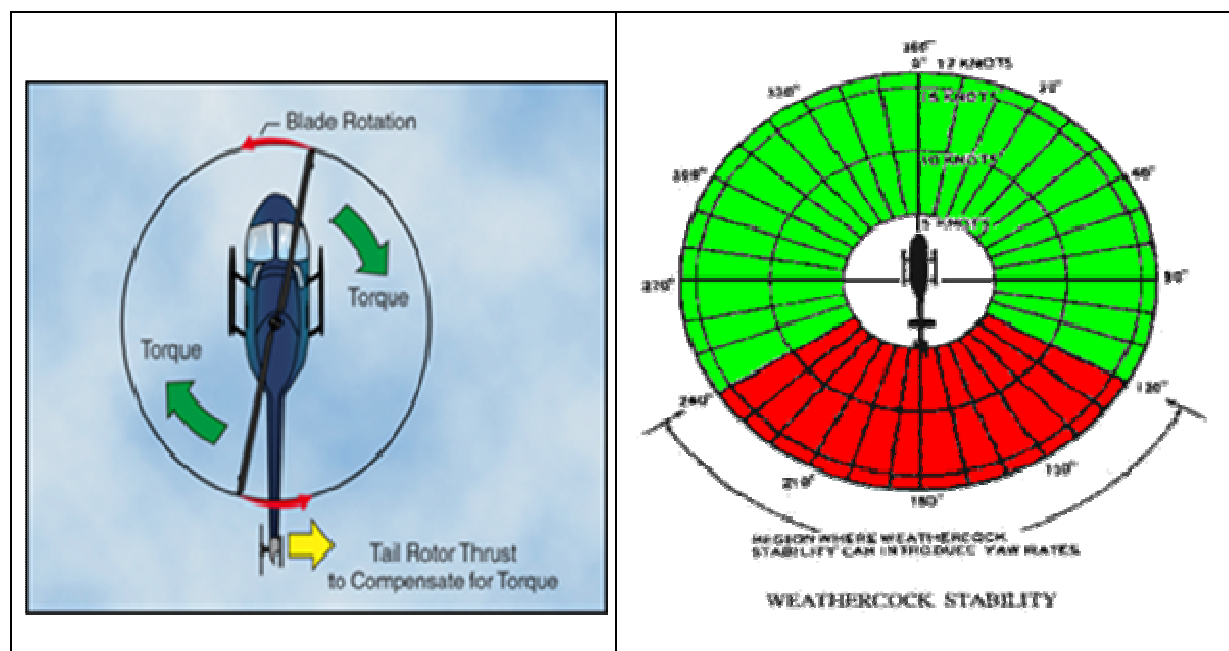
Any manoeuvre which requires the pilot to operate in a high-power, low-airspeed environment with a **left crosswind or tailwind** creates an environment where unanticipated right yaw may occur.

There is greater susceptibility to Loss of Tail Rotor Effect (LTE) in right turns. This is especially true during flight at low airspeed, since the pilot may not be able to stop rotation. The helicopter will attempt to yaw to the right. Correct and timely pilot response to an uncommanded right yaw is critical. The yaw is usually correctable if additional left pedal is applied immediately. If the response is incorrect or slow, the yaw rate may rapidly increase to a point where recovery is not possible.

**Figure 5:** Left: hand picture Shows forces produced by the main and tail rotor which are directly proportional to the speed of the aircraft. The right hand picture. Wind coming from green area good. Wind coming from red area (tailwind) bad. **The wind in this accident was 160° at 18 knots.**
