<b>AIRCRAFT ACCIDENT REPORT AND EXECUTIVE SUMMARY</b>
---

Reference:	CA18/2/3/9217	
<b>Aircraft Registration</b>	ZU-RHE	<b>Date of Accident</b>	5 September 2013		<b>Time of Accident</b>	1000Z
<b>Type of Aircraft</b>	AutoGyro GmbH (Microlight)		<b>Type of Operation</b>		Private	
<b>Pilot-in-command Licence Type</b>		National Pilot	<b>Age</b>	64	<b>Licence Valid</b>	Yes
<b>Pilot-in-command Flying Experience</b>		Total Flying Hours	723,8		Hours on Type	9,4
<b>Last point of departure</b>		Baragwanath Airfield (FASY), Gauteng				
<b>Next point of intended landing</b>		Baragwanath Airfield (FASY), Gauteng				
<b>Location of the accident site with reference to easily defined geographical points (GPS readings if possible)</b>						
Runway 31 at Baragwanath Airfield. Coordinates: (S 26°15'22.86", E 027°58'14.51")						
<b>Meteorological Information</b>		Temperature: 20°C; Wind direction: NW; Airspeed: 10km/h; Visibility: good				
<b>Number of people on board</b>	1 + 0	<b>No. of people injured</b>	0	<b>No. of people killed</b>	0

# AIRCRAFT ACCIDENT REPORT

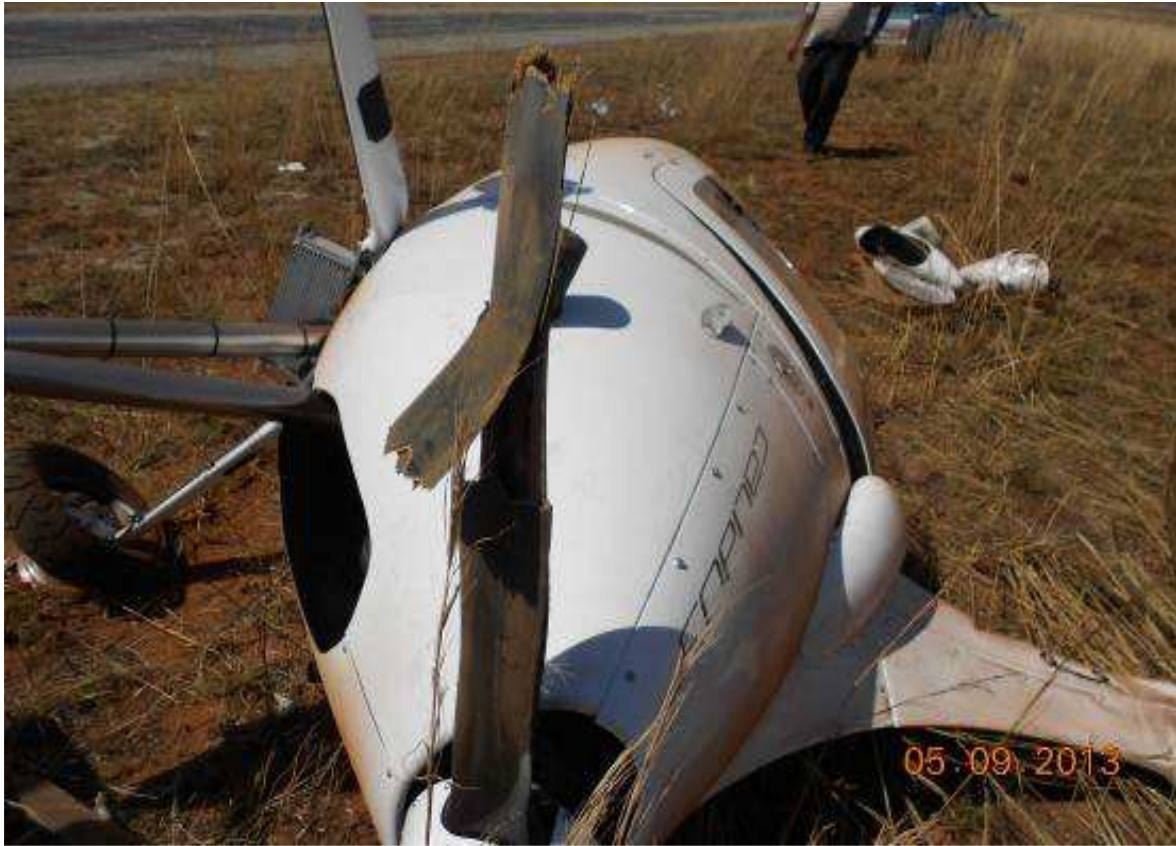
1.3.1. The accident sequence caused extensive damage to the main landing gear, nose section, rotor and propeller.

Figure 1: The rotors of the aircraft were destroyed during the accident.

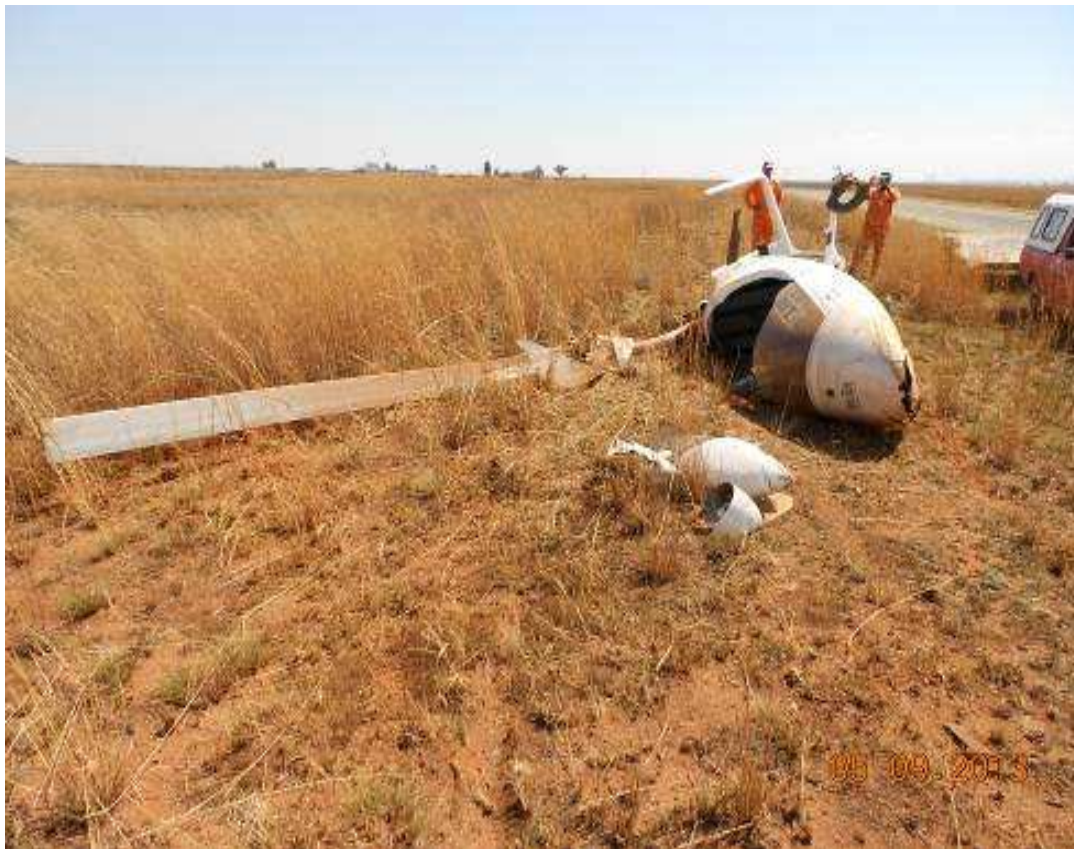
1.12.1 The aircraft struck the left side of the runway following the rollover during take-off. It came to rest on grass, lying parallel to runway 31 on its right side and facing the opposite direction, at the coordinates S26°15'22.86", E27°58'14.51".

**Figure 3:** The aircraft was extensively damaged.

1.12.2 The aircraft rolled over during take-off on runway 31, causing the rotor blade to strike the ground. This caused further instability and the pilot lost control. The accident sequence caused major damage to the main landing gear, nose section, rotor and propeller. The wreckage was fairly localised within a radius of 9,84ft. The fuselage structures and powerplant were still attached to the main wreckage.

1.12.3 Damage to the rotor blades and propeller showed evidence that the engine was on a high power setting during the accident.

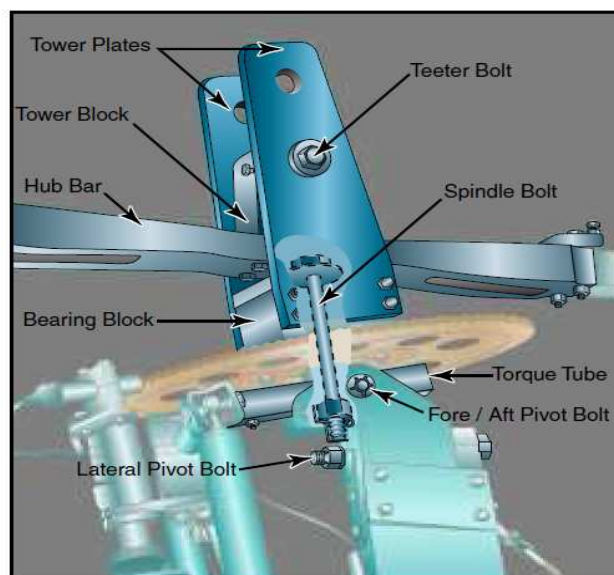
**Figure 4:** The semi-rigid, teeter-head system is found on most amateur-built gyroplanes. The rotor hub bar and blades are permitted to tilt by the teeter bolt.

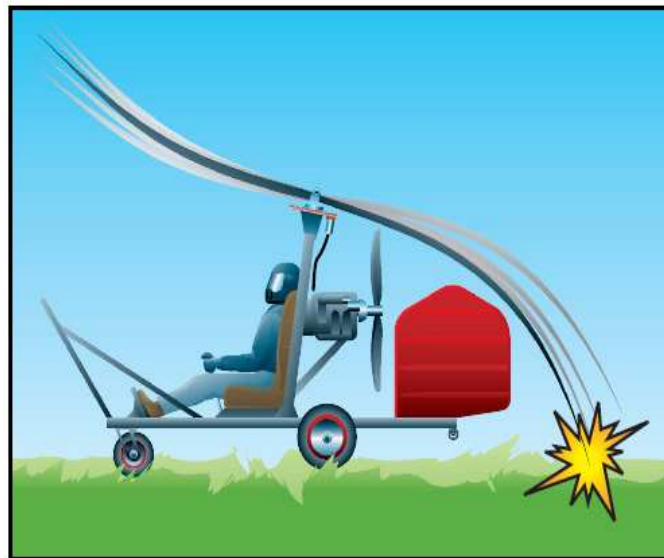
- 1.16.4 Blade Flap – On a gyroplane with a semi-rigid, teeter-head rotor system, blade flap may develop if too much airflow passes through the rotor system while it is operating at low r.p.m. This is most often the result of taxiing too fast for a given rotor speed. Unequal lift acting on the advancing and retreating blades can cause the blades to teeter to the maximum allowed by the rotor head design. The blades then hit the teeter stops, creating a vibration that may be felt in the cyclic control. The frequency of the vibration corresponds to the speed of the rotor, with the blades hitting the stops twice during each revolution. If the flapping is not controlled, the situation can grow worse as the blades begin to flex and bend. Because the system is operating at low r.p.m., there is not enough centrifugal force acting on the blades to keep them rigid. The chock of hitting the teeter stops combined with uneven lift along the length of the blade causes an undulation to begin, which can increase in severity if allowed to progress. In extreme cases, a rotor blade may strike the ground or propeller. Refer to figure 7.

**Figure 5:** Taxiing too fast or gusting winds can cause blade flap in a slow-turning rotor. If not controlled, a rotor blade may strike the ground.

To avoid the onset of blade flap, always taxi the gyroplane at slow speeds when the rotor system is at low r.p.m. Consideration must also be given to wind and direction. If taxiing into a 10-knot headwind, for example, the airflow through the rotor will be 10 knots faster than the forward speed of the gyroplane, so the taxi speed should be adjusted accordingly. When pre-rotating the rotor to accelerate slowly and smoothly, in the event blade flap is encountered, apply forward cyclic to reduce the rotor disc angle and slow the gyroplane by reducing throttle and applying the brakes, if needed. Refer to figure 5.

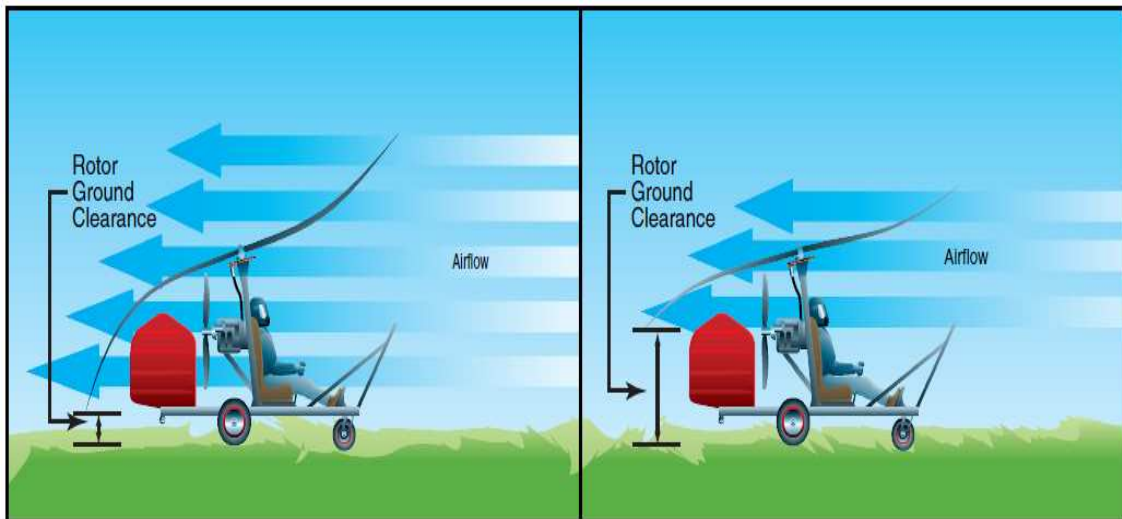
**Figure 6:** Decreasing the rotor disc angle of attack with forward cyclic can reduce the excessive amount of airflow causing the blade flap. This also allows clearance between the rotor blades and the surface behind the gyroplanes, minimizing the chances of a blade striking the ground.

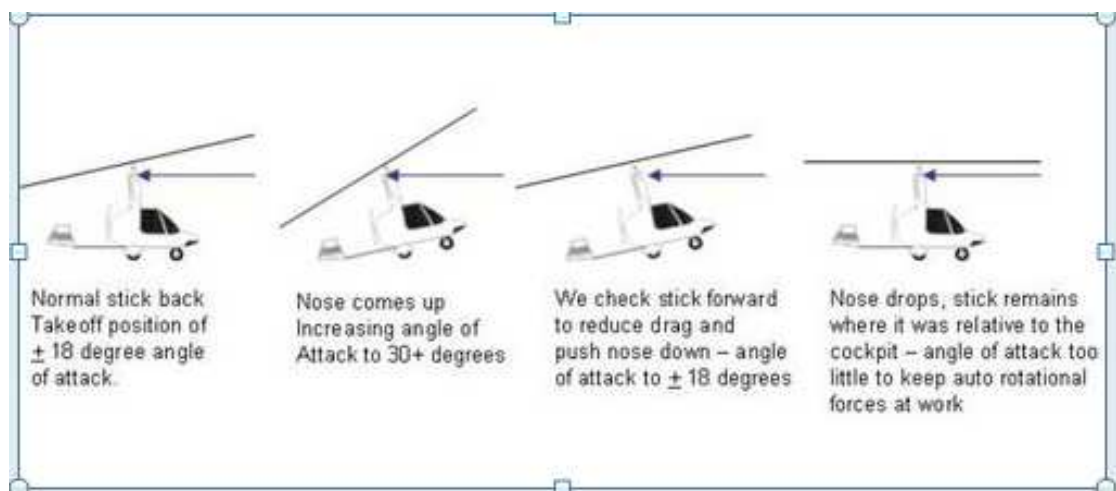
**Figure 7:** Gyro control stick position.

*“In a typical take-off roll, the stick is full back and the rotor is loaded as the drag increases with forward speed. The rotor speeds up to the point that the nose lifts and pilot must check forward on the stick to hold the nose down and to avoid getting airborne behind the power curve. As the nose drops again, the stick position may remain the same relative to the cockpit, causing the angle of attack becoming too small. This is the same as taking off with the stick forward, which will result in blade-flap regardless of rotor RPM. The disc skips along as the airspeed increases rapidly because there is no drag. The rotor is unloaded at this point.*

*“The safe method of take-off is to ensure that the rotor is loaded throughout the take-off roll until the gyro is airborne, whether it is behind the power-curve or not. In other words, you must feel rotor drag throughout the take-off roll. Once the wheels are off the ground, blade-flap cannot happen in steady flight. The best method then would be to push the nose forward, gain adequate airspeed and only then begin the climb-out.*

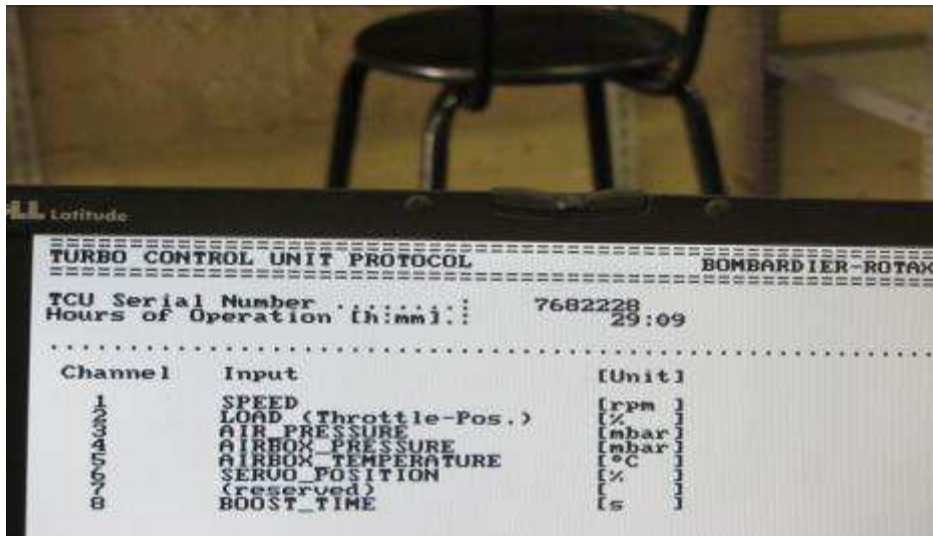
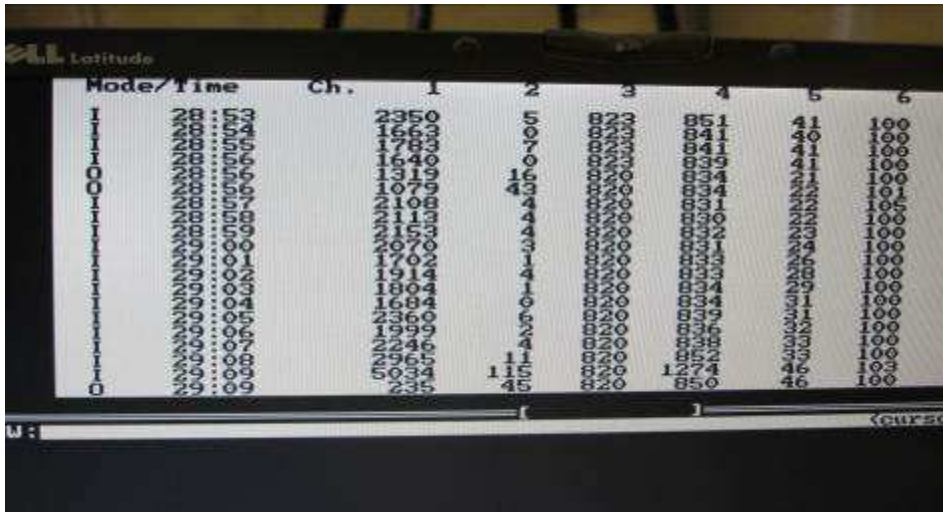
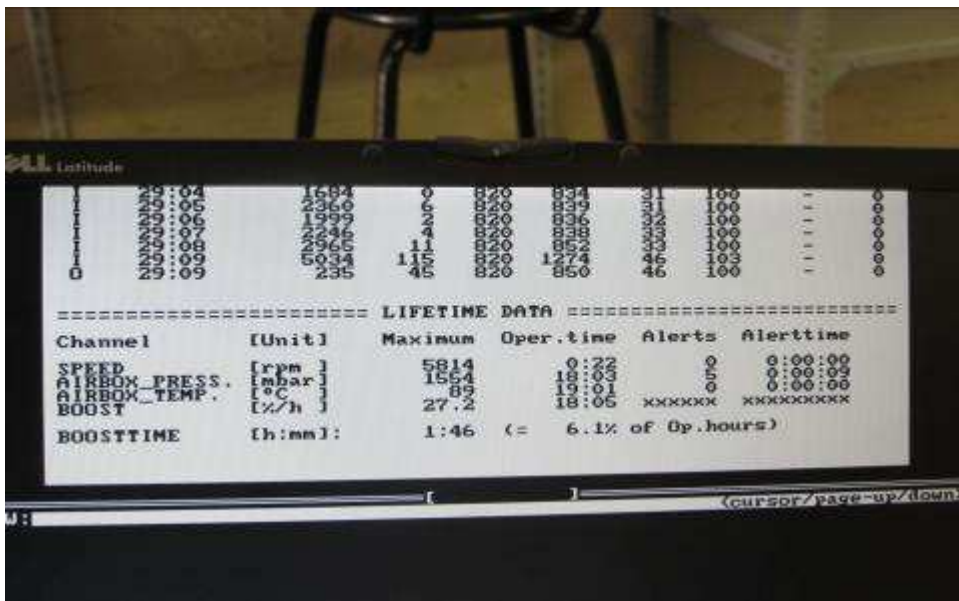
## Turbo control unit downloads results

- 1.16.2 All other damage was accounted for as the result of the impact during the accident sequence. The turbo control unit (TCU) downloads indicated normal settings for take-off operation with no over-speeding of the engine prior to the accident. (The TCU downloads are attached as Appendix A.)
