AIRCRAFT ACCIDENT REPORT AND EXECUTIVE SUMMARY

Reference:	CA18/2/3/9357	
Aircraft Registration	ZS-GVE	Date of Accident	13 September 2014		Time of Accident	0845Z
Type of Aircraft	Scheibe SF 25 B(Glider)		Type of Operation		Training (Part 141)	
Pilot-in-command Licence Type		National Pilot Licence	Age	62	Licence Valid	Yes
Pilot-in-command Flying Experience		Total Flying Hours	833.31		Hours on Type	680
Last point of departure		Springs Airfield (FASI): Gauteng Province				
Next point of intended landing		Springs Airfield (FASI): Gauteng Province				
Location of the accident site with reference to easily defined geographical points (GPS readings if possible)						
At Springs Airfield boundary to the left of Runway 03 (GPS coordinates S 26° 14' 154.86" E 028°23' 44,28"); Elevation 4495 feet						
Meteorological Information		Wind: Light and Variable; Temperature: 26° C; Visibility :CAVOK				
Number of people on board	2	No. of people injured	2	No. of people killed	0

AIRCRAFT ACCIDENT REPORT

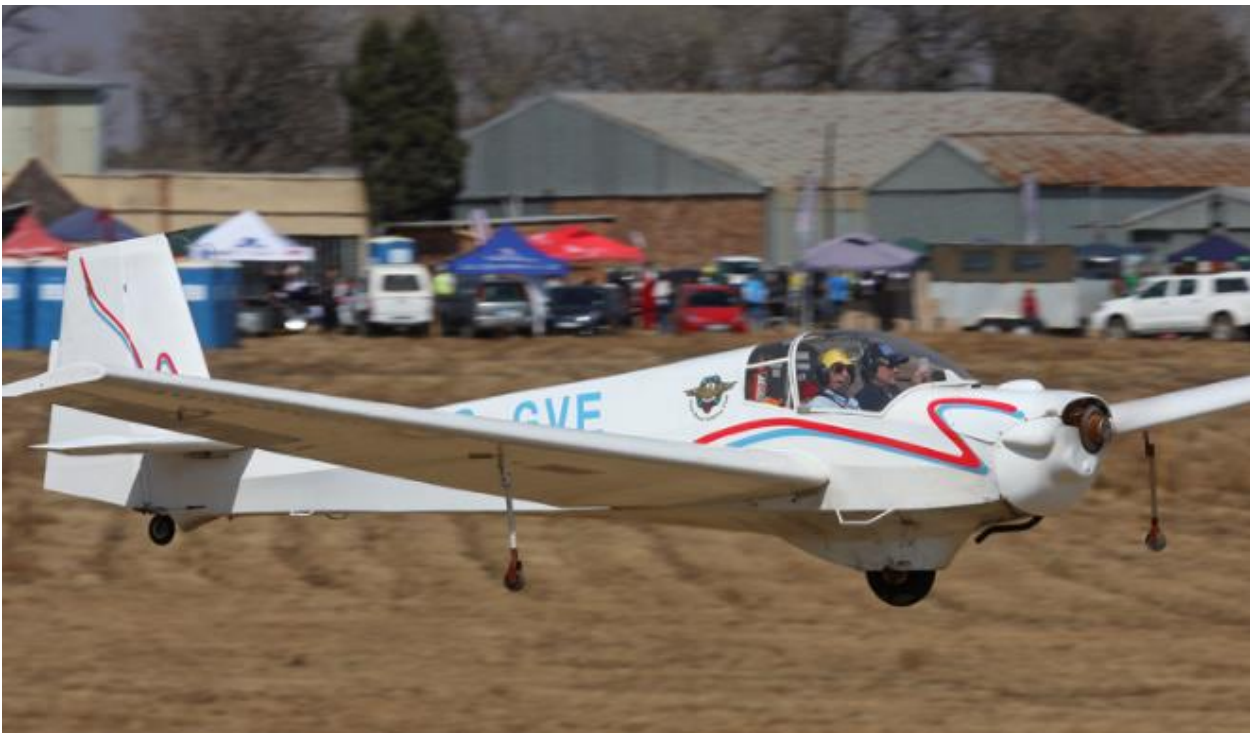
1.3.1 The aircraft sustained substantial damage during the accident.

Figure 1: Shows picture of ZS-GVE courtesy of Google.
