<b>AIRCRAFT ACCIDENT REPORT AND EXECUTIVE SUMMARY</b>
---

Reference:	CA18/2/3/9607	
<b>Aircraft Registration</b>	ZS-MYS	<b>Date of Accident</b>	21 March 2017		<b>Time of Accident</b>	1345Z
<b>Type of Aircraft</b>	Cessna 172N		<b>Type of Operation</b>	Training (Part 141)		
<b>Pilot-in-command Licence Type</b>	Student		<b>Age</b>	19	<b>Licence Valid</b>	Yes
<b>Pilot-in-command Flying Experience</b>	Total Flying Hours		40.2		<b>Hours on Type</b>	40.2
<b>Last point of departure</b>	Lanseria Aerodrome (FALA)					
<b>Next point of intended landing</b>	Lanseria Aerodrome (FALA)					
<b>Location of the accident site with reference to easily defined geographical points (GPS readings if possible)</b>						
Near Hekpoort at Oostermoed farm at GPS: S29° 49' 34.9" E027° 37' 08.1" Elevation 1323m.						
<b>Meteorological Information</b>	Surface Wind: 090° at 08 knots. Visibility >10km					
<b>Number of people on board</b>	1 + 0	<b>No. of people injured</b>	1	<b>No. of people killed</b>	0

## AIRCRAFT ACCIDENT REPORT

**Name of Owner** : Papa Charlie Partnership  
**Name of Operator** : Skyhawk  
**Manufacturer** : Cessna Aircraft Company  
**Model** : 172N  
**Nationality** : RSA  
**Registrati

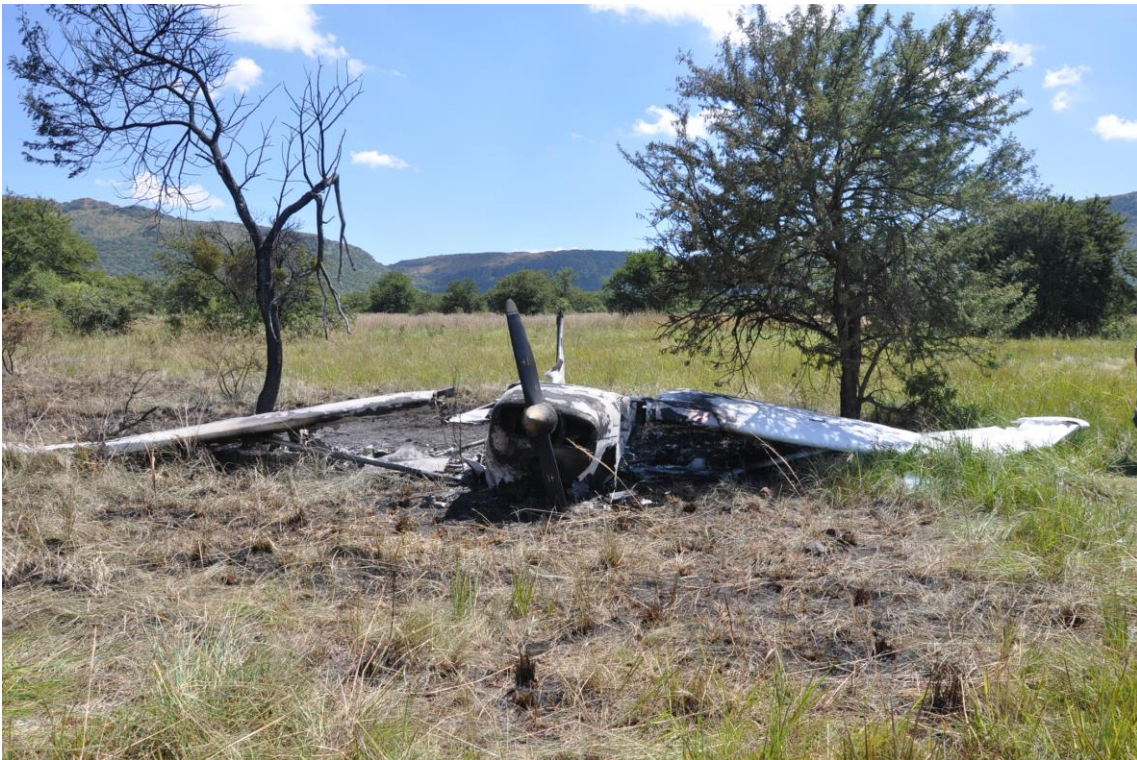
1.3.1 The aircraft was destroyed by post impact fire.

Figure 1: Wreckage of the aircraft

1.14.1 The aircraft was destroyed by post-impact fire.

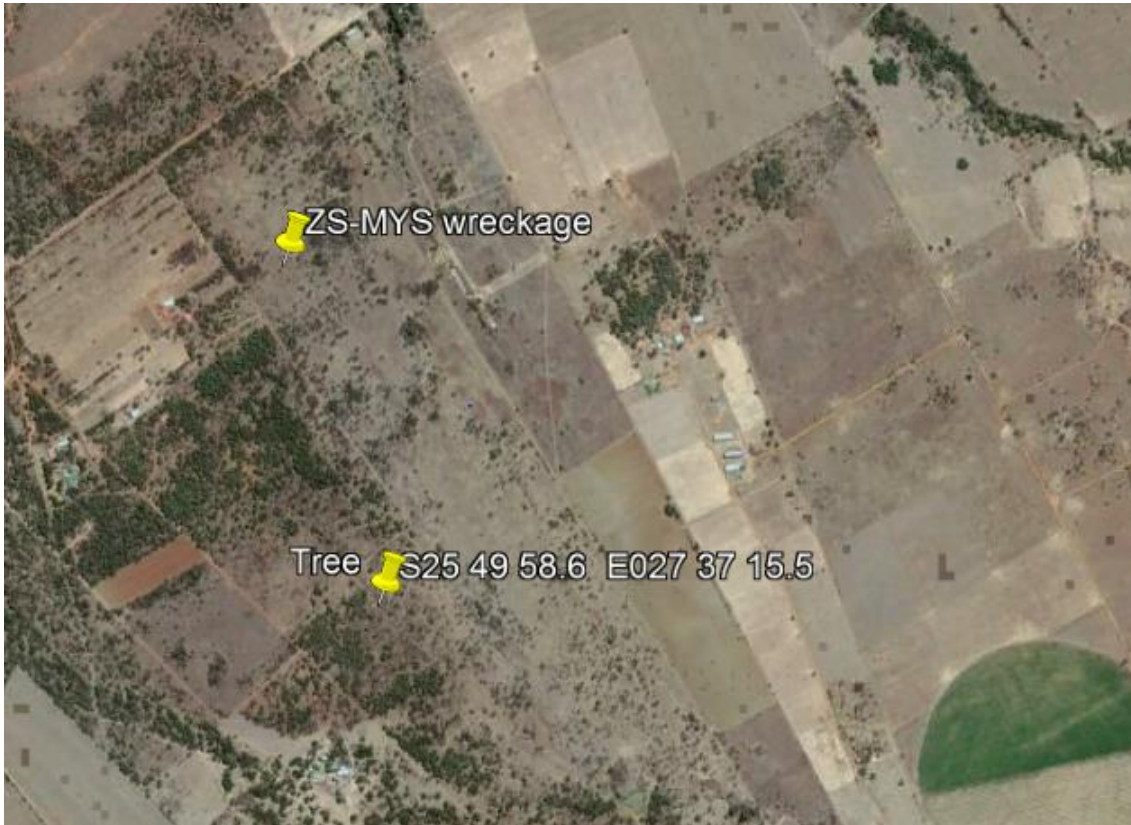
1.12.1 During the simulated forced landing, the aircraft was heading in a northerly direction. It lost height and the right-hand wing tip made contact with the tree before the aircraft impacted the ground. The aircraft skidded for approximately 700m before it came to rest, facing in a southerly direction, and caught fire.

Figure 2: Google map showing the distance between impacted tree and the wreckage

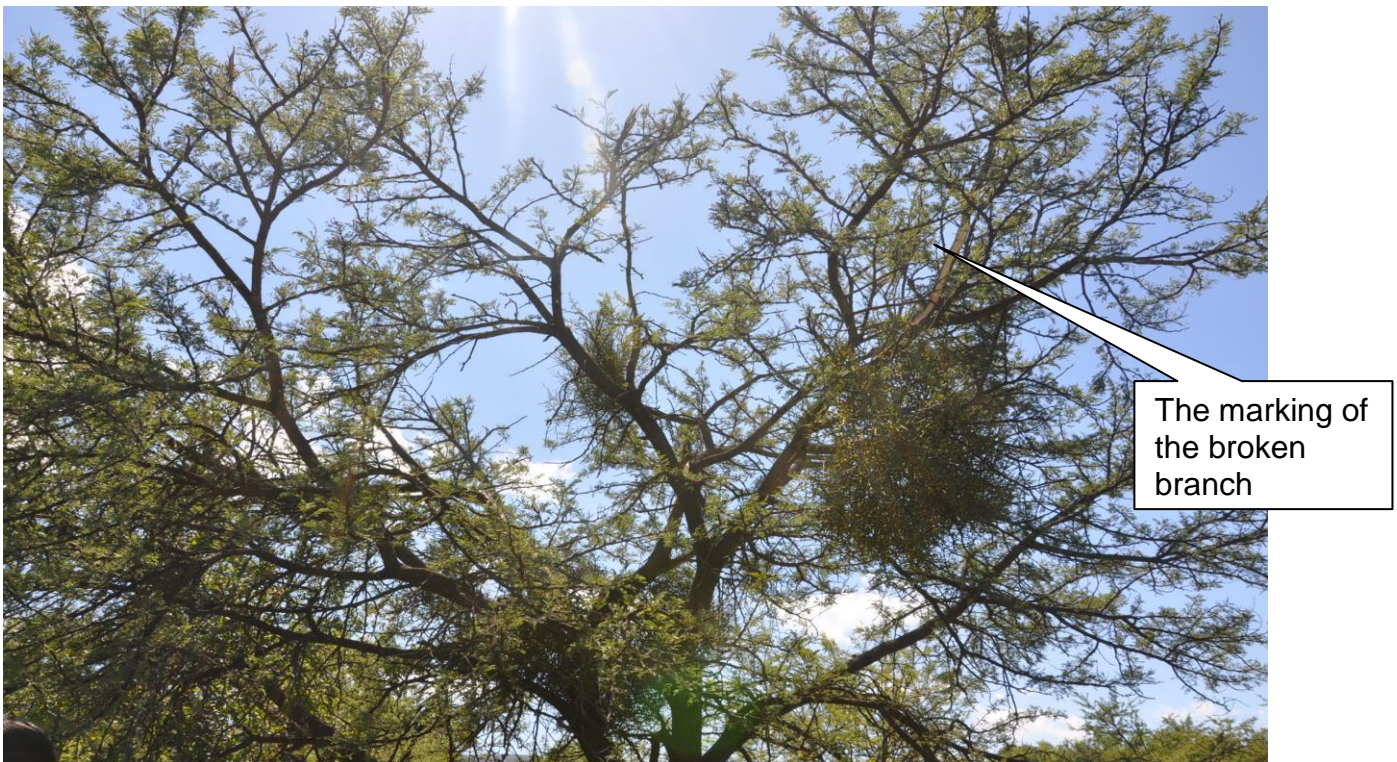
Figure 3: Showing the marking of the broken tree branch

- 3.2.1 Unsuccessful forced landing following a simulated engine failure, which led to the right-wing tip clipping the tree before the aircraft impacted the ground.
