<b>SHORT REPORT AND EXECUTIVE SUMMARY</b>
---

Reference:	CA18/2/3/9609	
<b>Aircraft Registration</b>	ZU-TMG	<b>Date of Accident</b>	16 March 2017		<b>Time of Accident</b>	1200Z
<b>Type of Aircraft</b>	PAPA 51 Thunder Mustang		<b>Type of Operation</b>	Private (Part 94)		
<b>Pilot-in-command Licence Type</b>		Airline Transport	<b>Age</b>	54	<b>Licence Valid</b>	Yes
<b>Pilot-in-command Flying Experience</b>			16 662	<b>Hours on Type</b>	50,2	
<b>Last point of departure</b>		Stellenbosch Aerodrome (FASH): Western Cape Province				
<b>Next point of intended landing</b>		Stellenbosch Aerodrome (FASH): Western Cape Province				
<b>Location of the accident site with reference to easily defined geographical points (GPS readings if possible)</b>						
Kogel Bay (GPS S 34° 14' 08.27" E 018° 50' 59.69") Elevation 10 feet						
<b>Meteorological Information</b>		Wind Calm ; Visibility: CAVOK; Temperature: 24 °C, dew point 8 °C				
<b>Number of people on board</b>	1+1	<b>No. of people injured</b>	2	<b>No. of people killed</b>	0

<b>AIRCRAFT ACCIDENT REPORT</b>
---------------------------------

**Name of Owner /Operator** : A J Basson  
**Manufacturer** : Thunder Mustang LLC  
**Model** : PAPA

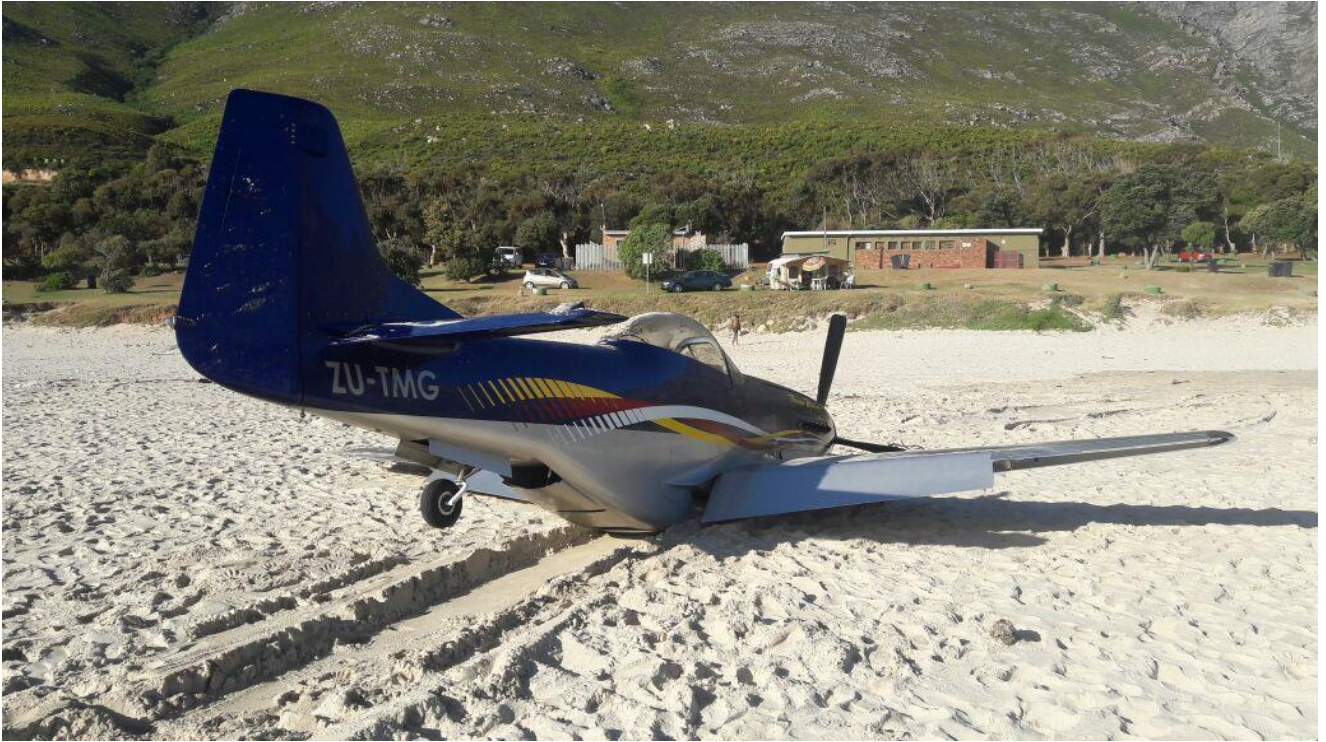
- 1.1.2 The pilot reported that he started a climb and right hand turn. After completing the 180° turn he opted to execute a forced landing on the beach. The undercarriage was not lowered and the aircraft skidded on the beach on its belly before coming to rest.
- 1.1.3 The pilot reported that while exiting the aircraft he bumped his head against the canopy and sustained a cut on his forehead. The passenger sustained a cut below his kneecap. The aircraft sustained substantial damage to the propeller, engine cowls, lower wing and bottom air intake scoop.

- 1.2.3 The aircraft was manufactured by Thunder Mustang LLC.
- 1.2.4 The aircraft had a total of 55 airframe hours at the time of the accident.
- 1.2.5 The last annual inspection on the aircraft was carried out on 8 August 2016 at 40,6 hours and it had flown 14,4 hours since the last inspection.
- 1.2.6 The Falconer V12 engine (SN RFI 12050) had accumulated 53,2 hours since new.
- 1.2.7 The MTV-16-1-E-C propeller (SN 98447) had accumulated 55 hours since new.
- 1.2.8 The coolant system was operating normally.
- 1.2.9 Loss of oil pressure followed by engine seizure.
- 1.2.10 There was a ruptured oil line that caused all oil to leak out; as a result the engine seized.

Figure 1: View of the aircraft after it came to rest

2.1.1 Unsuccessful forced landing following an inflight engine failure as a result of a failed oil supply pipe.
