## AIRCRAFT ACCIDENT SHORT REPORT

CA18/3/2/9858: In-flight engine failure that resulted in an unsuccessful forced landing.

**Date and time** : 25 January 2020 at 1715Z  
**Location** : On a beach next to Haga-Haga Holiday Resort, East London  
**Aircraft registration** : ZU-RNJ  
**Aircraft manufacturer and model** : Sanka AK 1-3  
**Last point of departure** : Morgan Bay Hotel, East London (Eastern Cape)  
**Next point of intended landing** : Glen Eden private farm, East London (Eastern Cape)  
**Location of accident site with reference to easily defined geographical points (GPS readings if possible)** : S32° 45' 39.50" E028° 15' 12.56  
**Meteorological information** : Temperature: 28°C; Wind Speed: 5 knots; Wind Direction: Easterly; Visibility: 10km  
**Type of operation** : Part 94  
**Persons on-board** : 1 + 0  
**Injuries** : None  
**Damage to aircraft** : Substantial

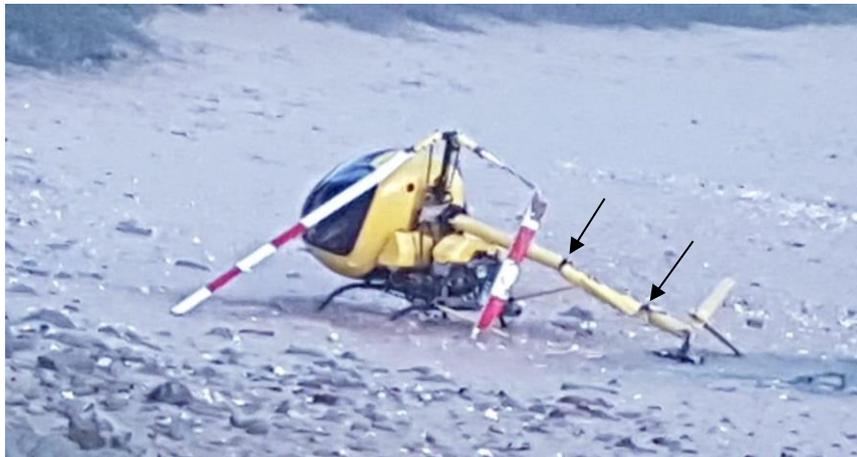
- 2.2 The helicopter had 40 litres of 95 Octane Unleaded motorcar fuel in a 72-litre capacity fuel tank prior to departure. The engine was started without fault. After the pilot had verified that the engine instruments readings were normal, he took off and climbed to 600 feet (ft) above ground level (AGL) at 80 knots (kt) indicated airspeed (IAS). About 8 minutes into the flight whilst positioned overhead Haga-Haga Holiday Resort, the low rotor revolutions per minute (RPM) light illuminated and the engine's RPM dropped. A few seconds later, the engine started to run rough and it eventually stopped. The pilot entered autorotation, but as he flared the helicopter for landing, he did not sufficiently arrest the descent rate, resulting in the helicopter skids impacting the ground very hard. The helicopter came to rest in an upright position on the beach. Before the helicopter came to rest, its main rotor had struck and damaged the tail boom. The helicopter sustained substantial damage, however, the pilot was not injured.

**Figure 2:** The helicopter as it came to rest on the beach. (Source: pilot)

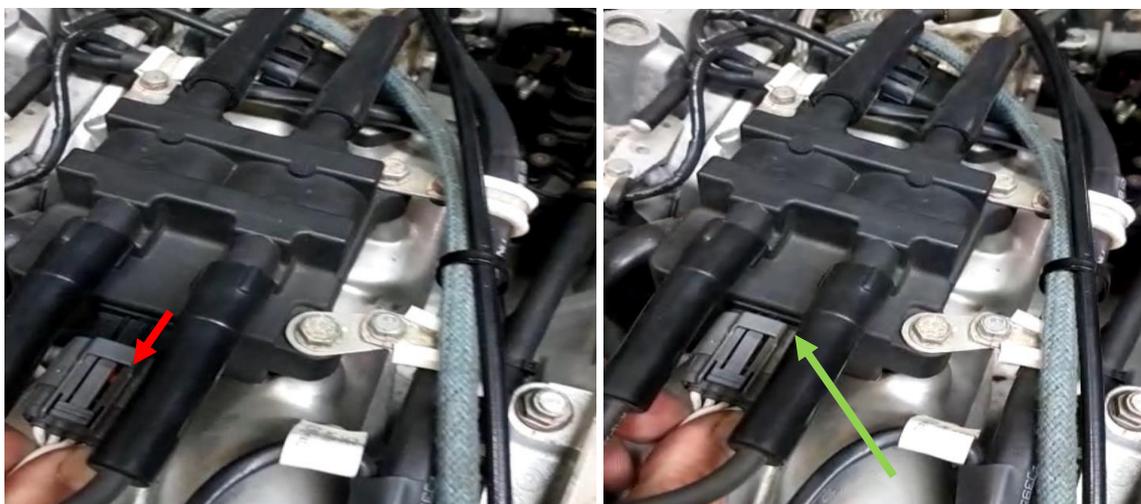
- 3.2 The last annual inspection on the helicopter was carried out on 18 March 2019 at 632.7 total recorded tachometer hours. The helicopter and the engine had logged a total of 640.2 hours at the time of the accident. Post-accident examination of the wreckage by the pilot at the accident site did not show any visible anomalies on the engine's exterior. The pilot reported that the helicopter had about 20 litres of fuel remaining in the fuel tank. Fuel was drained before the helicopter was recovered on a trailer to the pilot's residential area in Glen Eden, where it was parked in the garage. Parts of the rotor head were removed before the engine inspection was performed. Examination of the engine revealed a disconnected ignition coil plug.

**Figures 3/4:** A disconnected ignition coil plug found on the engine post-accident (left) and the ignition coil plug fitted back onto the connector (right).

4.1.9 Post-accident inspection of the engine indicated that the ignition coil plug, which feeds spark to all four-cylinder spark plugs, had disconnected in-flight and had caused a loss of spark and thus, the subsequent engine stoppage.

5.1 The engine stoppage was caused by the absence of spark in all four cylinders after the ignition plug had disconnected in-flight.

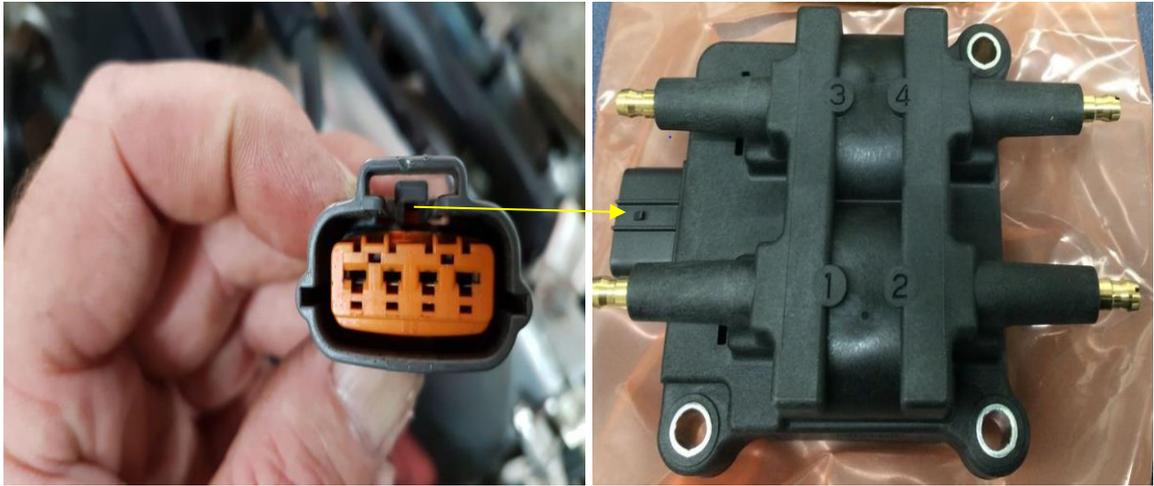
- 3.3 Further examination of the ignition coil plug showed that the rubber latch on the inside top part of the plug (Figure 5) that was intended to hold the plug to its position was damaged (Figure 6). The plug was returned to its position; however, the latch was unable to lock, and it could be pulled out easily.

**Figures 5/6:** The ignition coil plug (left) with an arrow showing the position of a damaged latch; and a fixed engine connector on the ignition coil pack (right).

- 3.4 The anomaly on the ignition coil plug showed that its separation from the engine's fixed connector on the coil pack area went unnoticed until it was completely detached. A video of the position of the ignition coil plug was sent to the manufacturer for their comment. The manufacturer's response was that under normal circumstances, the ignition coil plug will not fail as it has an in-built strong hold. The only time the ignition coil plug is removed is when there is a need to work on the intake manifold area. There was no evidence of such task being recorded in the aircraft flight folio. The manufacturer informed the investigation team that it was the first time an anomaly of this nature was reported since the Subaru EJ-25 engine came into operation in 1996. The investigation was, therefore, unable to determine how the plug got damaged, however, previous maintenance defects could not be ruled out.

6.1 The ignition coil plug was not properly fitted during maintenance, as a result, it disconnected in-flight.

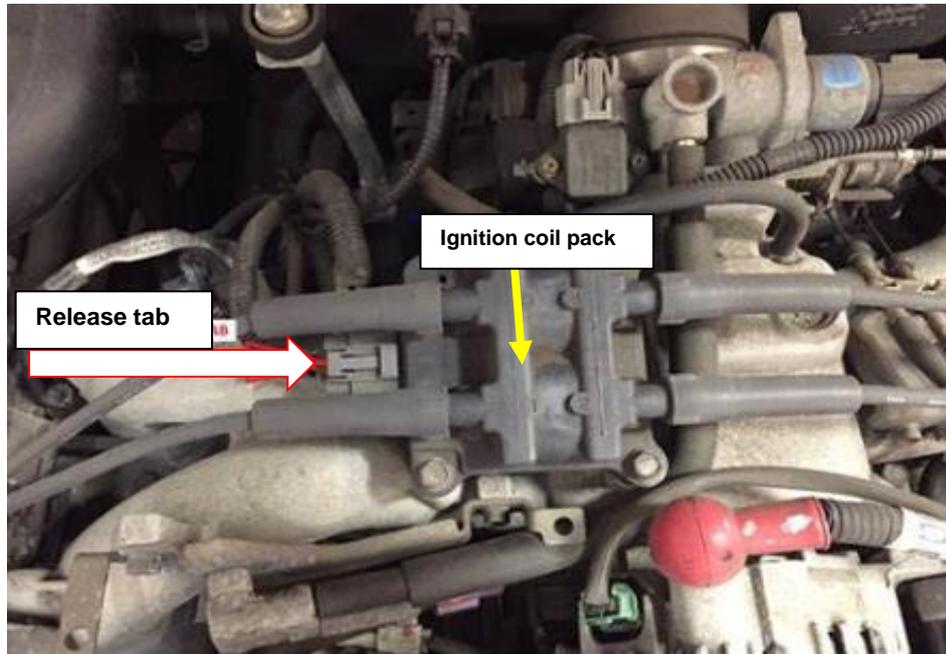
- 3.5 A decision was made to temporarily secure the ignition coil plug to the engine's fixed connector from which a small amount of fuel was uplifted to facilitate the engine function test. Before the test, the drive belts were removed, and the engine was started without difficulty. The engine was run up to 104% revolutions per minutes (RPM) and it operated normally. The investigation concluded that the engine stoppage was caused by the absence of spark in all four cylinders after the ignition plug had disconnected. The plug is removed by pressing the 'PRESS' key release tap (see Figure 7). To fit it back, it must be carefully inserted into the engine's fixed connector until the latch locks. The latch has a strong hold and, if properly fitted, will not disconnect.

**Figure 7:** The “PRESS key” release tap.
