PRELIMINARY ACCIDENT REPORT

Reference number : CA18/2/3/9727
Name of owner : Calitz GS
Name of operator : Private (Part 91)
Manufacturer : Robinson Helicopter Company
Model : R22 Beta II
Nationality : South African
Registration marks : ZS-HBP
Place : Thaba Thala Safaris Game Reserve, Eastern Cape
Date : 15 August 2018
Time : ±0800Z

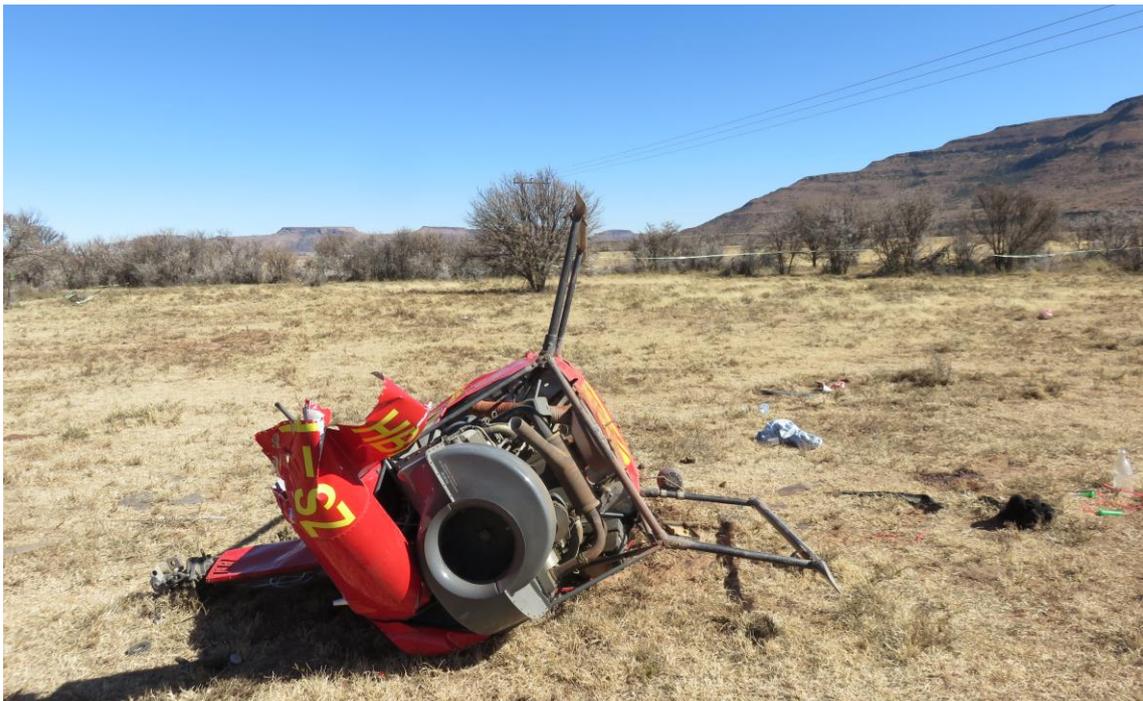
- 3.5 The helicopter was found lying on its left side. The tail boom was severed and both main rotor blades were found to have separated from the main rotor hub assembly. One main rotor blade was lying in close proximity to the main wreckage, the other main rotor blade was approximately 82 m away. The main wreckage was lying 21 m from a set of power lines, which consisted of three wires, 1.5 m apart in the horizontal plane and approximately 10 m (33 ft) above ground level. The two supporting pylons were 192 m apart. The wires were intact, and there was no disruption of the power supply in the area. The middle wire displayed evidence of arcing, as can be seen in Figures 2 and 3.

Figure 1: The main wreckage as it came to rest with electrical conductors visible to the right

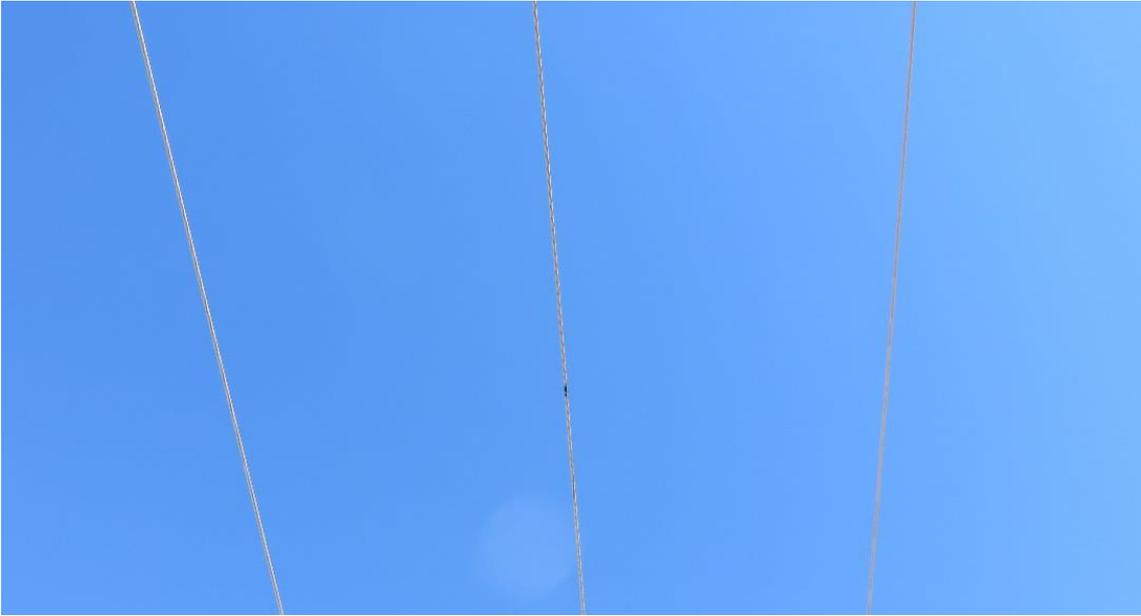
Figure 2: A view of the three wires with the arcing visible on the middle wire

- 4.7 Fine weather conditions prevailed at the time of the accident, and weather was not considered to have had any bearing on the accident.
- 4.8 The main wreckage was found lying on its left side some 21 meters from a set of power lines (Figure 2), which consisted of three wires 1.5 metres apart in the horizontal plane and approximately 10 m (33 ft) above ground level. The middle wire displayed evidence of arcing.

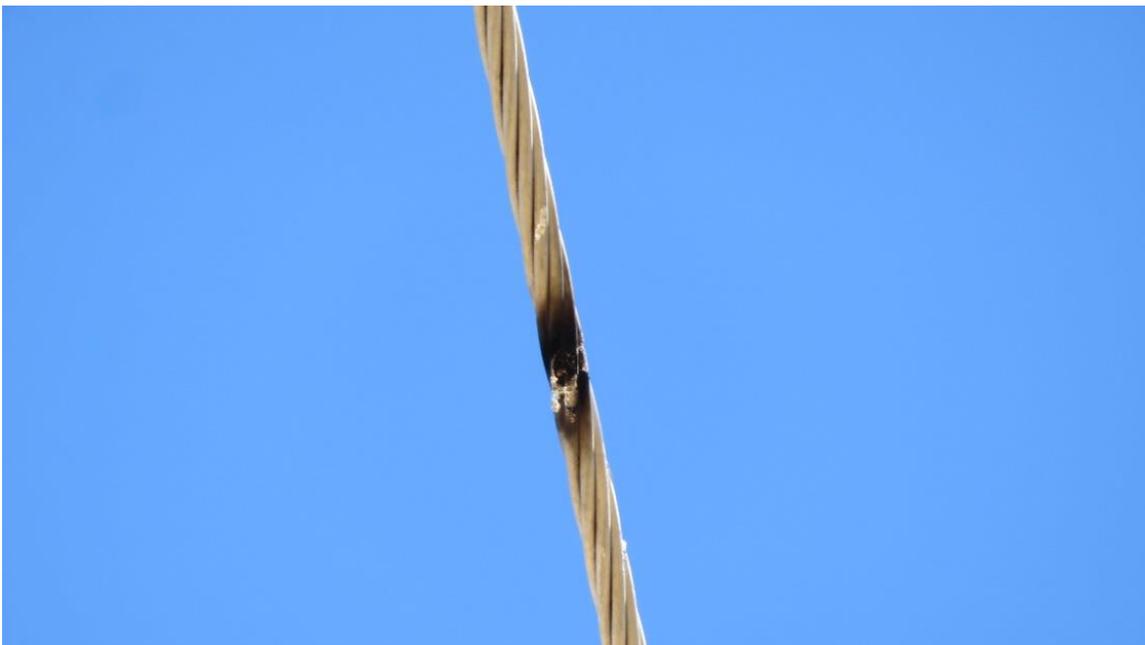
Figure 3: The middle wire of the three, displaying evidence of arcing
