**CIVIL AVIATION
AUTHORITY**

AIRWORTHINESS DIRECTIVES

SUBJECT INDEX

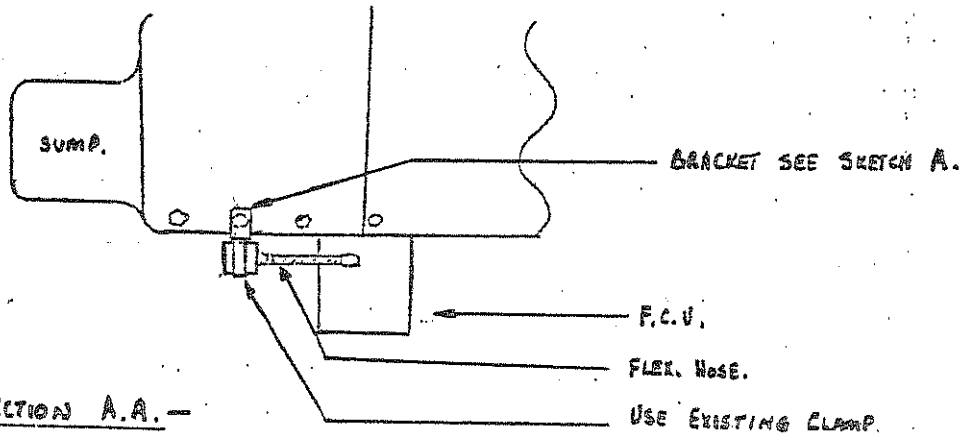
FUEL PRESSURE LINE MODIFICATION — DRAWING N° FM 07 —

The flexible fuel pressure hose between the fuel control unit and fuel pressure transducer can become hard and brittle causing eventual fuel leakage due to its close proximity to the exhaust segments. To prevent this accomplish the following:

- (ii) Remove fuel pressure transducer from existing location (clamped to no. 3 cylinder induction pipe) and retain clamp and attaching hardware.
 - (iii) Manufacture bracket from 4130 steel to dimensions shown on sketch A, minimum thickness of 0,060 and fit bracket to new position below no 1 cylinder utilizing existing sump attach bolt as indicated in sketch.

- (iv) Attach fuel pressure transducer to steel bracket with existing fuel pressure transducer clamp using AN 3-7A bolt, AN 960-10 washer and AN 363-1032 nut.

- (v) Manufacture new flexible hose, total length 11 cm, measured from outside ends of hose fitting nuts.
 - (vi) Original hose may be utilized and shortened, provided the hose is serviceable, by removing hose end fitting, which attaches to fuel pressure transducer, shortening hose to correct length and re-fitting hose end fitting.

MATERIALS: 4130 STEEL
1.524 mm
THICKNESS.
