## AIRCRAFT ACCIDENT REPORT AND EXECUTIVE SUMMARY

Reference:	CA18/2/3/8067	
<b>Aircraft Registration</b>	ZU-VOS	<b>Date of Accident</b>	4 February 2006		<b>Time of accident</b>	1200Z	
<b>Type of Aircraft</b>	Lambda UFM-13	<b>Type of Operation</b>		Private Flight			
<b>Pilot-in-command Licence Type</b>		Private Pilot	<b>Age</b>	48	<b>Licence Valid</b>	Yes	
<b>Pilot-in-command Flying Experience</b>		Total Flying Hours	1 100.0		Hours on Type	17.1	
<b>Last point of departure</b>		Port Alfred Aerodrome (FAPA)					
<b>Next point of intended landing</b>		Port Alfred Aerodrome (FAPA)					
<b>Location of the accident site with reference to easily defined geographical points (GPS readings if possible)</b>							
Port Alfred Aerodrome Runway 10L (left).							
<b>Meteorological Information</b>		Surface wind; 010°/15 to 18 kts, Visibility; 10 km.					
<b>Number of people on board</b>	1 + 1	<b>No. of people injured</b>	0		<b>No. of people killed</b>	0	
<b>Synopsis</b>

<b>Probable Cause</b>							
Due to limited controllability following the failure of the right-hand flapperon in flight, due to a flutter, a hard landing followed.							
<b>IARC Date</b>				<b>Release Date</b>

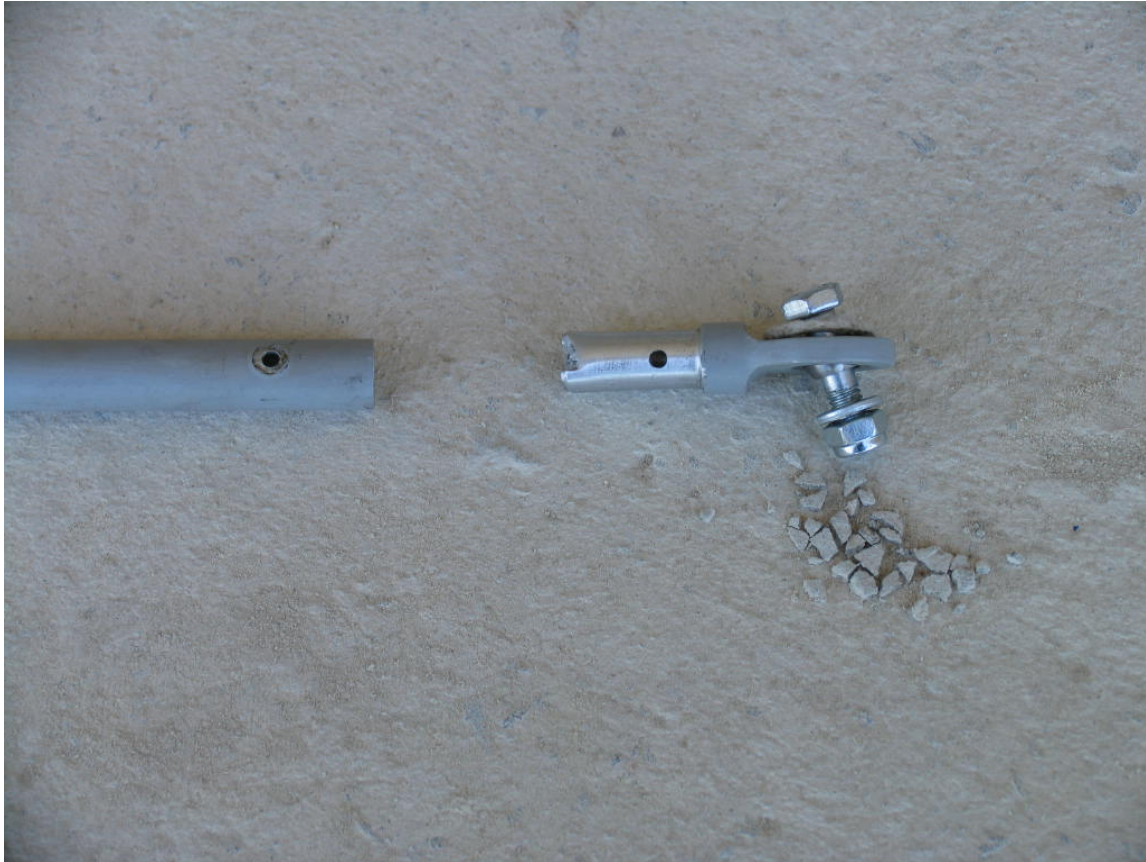
1.16.1 A test report was received from the original Aircraft Manufacture with reference to a further investigation into the failure of the flapperon flight control surface push-pull rod. The manufacturer conducted tests to establish what the required forces would have been for the push rod to fail in the way it did. The report also provided engineering calculations to determine the strength of material and manufacturing process applied to reinforce the grip between the two parts (Centre Rod & eye bolt rod end) held together by rivets.

View of flapperon push/pull eyeball end, which was found detached.

2.2 Further investigation showed evidence that the push/pull control rod of the right-hand side flapperon had failed. The flapperon control push/pull rod became disconnected at the eyeball fitting, where two rivets were installed. The rivets could not be found inside the aircraft. The failure of the attachment fitting was attributed to the extreme forces that acted on the control system during the failure of the flapperon control surface. The aircraft had gone through different quality control checks, when it was assembled at the manufacturer, prior to it having been shipped to South Africa. Again upon arrival in South Africa, at the facility of the local manufacturer/distributor, all the flight control rods and primary flight control surfaces were inspected for security of installation and attachment.

- 3.1.6 The rivets installed on one of the push-pull rods failed at the eyeball-end.
- 3.1.7 The instrument panel layout included in the Aircraft's Operating Handbook is not as per equipment installed in the aircraft.

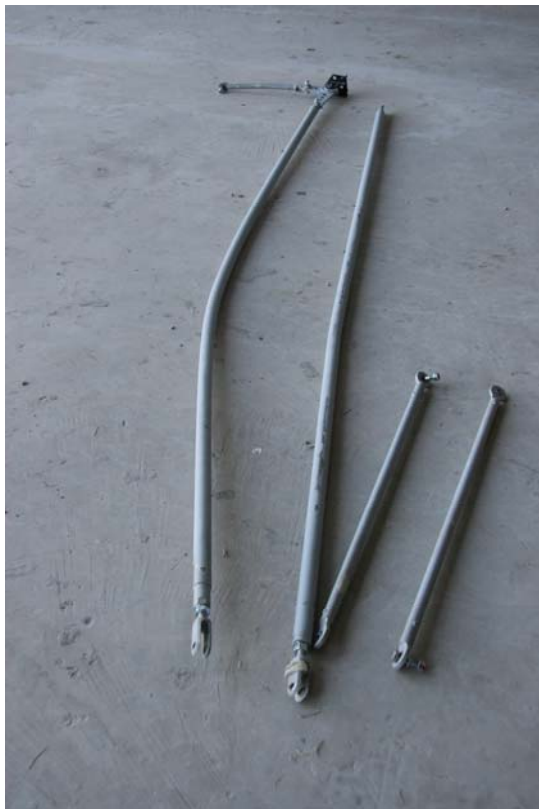
1.16.2 Several of the flapperon control rods were found to be bent as a result of the loads exerted on them in flight. Copies of documentation received from the Aircraft Manufacture explain the load limitations.

View of bent flapperon push-pull control rods.

- 4.4 It is recommended that the SACAA calls on the inspection of the flapperon control system of EFIS equipped Lambada aircraft to verify that no damage exists that may have been unintentionally caused.

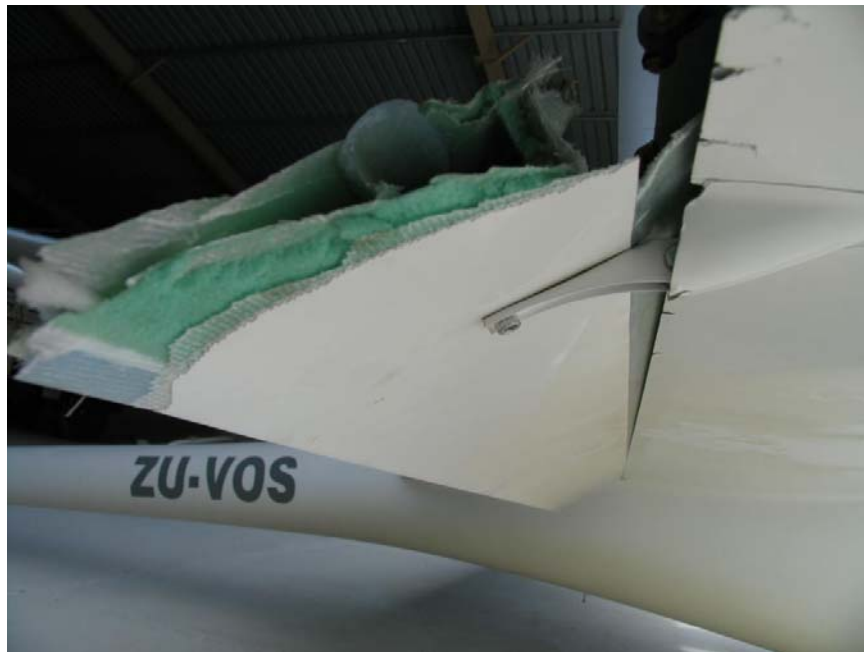
1.12.1 The inner section of the flapperon, 1.58 m in length, remained attached to the right wing structure of the aircraft, with the outer 3.72 m of flapperon separating from the wing. It was never recovered as it is believed that it probably fell into the sea.

Section of flapperon, 1.58m in length, that remained attached to the wing structure.

5. Available evidence indicates that the control surface most probably had been subjected to flutter and as a result caused the flapperon to fail and to separate from the wing structure. The reason for the inner section remaining attached could be associated with the severity of the oscillations that the flapperon had been exposed to during flutter.

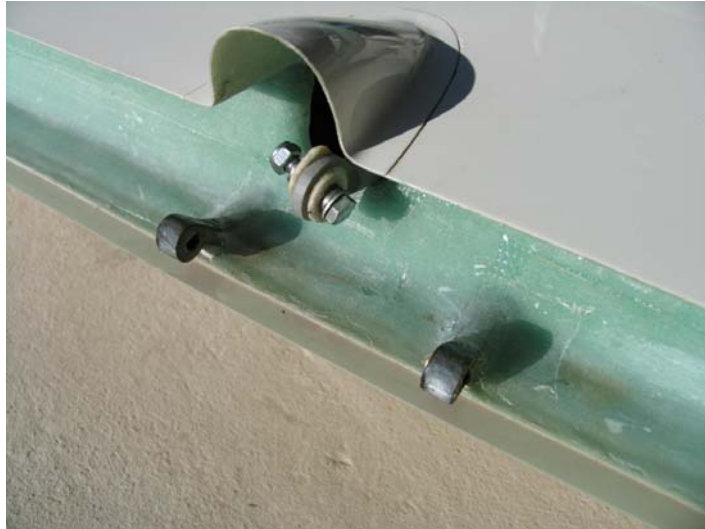
There is a total of nine hinge attachments to the trailing edge of the wing structure to accommodate the installation of the flapperon. The material of the wing hinges is made out of carbon as well as glass fibre and was tested by the manufacturer to withstand the required design limitations/forces imposed on them.

View of two of the hinges supporting the flapperon control surface.

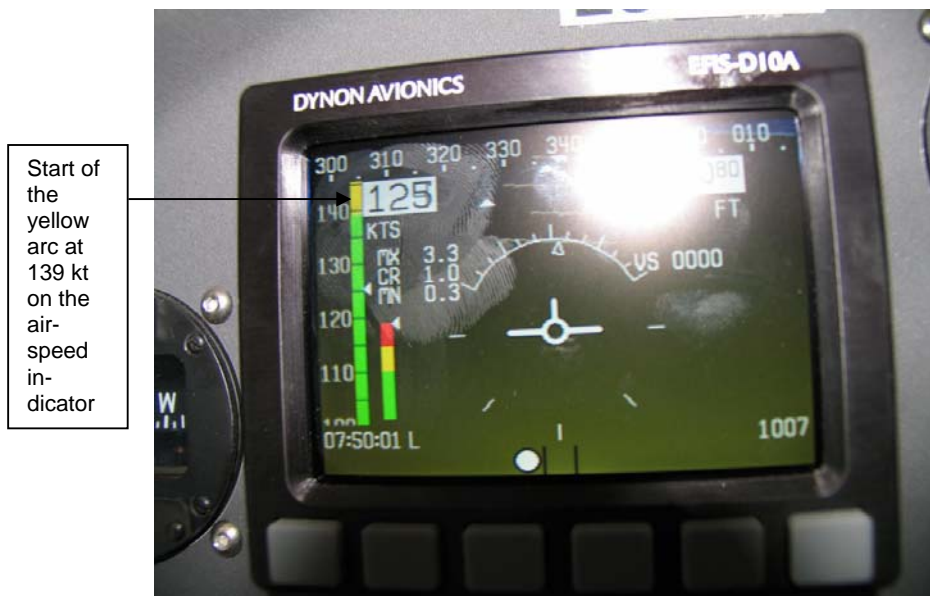
A view of the EFIS instrument displaying the airspeed indicator on the left-hand side.

2.3 The Dynon Avionics EFIS-D10A primary flight instrument system was tested and it was found that the instrument airspeed indicator markings did not conform to the values as stipulated in the Pilots' Operating Handbook (POH). The instrument was therefore not calibrated according to the required design limitations of the aircraft. It should be noted that the aircraft had flown a total of 17.1 hours when the failure of the flapperon occurred. Although the flight in question was still stored in the non-volatile memory of the GPS unit, it could be seen that the pilot had executed several turns prior to the failure of the flapperon, however, no detailed information indicating the airspeed and angle of bank could be downloaded.

calibrated. The airspeed limitations on the instrument displayed substantial discrepancies/errors, with the instrument under reading, especially when it came to critical airspeed limitations. This under reading could therefore result in the actual airspeed much higher than indicated.

- 3.3.1 Erroneous airspeed calibration of the EFIS flight instrument, resulting in a Vne display error of 38%.

- 4.3 It is recommended that the Commissioner should perform inspections and tests on the Lambada Aircraft and installed Dynon Avionics EFIS-D10A instrument sold by Manufacturing Organisation (M614). This is to satisfy the requirement by the manufacturer of calibration in terms of Airspeed Limitations as stipulated in the Aircraft Operating Manuals.

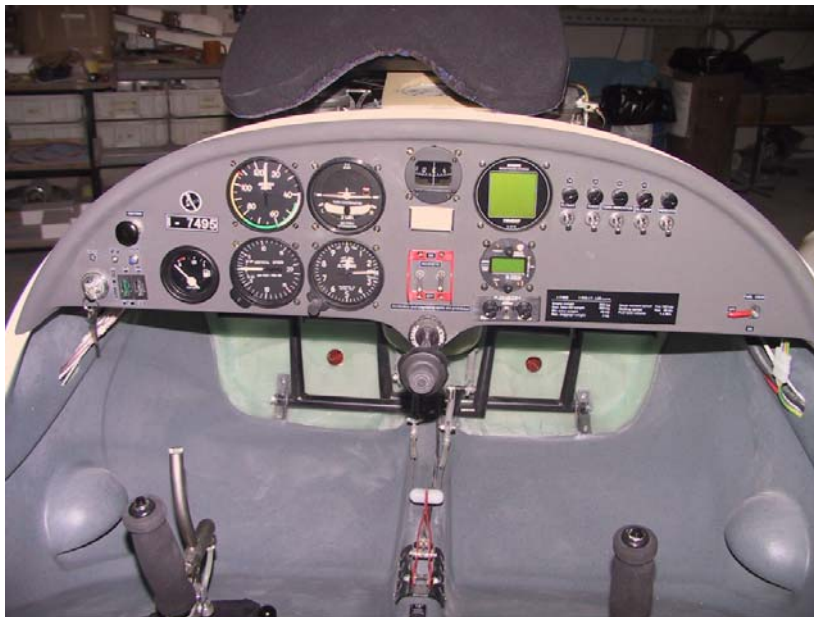
Conventional cockpit layout with the Vne indicated in red at 108 kts on the airspeed indicator.
