SOUTH AFRICAN CIVIL AVIATION AUTHORITY

ACCIDENT REPORT – EXECUTIVE SUMMARY

Date of Accident	21-12-2000	Time of Accident	1708 Z	
Aircraft Registration	ZS-TOW	Type of Aircraft	Gates Learjet 35A	
Pilot-in-command Licence Type	Airline Transport		Licence Valid	Yes
Pilot-in-command Flying Experience	Total Flying Hours	11900.00	Total Hours on Type	1000.00
Type of Operation	Domestic Charter Flight			
Last point of departure	Capetown International Airport			
Next point of intended landing	Johannesburg International Airport

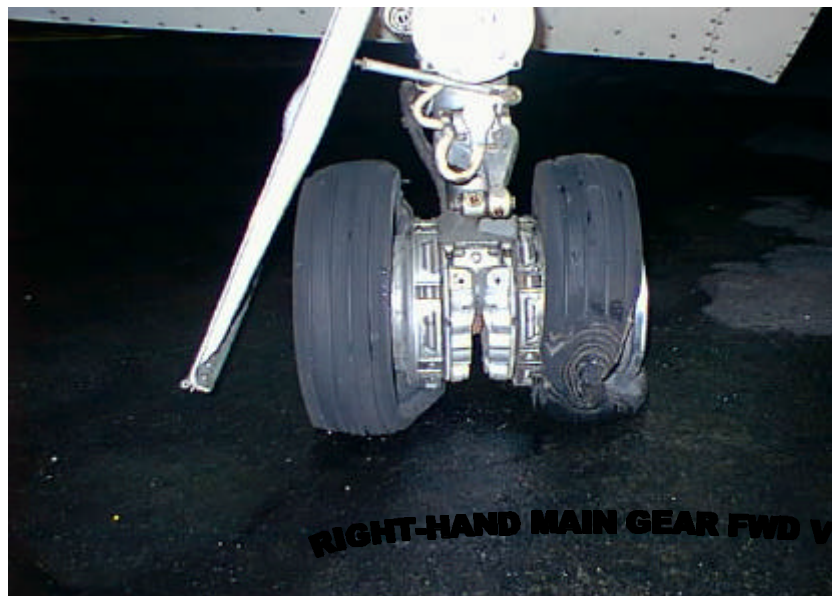
RIGHT-HAND MAIN GEAR FWD VIEW

An inspection of the landing gear revealed flat spots on all four main wheel tyres and the main wheels deflated. However, no signs of overheating or damage were noted on the brake assemblies.

The four main wheel assemblies were replaced and the aircraft flown subsequently without any further problems.
