AIRCRAFT ACCIDENT REPORT AND EXECUTIVE SUMMARY

Reference:	CA18/2/3/7847	
Aircraft Registration	ZS-CRW	Date of Accident	21 August 2004		Time of Accident	1600Z
Type of Aircraft	Cessna 210A		Type of Operation		Sport (Para-dropping)	
Pilot-in-command Licence Type		Commercial	Age	35	Licence Valid	Yes
Pilot-in-command Flying Experience		Total Flying Hours	396,7		Hours on Type	3,5
Last point of departure		Klerksdorp Aerodrome (FAKD)				
Next point of intended landing		Klerksdorp Aerodrome (FAKD)				
Location of the accident site with reference to easily defined geographical points (GPS readings if possible)						
Bush-type terrain 500m short of Runway 36 at Klerksdorp Aerodrome. GPS position: S26°52.947' E026°43.277'						
Meteorological Information		North-westerly wind at 8kts. CAVOK				
Number of people on board	1 + 0	No. of people injured	1	No. of people killed	0	
Synopsis						
<p>The pilot was approached by the operator to assist with a para-dropping operation at Klerksdorp Aerodrome (FAKD). On the day prior to the operation, the pilot completed his type conversion onto the Cessna 210. The conversion training was done by a Grade II instructor. The pilot stated that during the conver

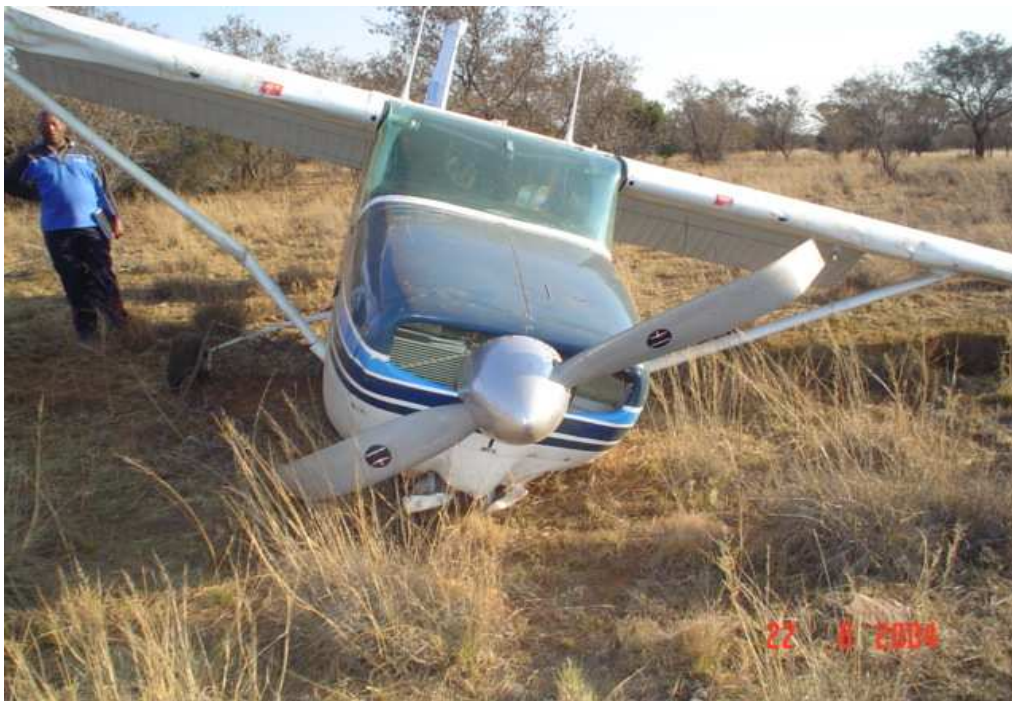
- 1.3.1 The aircraft sustained damage to both wings, the right-hand wing strut, left-hand landing gear, lower engine cowling, lower fuselage, nose landing gear and propeller.

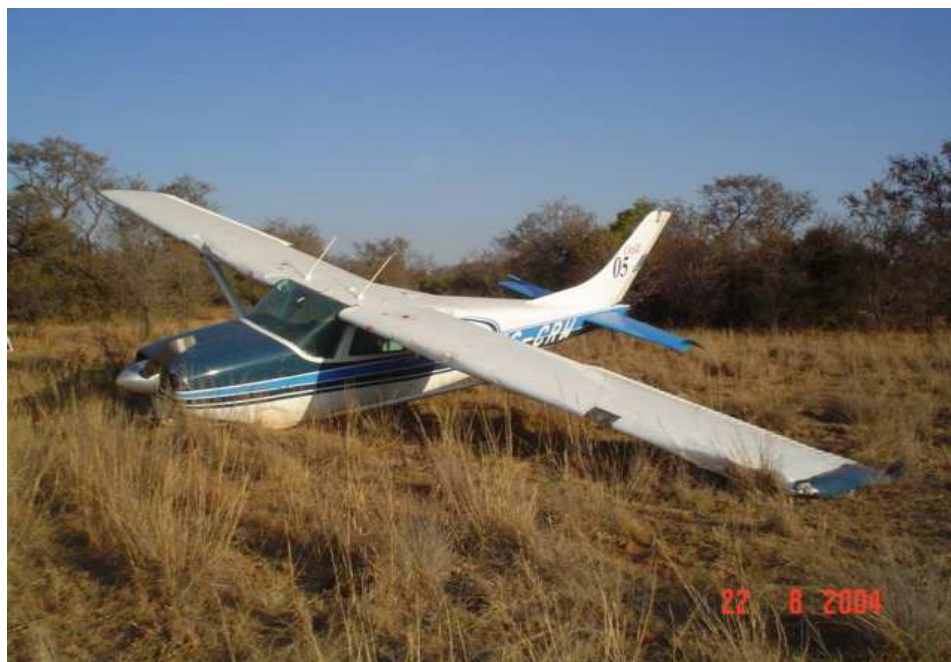
1.12.1 The aircraft struck the trees and executed a forced landing 500 metres short of Runway 36 and to the left of the extended centreline of the runway. The distance from the first impact with the trees to where the aircraft came to a stop was 80 metres.
