EXECUTIVE SUMMARY AND SERIOUS AIRCRAFT INCIDENT REPORT

Reference:	CA18/3/2/0648	
Aircraft Registration	ZS-OAF	Date of Incident	03 May 2008		Time of Accident	0804Z
Type of Aircraft	BOEING B737-453		Type of Operation		Domestic Scheduled Flight	
Pilot-in-command Licence Type		ATP	Age	44	Licence Valid	Yes
Pilot-in-command Flying Experience		Total Flying Hours	11434.9		Hours on Type	1109.7
Last point of departure		Cape Town International Airport (FACT)				
Next point of intended landing		Port Elizabeth Airport (FAPE)				
Location of the incident site with reference to easily defined geographical points (GPS readings if possible)						
During take-off from Runway 19 at Cape Town International Airport.						
Meteorological Information		The weather was fine; Temperature:14°C Wind: Southerly/light.				
Number of people on board	2 + 4 + 143	No. of people injured	0	No. of people killed	0	
Synopsis						
<p>On 03 May 2008, the Boeing B737- 453 was scheduled to fly on a scheduled domestic flight from Cape Town International Airport to Port Elizabeth Airport.</p> <p>At approximately 0800Z, the aircraft taxied to the threshold of Runway 19 at Cape Town International for the take-off. The Captain

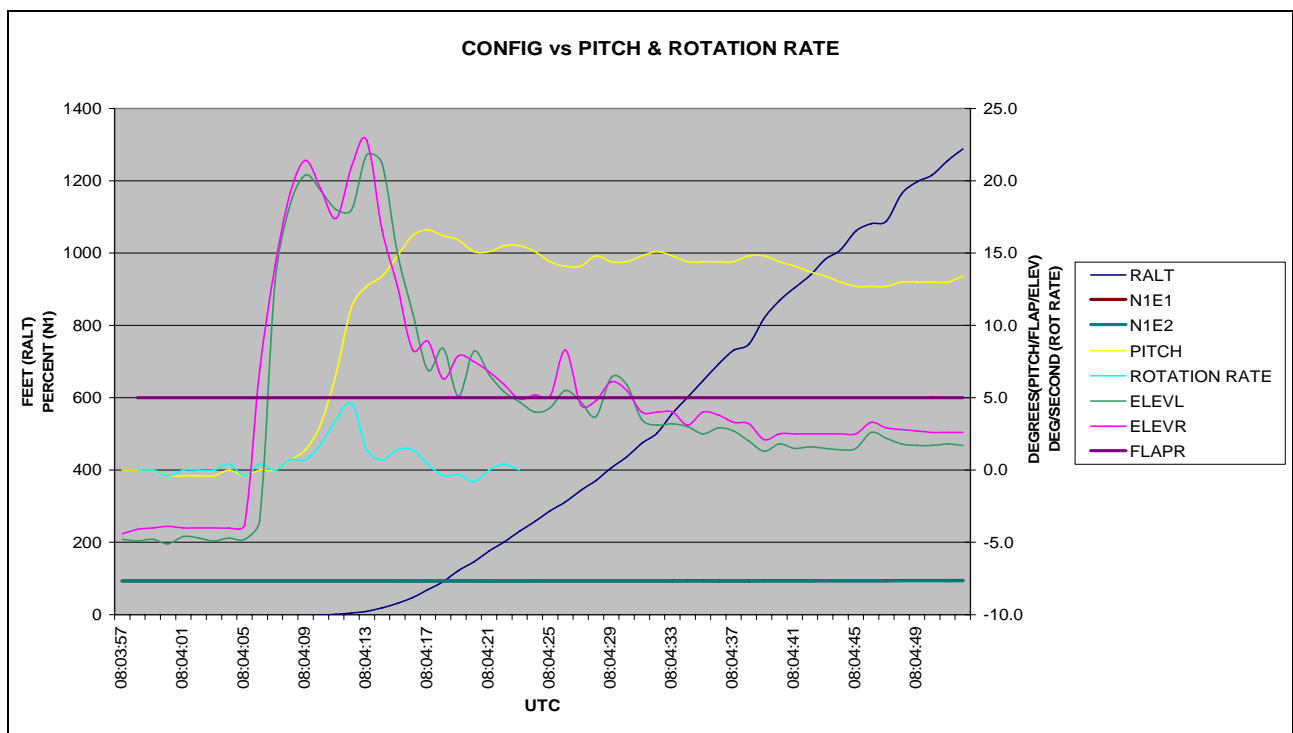
FIGURE 1: CONFIGURATION VERSUS PITCH & ROTATION RATE

- The yellow line on the above graph shows the aircraft pitch of 11.3° when the aircraft became airborne. The red & light green line shows the elevator left & right indication of approximately 20° during the take-off run.
- The dark green horizontal line on the graph shows No. 1 & 2 Engines N1 engine speed at approximately 93.5%. The purple horizontal line shows the flaps extended to 5° during take-off.

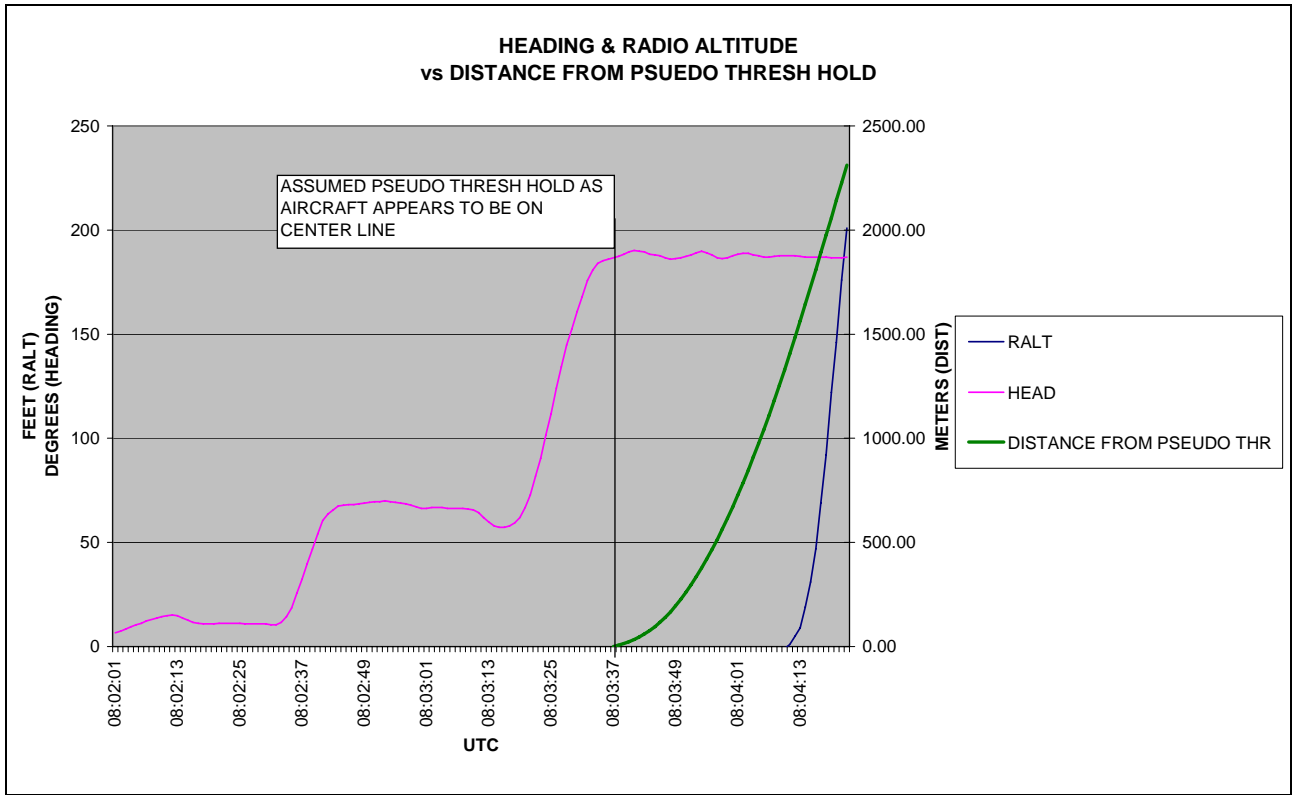
HEADING & RADIO ALTITUDE

- The red line on the graph shows the aircraft's heading during taxiing at 0802.01Z to the threshold of Runway 19 (heading 190°).
- The blue line shows the aircraft becoming airborne (air-mode) at approximately 0804:12Z (main & nose landing gear wheels off the runway during rotation)
- The green line shows the aircraft's distance of approximately 1850m from the threshold to rotation.

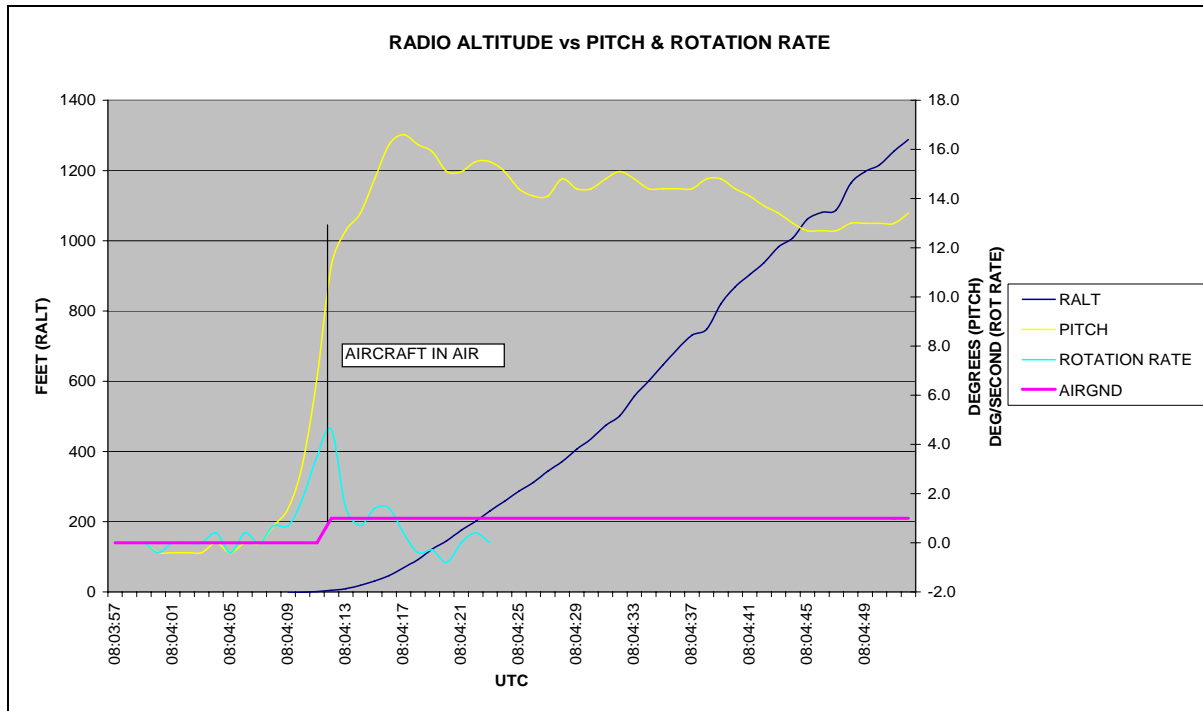
RADIO ALTITUDE VERSUS PITCH & ROTATION RATE

- The red line shows the aircraft during the take-off roll which became airborne at approximately 0804:13
- The yellow line shows the average degrees of pitch of approximately 4.6° before the aircraft became airborne at approximately 0804:13Z.
- The dark blue line shows the radio altitude (RALT) from 0 climbing through 1300ft.

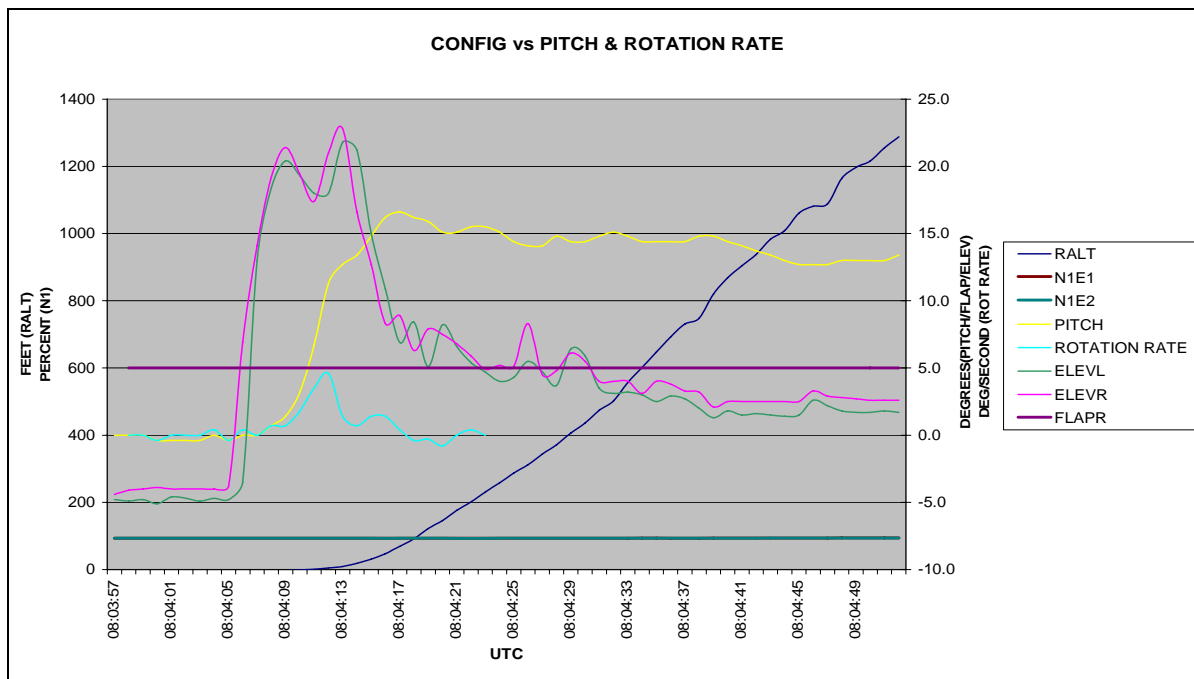
CONFIGURATION VERSUS PITCH & ROTATION RATE

- The Graph shows the combined figures as shown in Figure 1 and 2 but also includes the dark green line which indicates No. 1 & 2 Engines N1 engine speed at approximately of 93.5 %. The horizontal purple line shows the flaps extended to 5° during take-off.
