AIRCRAFT ACCIDENT REPORT AND EXECUTIVE SUMMARY

Reference:	CA18/2/3/8619	
Aircraft Registration	ZU-GAM	Date of Accident	22 February 2009		Time of Accident	1515Z
Type of Aircraft	Pipistrel Taurus Glider		Type of Operation	Private		
Pilot-in-command Licence Type	Glider	Age	50	Licence Valid	Yes	
Pilot-in-command Flying Experience	Total Flying Hours	Approximately 1101.4		Hours on Type	Unknown	
Last point of departure	Geluk Private Game Lodge – Limpopo					
Next point of intended landing	Geluk Private Game Lodge – Limpopo					
Location of the accident site with reference to easily defined geographical points (GPS readings if possible)						
Geluk Private Game Lodge, approximately 86 km north-west of Thabazimbi, GPS Position: S24°20,958', E026°58,467'; Elevation = 2 920 ft ASL						
Meteorological Information	Wind: 340 @ 7 knots ; Temperature: 27 °C; CAVOK					
Number of people on board	1+0	No. of people injured	0	No. of people killed	1	
Synopsis	<p>A pilot took off unaccompanied from his private farm on a private flight on 22 February 2009 at approximately 1513Z. Witness reported that he saw the aircraft climbing out and after it had reached a considerable height, he heard what sounded

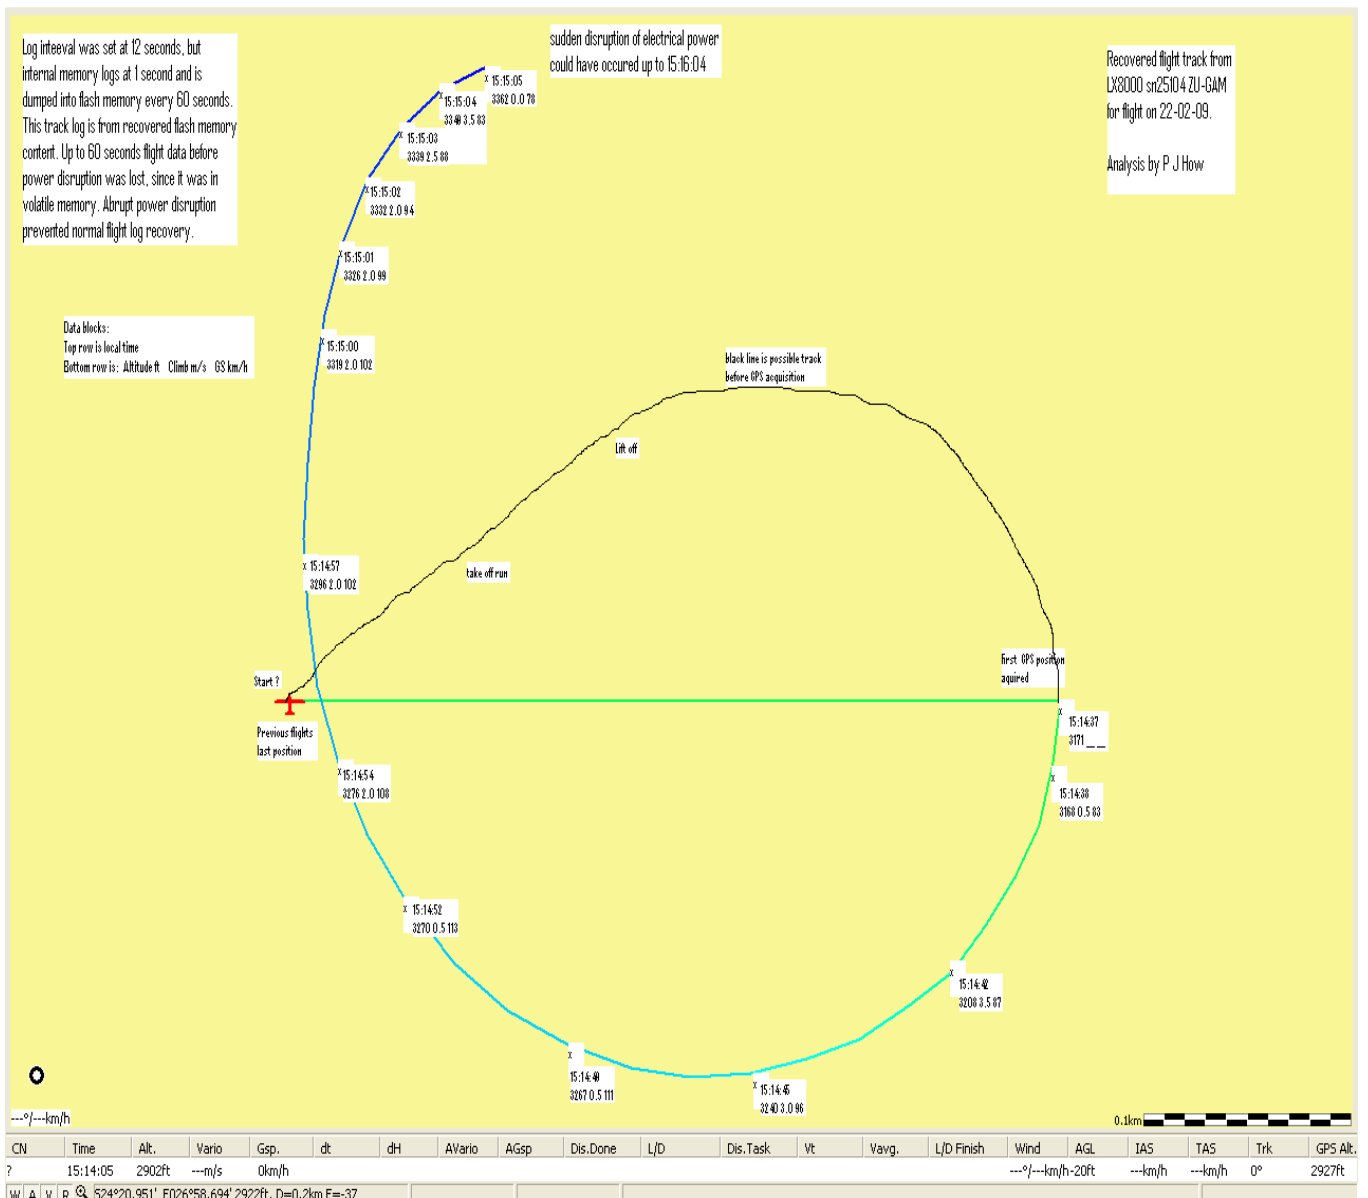
Figure 1: Flight data

1.1.6. Figure 1 shows the flight data as extracted from an LX 8000 digital navigation unit which was found fitted to the aircraft.

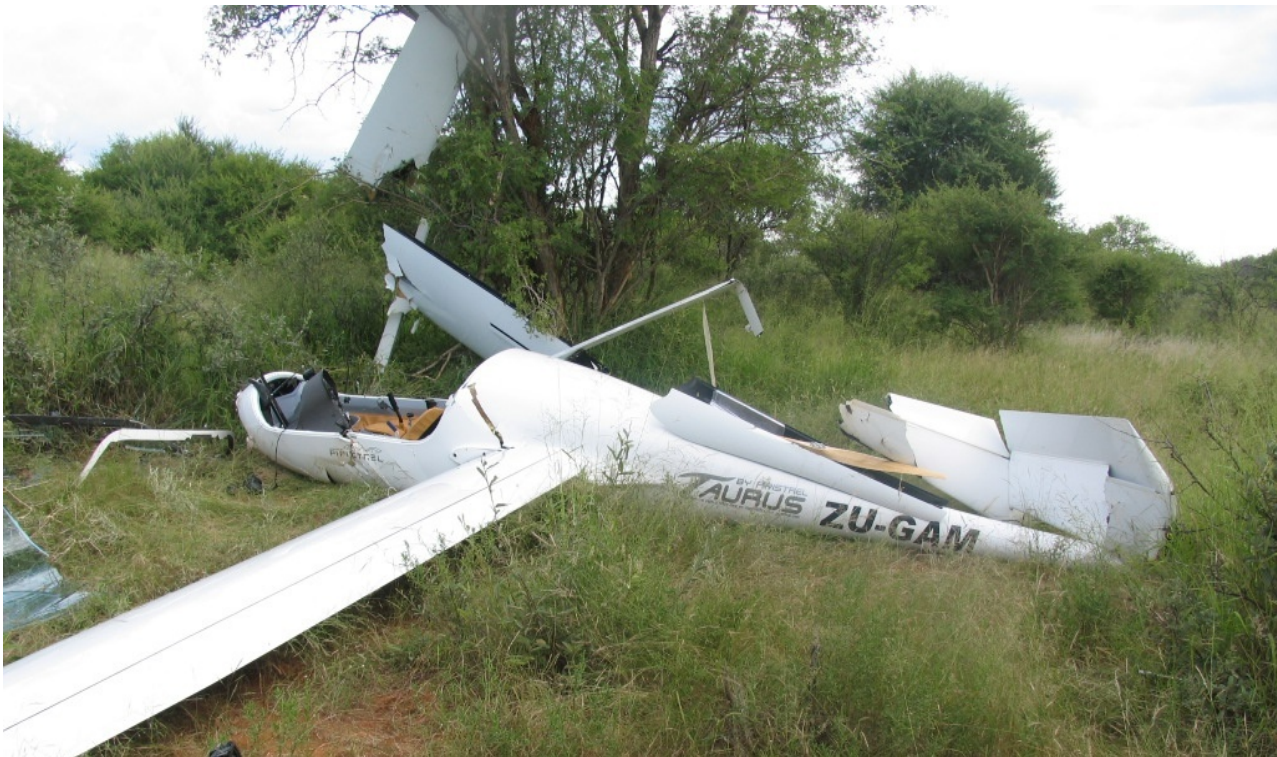
1.3.1. The aircraft was destroyed.

Photo 1: Damage to aircraft

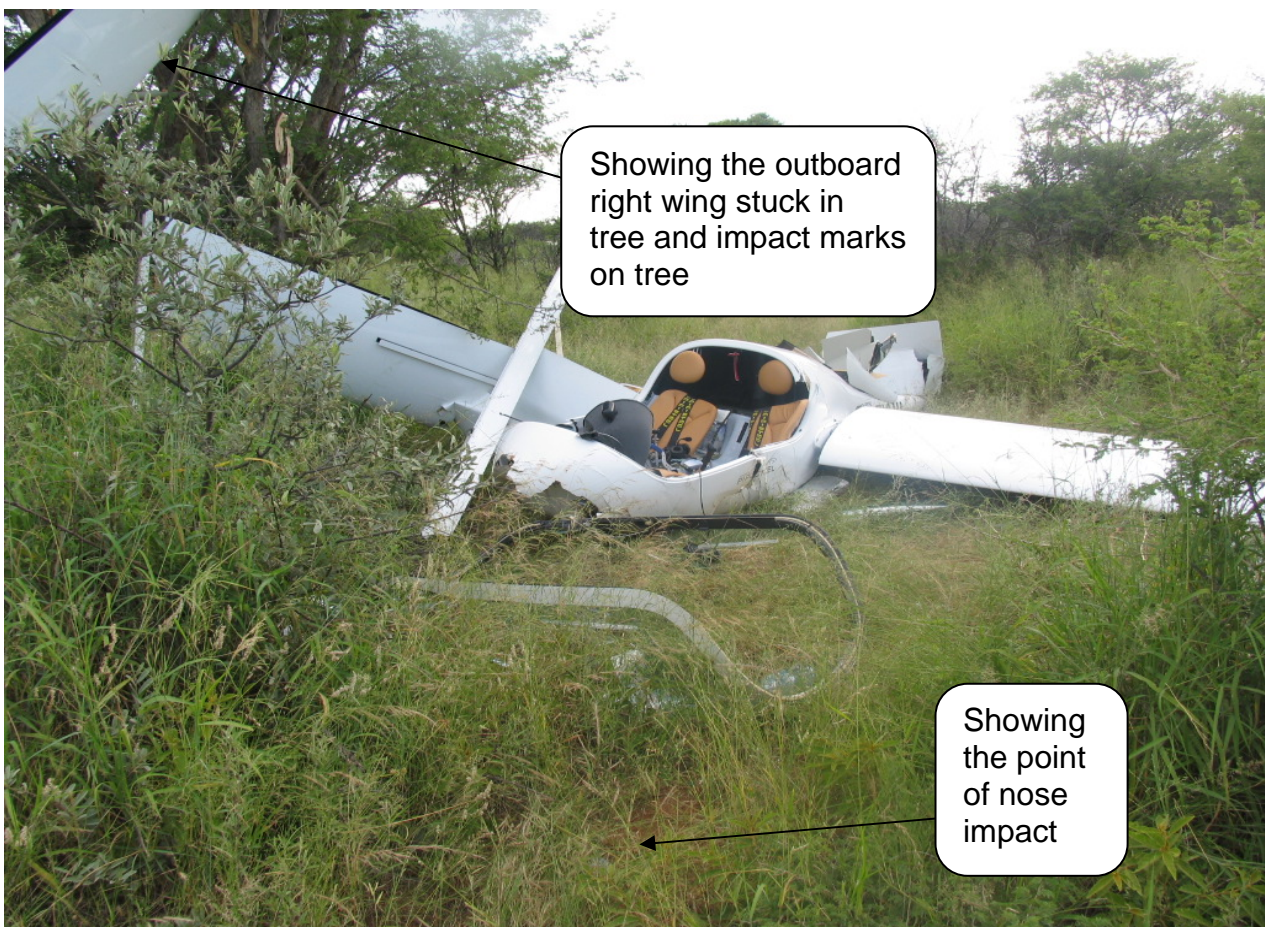
1.12.1. The aircraft was seen tumbling tail over nose towards the ground before crashing against a tree. The right wing was caught in the tree.

1.12.2. The aircraft seemed to have been spinning in an anticlockwise direction when it hit the tree, because it was twisted into a clockwise direction and the right wing was severed approximately 2,5 m from the wing root.

Photo 2: View from the front and impact marks

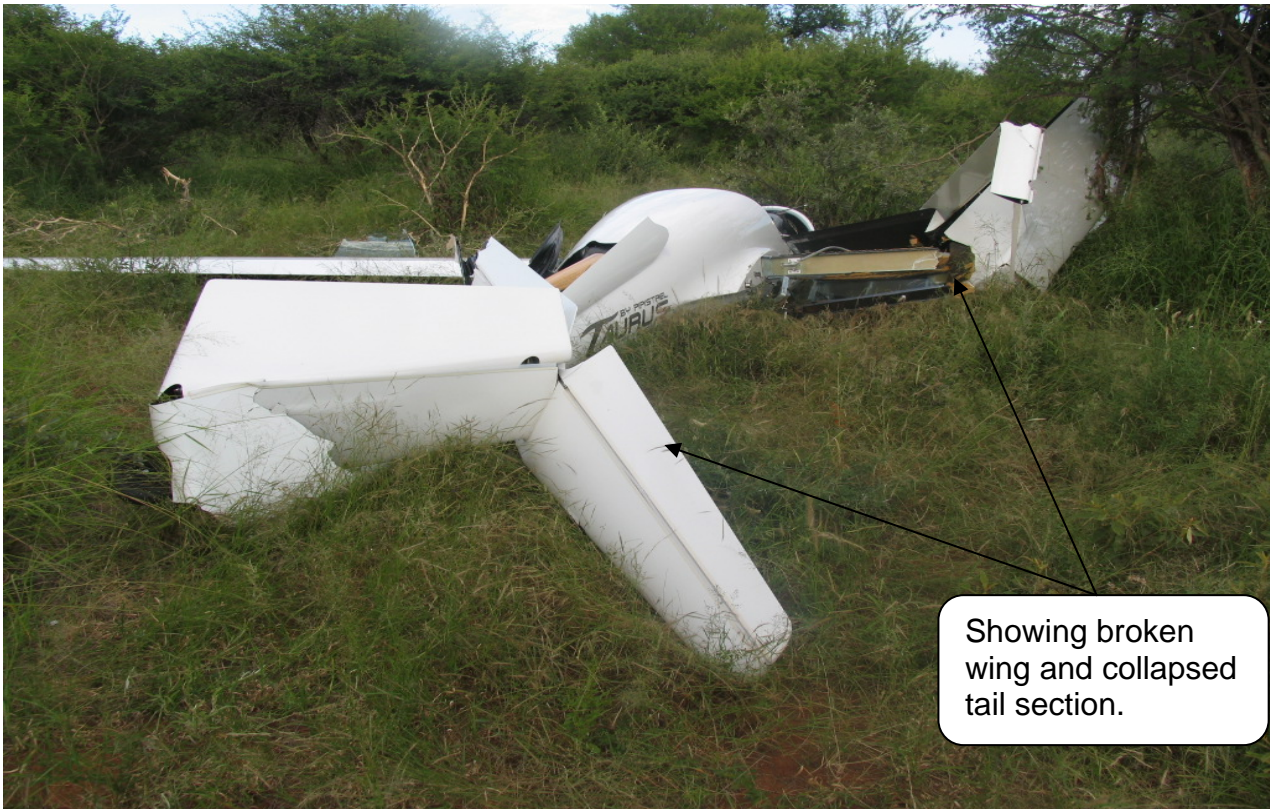
Photo 3: View from behind and aircraft damage

1.12.4. The tail-plane and fin were severed from the fuselage during impact, but were kept retained in position by the rudder cables.

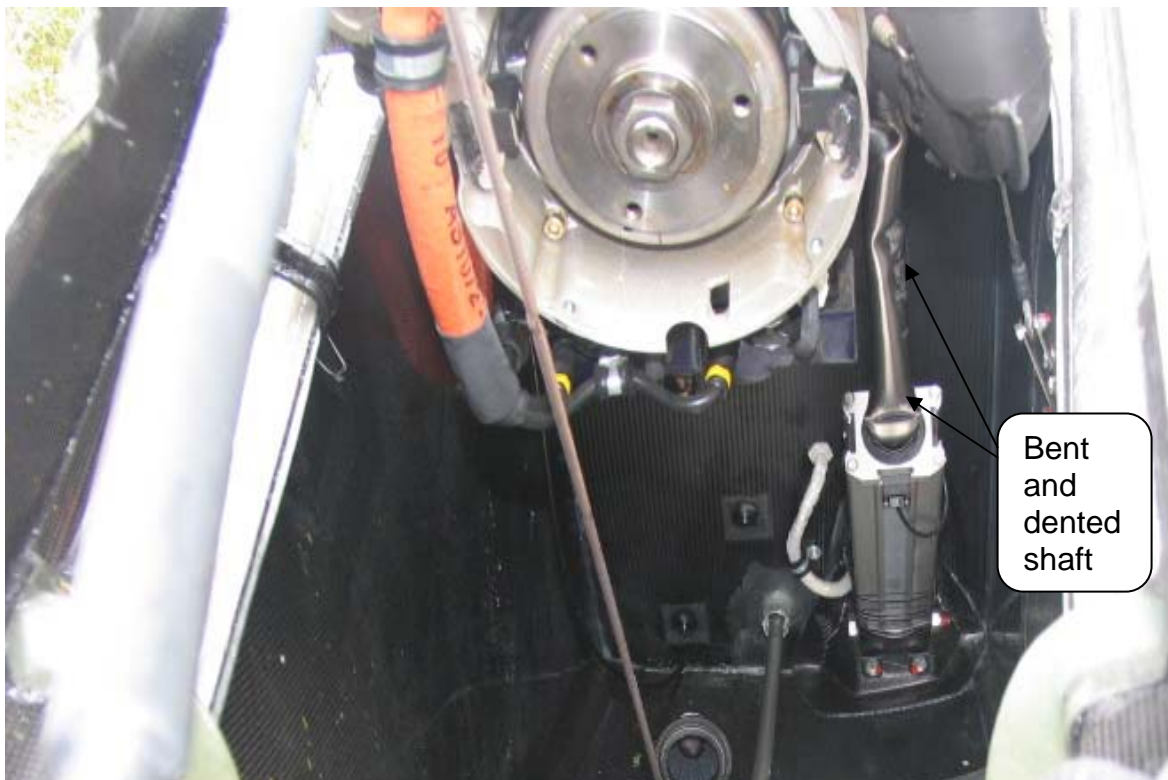
1.16.2. The actuator shaft that extends and retracts the engine, which also helps keep the engine in the extended position when in use, was found bent. It also had several dents and scuff marks, and it was therefore also concluded that the engine was not fully retracted when the aircraft crashed.

Photo 4: Bent extension/retraction shaft

The engine pylon extension cylinder push rod was found to have buckled in three places from a fully extended, erect position, indicating that the engine retraction process had not yet begun. The propeller was also not in its détente during initial impact, as evidenced by the witness marks and damage to the engine doors and propeller, which showed that the propeller had been about 15 deg. off the stowing position at the time of impact.
