**INTERIM REPORT IN RESPECT OF THE INVESTIGATION INTO THE CAUSE(S) OF AN ACCIDENT INVOLVING AN EMBRAER 135 LR AIRCRAFT, ZS-SJW DURING LANDING AT GEORGE AIRPORT ON 7 DECEMBER 2009.**

**Issued by the AIID**

22 December 2009

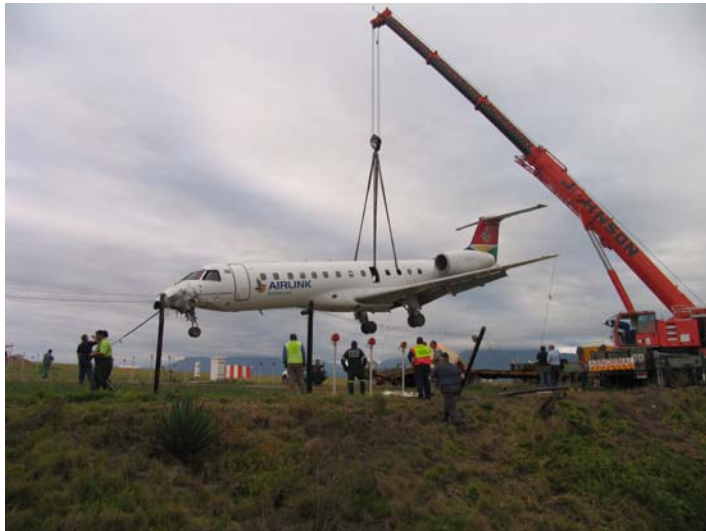
5.1 The aircraft suffered extensive damage especially to the nose and aft fuselage area when it came to rest in a nose down attitude on a public road.

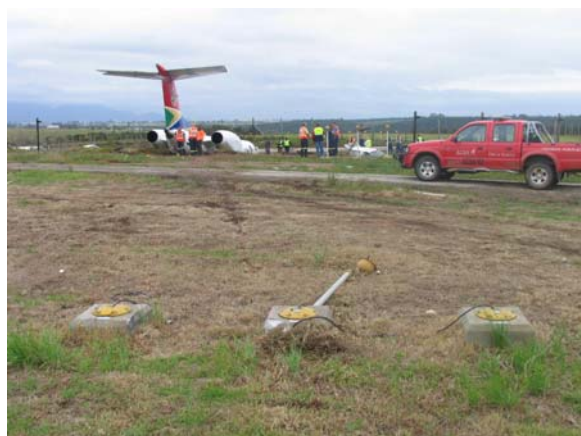
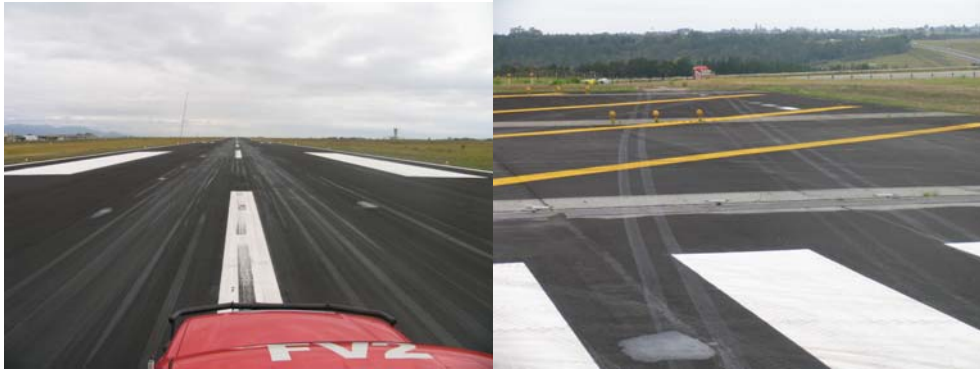
NOTE: The runway was resurfaced during the course of the year. This task was completed in November 2009.

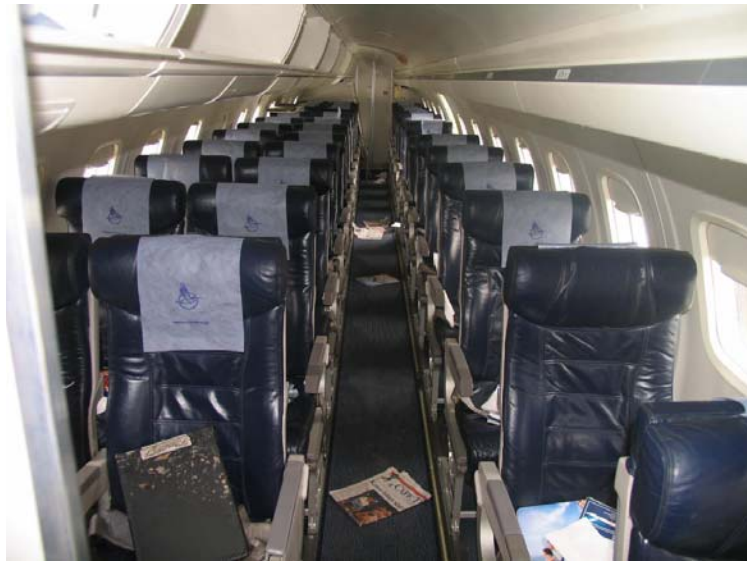
- 9.1 The accident was survivable as the cockpit and cabin area remained intact. The cockpit crew, as well as the cabin attendant, was wearing their four point safety harnesses. Due to the collapse of the nose landing gear assembly the entire cockpit floor structure where pushed upwards resulting in a substantial deformation. The first officer seated on the right-hand side, right lower leg had to be freed by rescue personnel before he was able to vacate the cockpit.
- 9.2 All passengers were wearing their aircraft equipped safety harness (lap straps) with only one seat (7A) back rest collapsing partially to a 45° angle.
