PRELIMINARY SERIOUS INCIDENT REPORT

Serious Incident
- Preliminary Report -
AIID Ref No: CA18/3/2/1368

On Wednesday morning, 25 August 2021 at 0721Z, a Piper PA-28R-200 (Prima 285) aircraft with registration ZS-PTV and a Boeing 737-400 (Safair 142) aircraft with registration ZS-JRE were both approaching East London Aerodrome (FAEL) at about the same time. The FAEL aerodrome control instructed Prima 285 (ZS-PTV) to make a right turn to allow Safair 142 (ZS-JRE) to land after air traffic control (ATC) cleared it for landing on Runway 11 at FAEL; however, the pilot of Prima 285

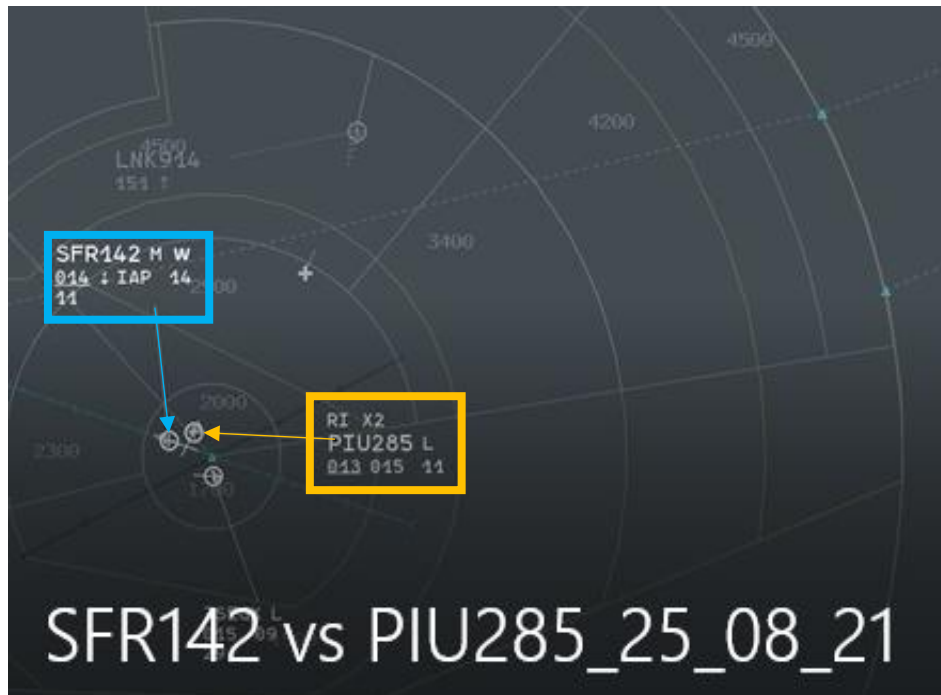
Figure 3: Safair142 and PIU285 at 07:25:08 hours, at which time the vertical separation was around 100ft and a lateral separation of around 0.2nm (370.4m).

- 1.1.6. At 07:24:28Z, ATC cleared Safair 142 (ZS-JRE) to land. At 07:25:12Z, Safair 142 (ZS-JRE) enquired from ATC if he was aware of traffic turning base leg for Runway 11 in front of them.

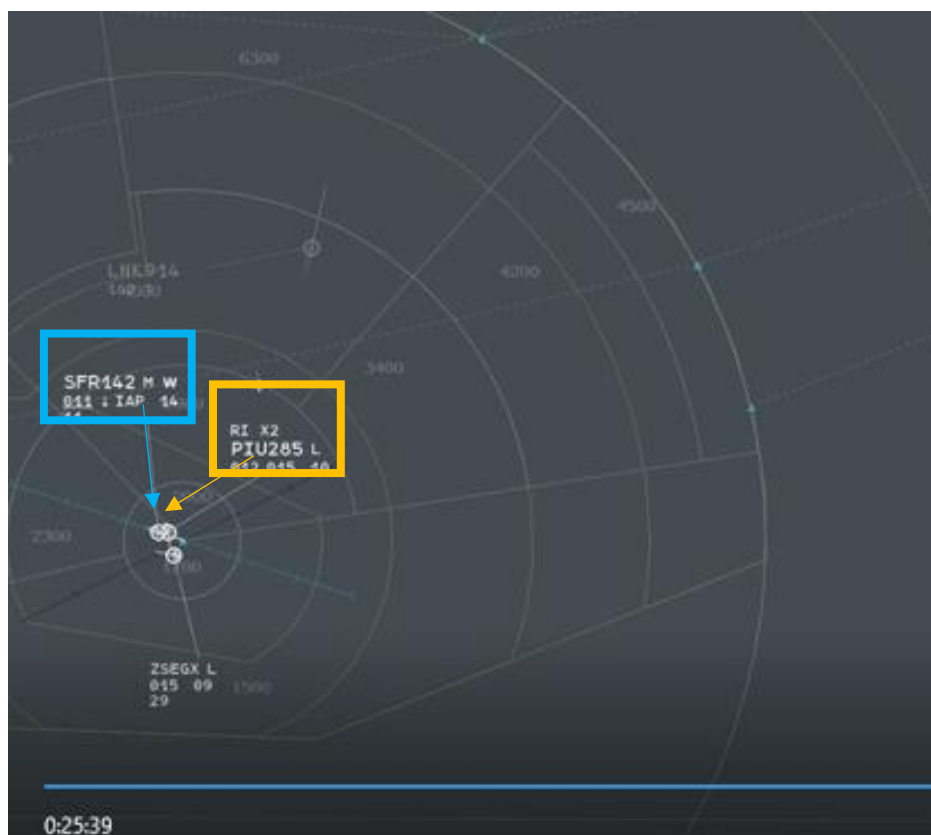
Figure 4: SFR142 and PIU285 at 07:25:39 hours, at which time the vertical separation was around 100ft and no lateral separation.

- 1.1.7. At 07:25:27Z, ATC instructed the pilot of Prima 285 (ZS-PTV) to turn right and report final approach for Runway 11. At 07:25:35Z, ATC again instructed the pilot of Prima 285 (ZS-PTV) to turn right immediately, this time with a much more forceful tone. However, the pilot continued with the left turn.
