SOUTH AFRICAN CIVIL AVIATION AUTHORITY
(SACAA)

ACCIDENT INVESTIGATION REPORT

FINAL REPORT

**Jetstream Aircraft 4100 ZS-NRM:
Loss of control after engine failure
and misidentified engine shutdown
after take-off from Durban Airport,
South Africa
on 24 September 2009**

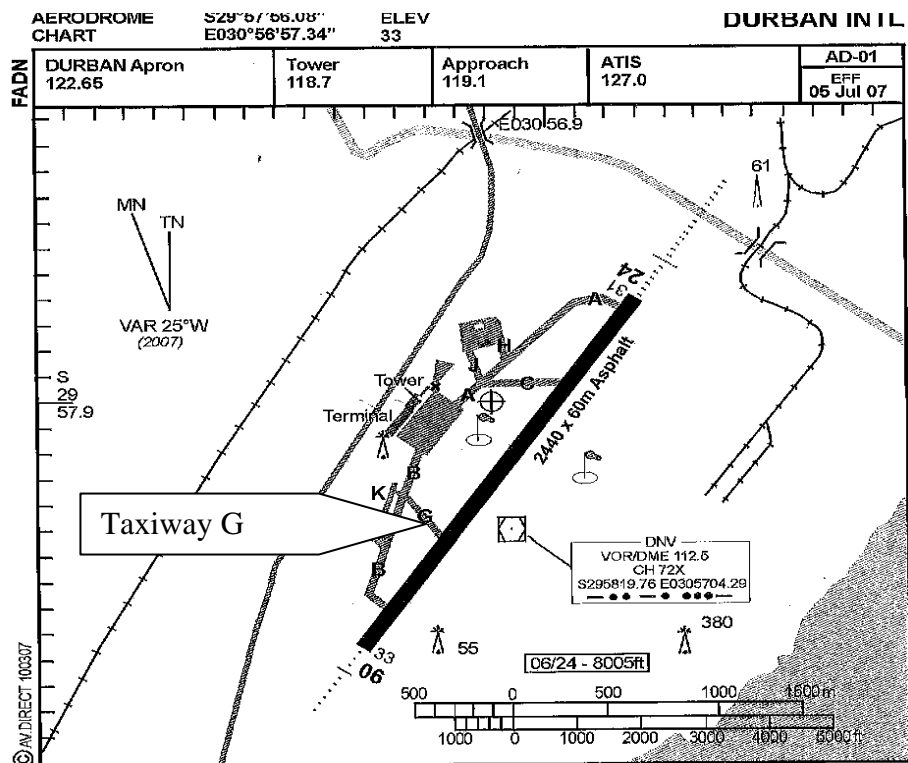
Figure 2. Durban International Airport.

1.1.5 The tower controller later stated that the aircraft was still on the runway and in the vicinity of the intersection with taxiway G when he became aware of smoke coming from it. He could not, however, make out exactly from which part of the aircraft the smoke was coming from.

- 1.1.6 The technician on the ground in parking bay A4 reported watching the accident aircraft take off. He stated that the takeoff roll appeared uneventful but that just after rotation there was “a large cloud of black smoke that erupted from the right-hand engine”. During the climb, the smoke changed colour to a whitish-brown and diminished in volume. As the aircraft crossed the end of the runway, it appeared to yaw to the right and then started to lose altitude. It then veered suddenly to the left, rapidly losing altitude, before disappearing from view.
