## AIRCRAFT ACCIDENT REPORT AND EXECUTIVE SUMMARY

Reference:	CA18/2/3/8067	
<b>Aircraft Registration</b>	ZU-VOS	<b>Date of Accident</b>	4 February 2006		<b>Time of accident</b>	1200Z	
<b>Type of Aircraft</b>	Lambda UFM-13	<b>Type of Operation</b>		Private Flight			
<b>Pilot-in-command Licence Type</b>		Private Pilot	<b>Age</b>	48	<b>Licence Valid</b>	Yes	
<b>Pilot-in-command Flying Experience</b>		Total Flying Hours	1 100.0		Hours on Type	17.1	
<b>Last point of departure</b>		Port Alfred Aerodrome (FAPA)					
<b>Next point of intended landing</b>		Port Alfred Aerodrome (FAPA)					
<b>Location of the accident site with reference to easily defined geographical points (GPS readings if possible)</b>							
Port Alfred Aerodrome Runway 10L (left).							
<b>Meteorological Information</b>		Surface wind; 010°/15 to 18 kts, Visibility; 10 km.					
<b>Number of people on board</b>	1 + 1	<b>No. of people injured</b>	0		<b>No. of people killed</b>	0	
<b>Synopsis</b>

<b>Probable Cause</b>							
Due to limited controllability following the failure of the right-hand flapperon in flight, due to a flutter, a hard landing followed.							
<b>IARC Date</b>				<b>Release Date</b>

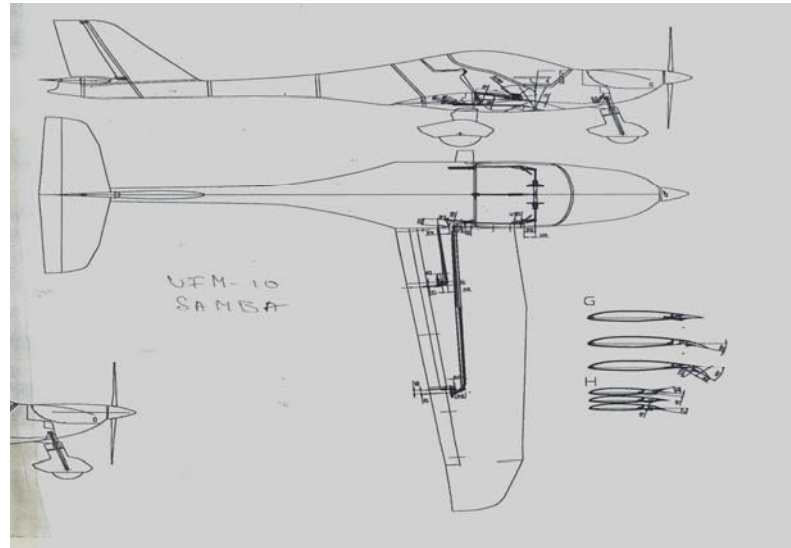
- (i) It is possible that the flapperon may have been exposed to some sort of fluttering during flight, causing the wing hinges to fail and allowing the movement clearance within the push – pull control system to be greater than allowed for by its design. The flapperon could now have a deflection up or down, causing the safety guard strip to become dislodged from its position in the wing trailing edge. The flapperon then got stuck in the full up position, leaving the flight control stick as the only free-moving mechanism in the control system; with the pilot applying a force to the control stick and an opposing fluttering force exerted in the control system from the flapperon. As a result the weakest link in the control system, the eyeball end, failed. The flapperon was loose from the wing on the in board side, exposed to undetermined loads and fluttering vibration, causing the flight control surface to fail and separate from the wing in flight. Have in mind that the information, sequence of events

A schematic view of the flaperon control layout for the aircraft type in question

2.2 Further investigation showed evidence that the push/pull control rod of the right-hand side flapperon had failed. The flapperon control push/pull rod became disconnected at the eyeball fitting, where two rivets were installed. The rivets could not be found inside the aircraft. The failure of the attachment fitting was attributed to the extreme forces that acted on the control system during the failure of the flapperon control surface. The aircraft had gone through different quality control checks, when it was assembled at the manufacturer, prior to it having been shipped to South Africa. Again upon arrival in South Africa, at the facility of the local manufacturer/distributor, all the flight control rods and primary flight control surfaces were inspected for security of installation and attachment.

- 4.4 It is recommended that the SACAA calls on the inspection of the flapperon control system of EFIS equipped Lambada aircraft to verify that no damage exists that may have been unintentionally caused.
