**INTERIM REPORT IN RESPECT OF THE INVESTIGATION INTO THE CAUSE(S) OF AN ACCIDENT INVOLVING AN EMBRAER 135 LR AIRCRAFT, ZS-SJW DURING LANDING AT GEORGE AIRPORT ON 7 DECEMBER 2009.**

**Issued by the AIID**

22 December 2009

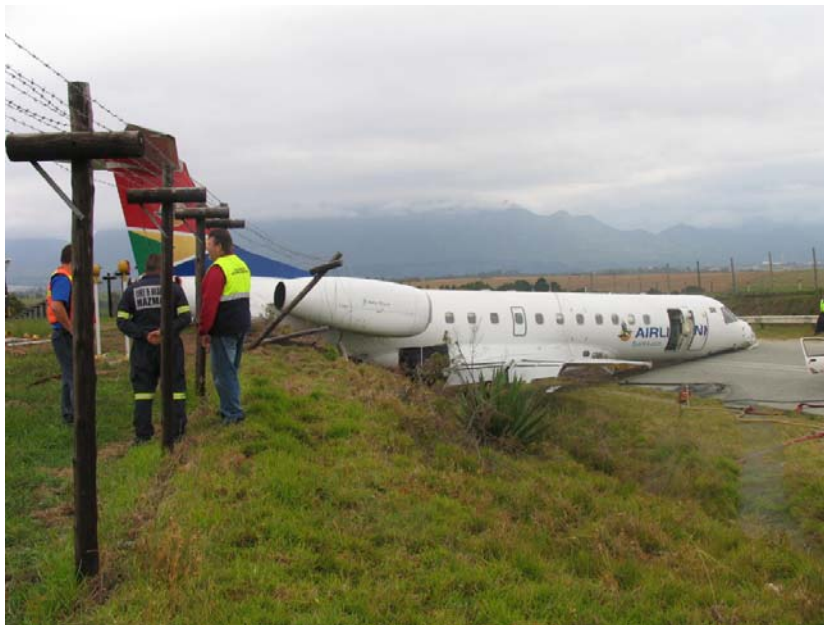
The accident occurred during daylight conditions at a geographical position determined to be South 34°00.306' East 022° 23.534' at an elevation of 610 feet above mean sea level (AMSL).

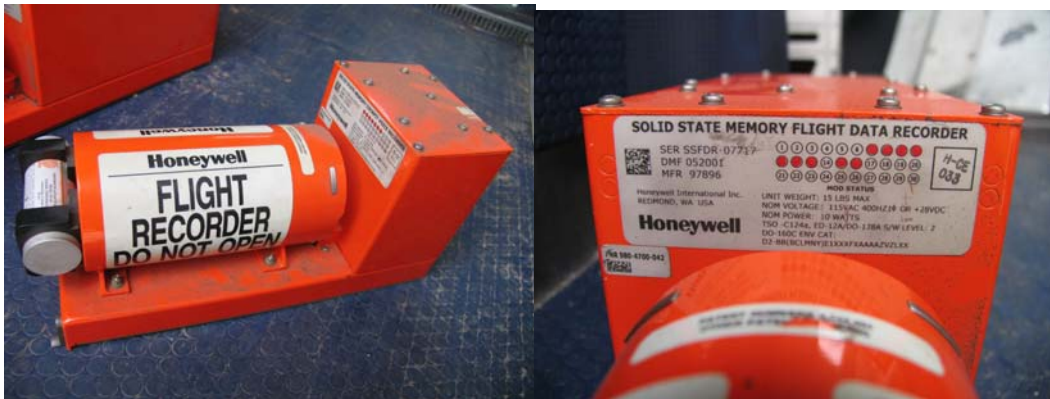
The aircraft was equipped with a Honeywell solid state cockpit voice recorder (CVR), model CVR120-03737 as well as a Honeywell solid state flight data recorder (FDR), model SSFDR-07717.
